The Definition of Taper Failure in Metal-On-Metal Modular Total Hip Replacement

The Definition of *Taper Failure* in Metal-On-Metal Modular Total Hip Replacement

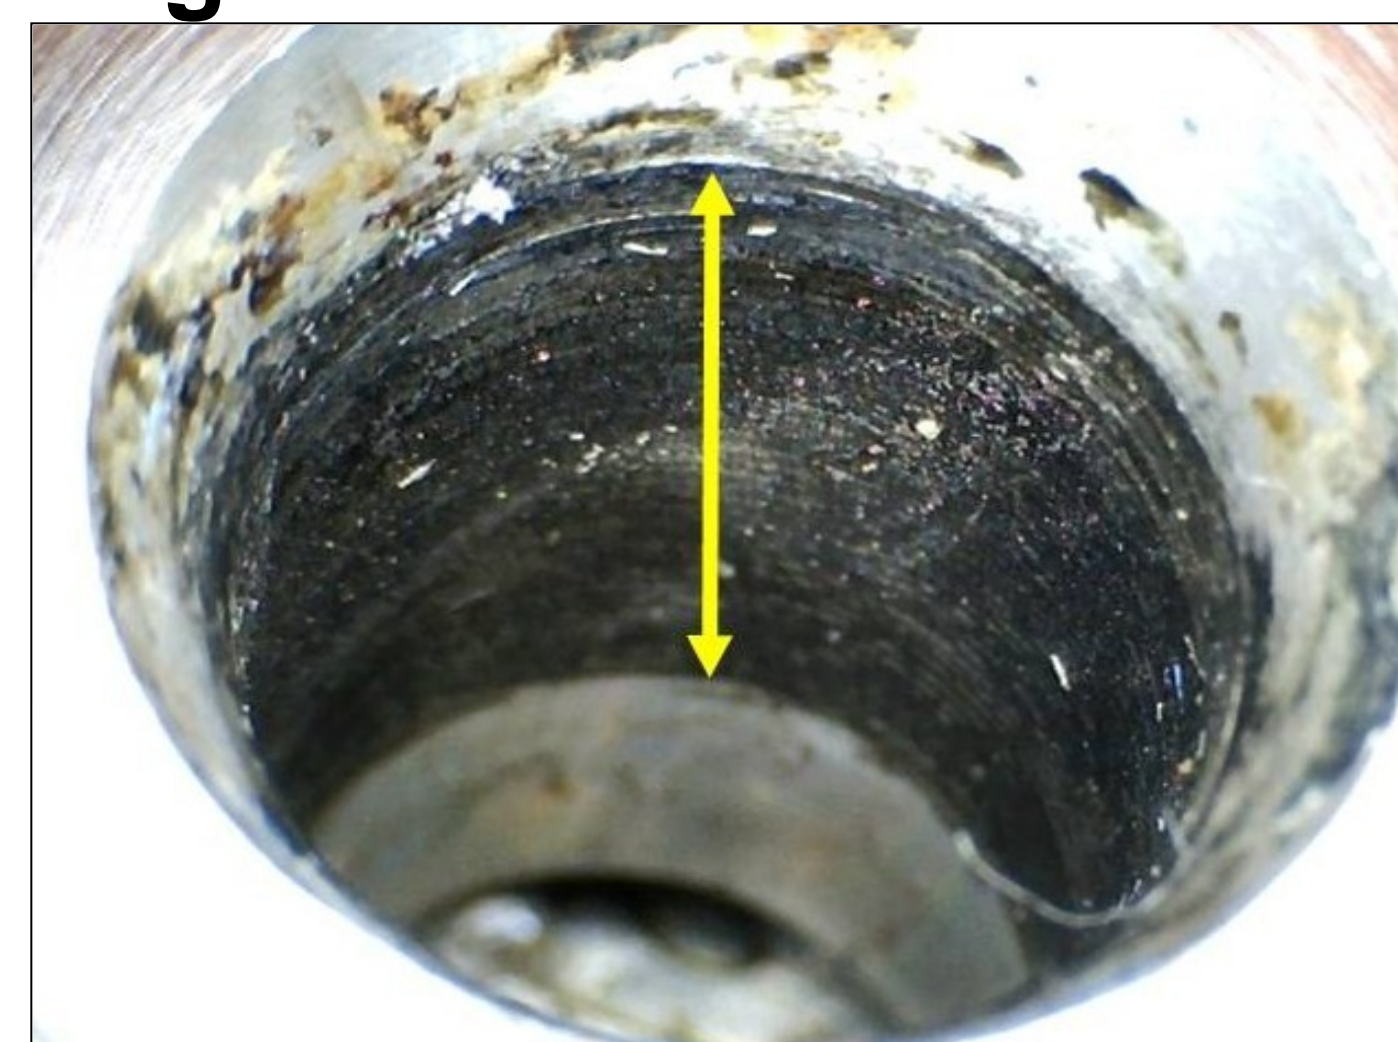
Figure 1 – A 9mm/10mm female taper retrieved after 56 months with very severe corrosion
 Figure 2 – A 12mm/14mm taper retrieved after 40 months with a the zone of imprinting (red arrow)
 Figure 3 – A scanning electron microscopy image showing a femlae taper surface with typical mechanical wear and imprinting, with black corrosion debris between the imprinted grooves.

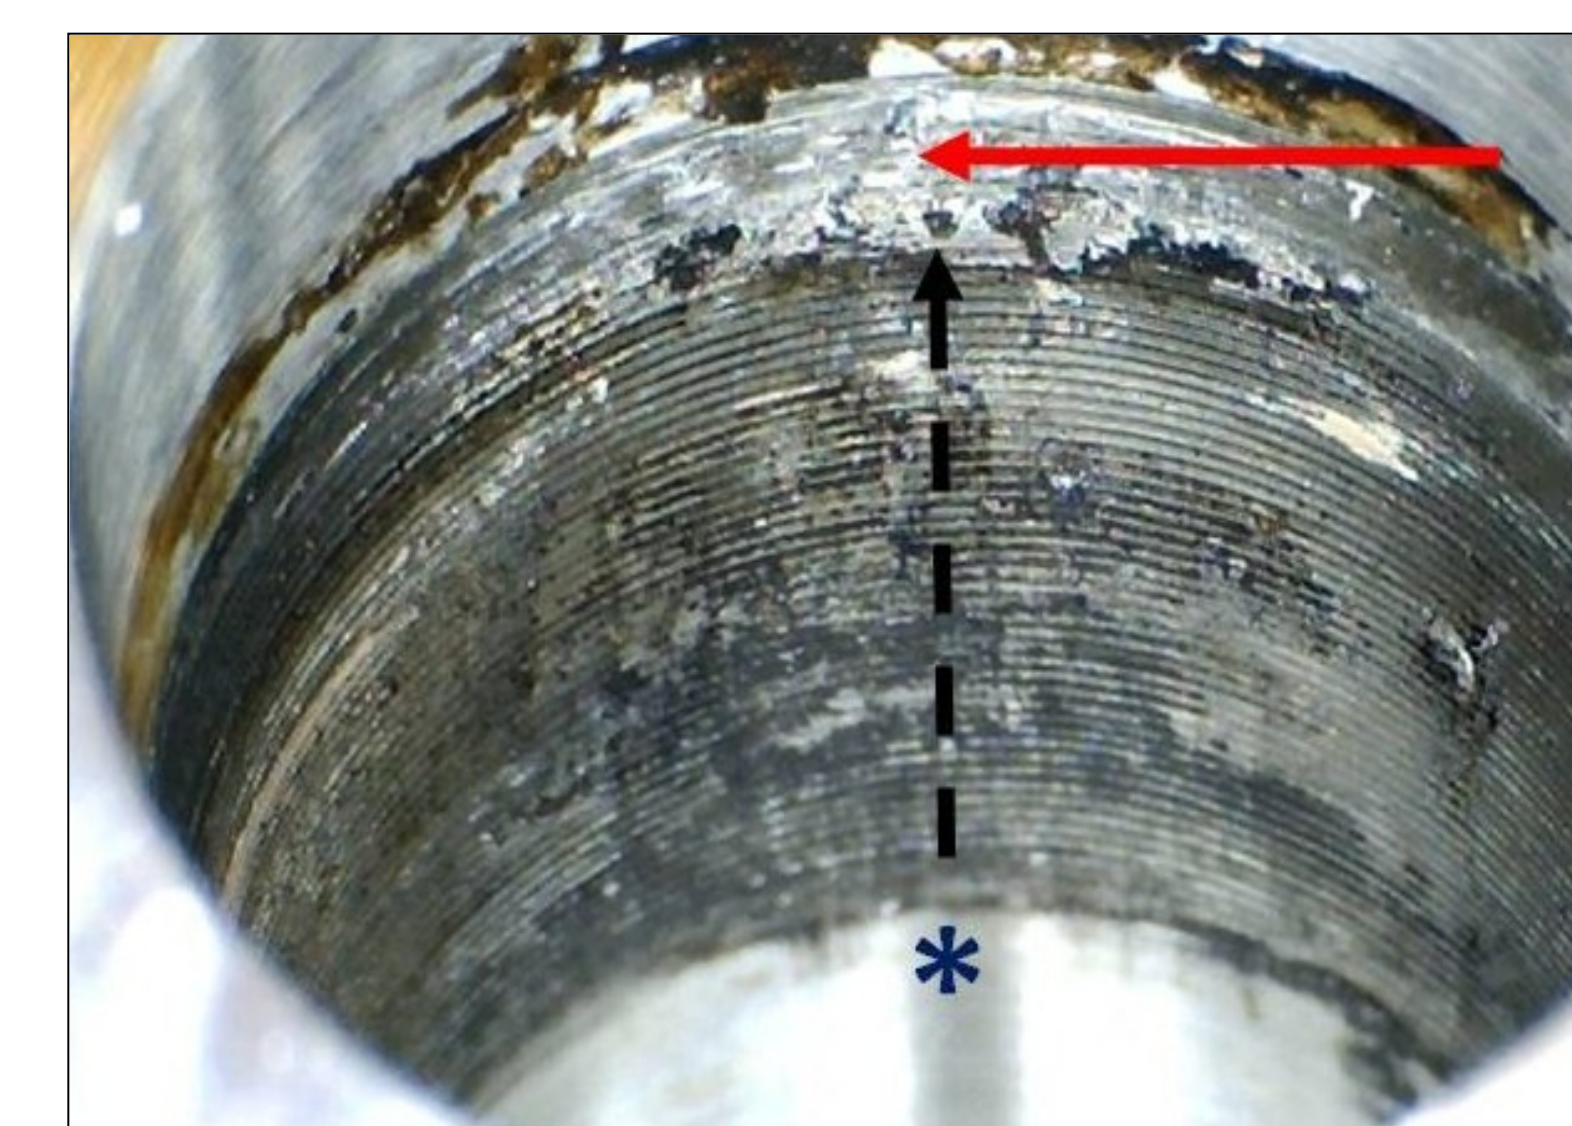
Figure 4a

4a) A photograph of a female taper surface with severe corrosion. A wear scar is visible at the superficial margin where the base of the trunnion was in contact (red arrow).

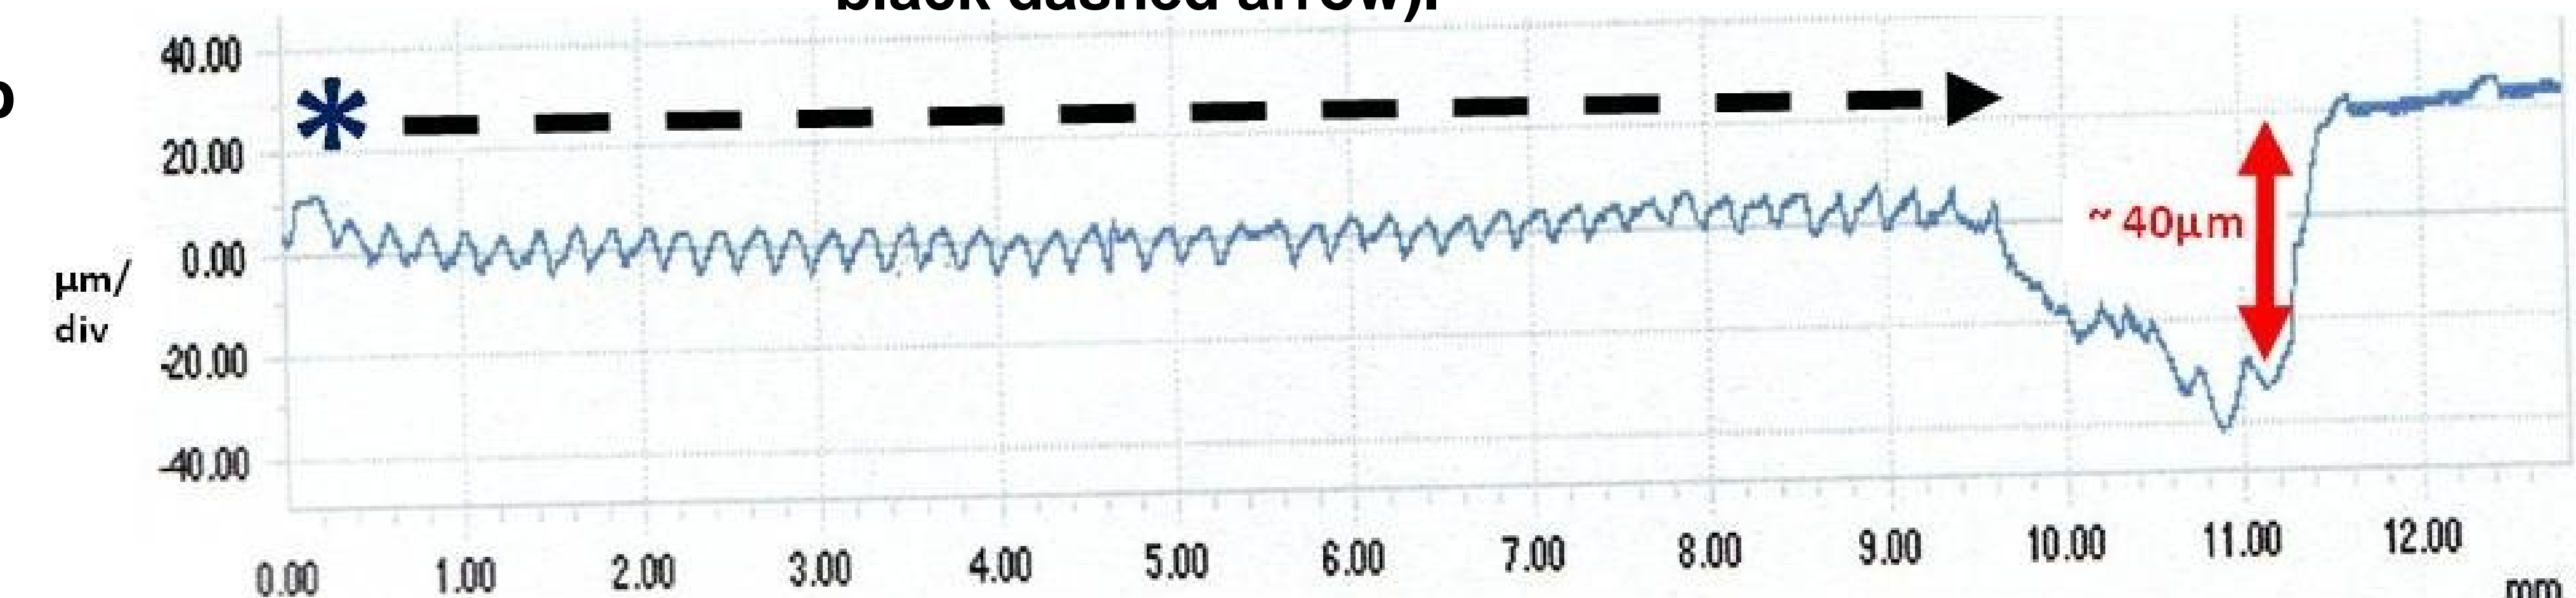
Figure 4b

4b) A profilometry tracing of the same female taper surface. The trace at 0.00mm indicates the surface profile at the base of the bore (shown by asterisk) and the profile at 12mm corresponds to a location near the rim of the bore. The red arrow shows material loss to a depth of approximately 40µm. The ridged pattern can be seen over a distance of between 9-10 mm leading up to the wear scar (shown by the black dashed arrow).
