# CORROSION IS THE MAIN MECHANISM OF MATERIAL LOSS AT THE TAPER JUNCTION OF LARGE HEAD METAL ON METAL HIP REPLACEMENTS

A.K. Matthies<sup>1</sup>, R. Racasan<sup>2</sup>, P. Bills<sup>2</sup>, A. Panagiotidou<sup>1</sup>, L. Blunt<sup>2</sup>, J. Skinner<sup>1</sup>, G. Bluun<sup>1,3</sup>, A.J. Hart<sup>1,3</sup>

<sup>1</sup>Royal National Orthopaedic Hospital, UK, <sup>2</sup>University of Huddersfield, UK, <sup>3</sup>University College London, UK

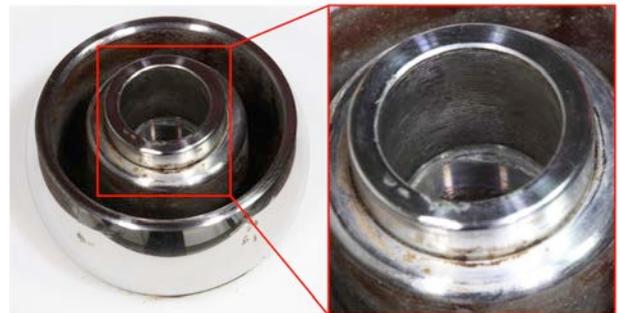
**Results:** 81 out of 90 (90%) retrieved head and stem taper surfaces showed evidence of corrosion. Of these, 14 were classified as mildly corroded, 26 as moderately corroded, and 41 as severely corroded. Microscopy also revealed evidence in all cases that the machined thread of the stem taper had been transferred, or “imprinted” onto the head taper surface. An example of severe corrosion and “imprinting” is shown in Figure 1. SEM confirmed the presence of corrosion debris, pits and fretting damage. Volumetric wear of the taper surfaces was significantly lower than the combined volumetric wear of the bearing surfaces ( $p = 0.015$ ).

Figure 1: Photographs showing a case of severe taper corrosion with imprinting of the stem taper screw thread onto the head taper surface

**Discussion and Conclusions:** The taper junction contributes significantly less than the bearing surfaces to the total wear volume. Therefore the volume of material alone cannot explain the higher failure rate of LH-MOM when compared to MOM hip resurfacing. However, our results support corrosion as the main mechanism, and it is possible that ionic corrosion products are a more potent inflammatory stimulator than the particulate wear debris originating from the bearing surfaces. The mechanism is likely to involve galvanic and mechanically assisted corrosion. The taper junction provides an ideal crevice and the screw thread facilitates fluid movement to and from the joint. Imprinting of the stem taper surface supports the role of galvanic corrosion, whereby one surface (the head taper) is preferentially corroded.

**Clinical Significance:** A predominantly galvanic process has important implications for revision surgery, and surgeons can be reassured that the stem taper is likely to be undamaged allowing retention of a well-fixed femoral stem.
