The Influence of Wheel/Rail Contact Conditions on the Microstructure and Hardness of Railway Wheels

Paul Molyneux-Berry ^{1)*}, Claire Davis ²⁾ and Adam Bevan ¹⁾

1) Institute of Rail Research, School of Computing and Engineering, University of Huddersfield

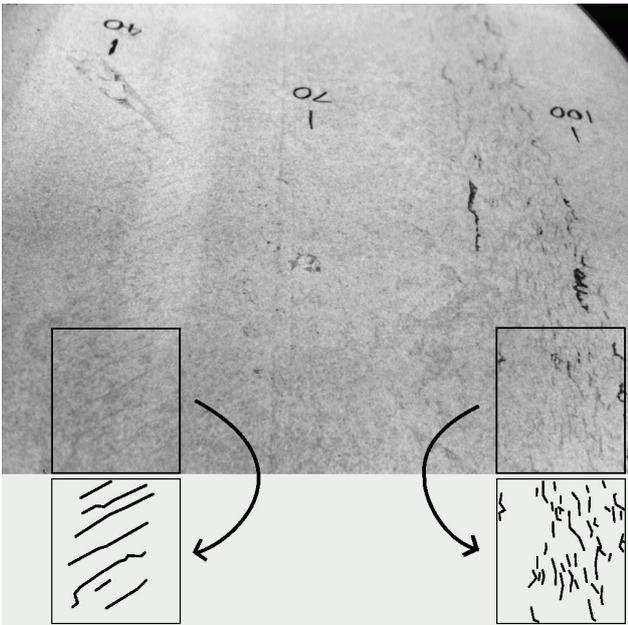
The selected wheel was from a powered axle, with a stress history consistent with that presented in Figure 3 and Table 1. The wheel had been renewed on reaching the minimum permissible diameter. It had run nearly 170,000 miles ($\approx 270,000\text{km}$) since last being turned on the wheel lathe. Some circumferential RCF cracking was apparent towards the field side of the tread, and a few fine surface cracks were just visible in the flange root area (as shown in Figure 4).

Fig. 4. Two bands of cracks on surface of wheel, highlighted with dye penetrant. The flange is to the left, the field side to the right. Inverted numerals (40, 70, 100) indicate distance from the back of the flange in millimetres. A manually enhanced sample of each crack band is shown below the original in the boxes. Flange root (Region C, left) has long angled surface cracks. Field side band (Region E, right) has circumferential cracks; some of these are longer and penetrate more deeply.

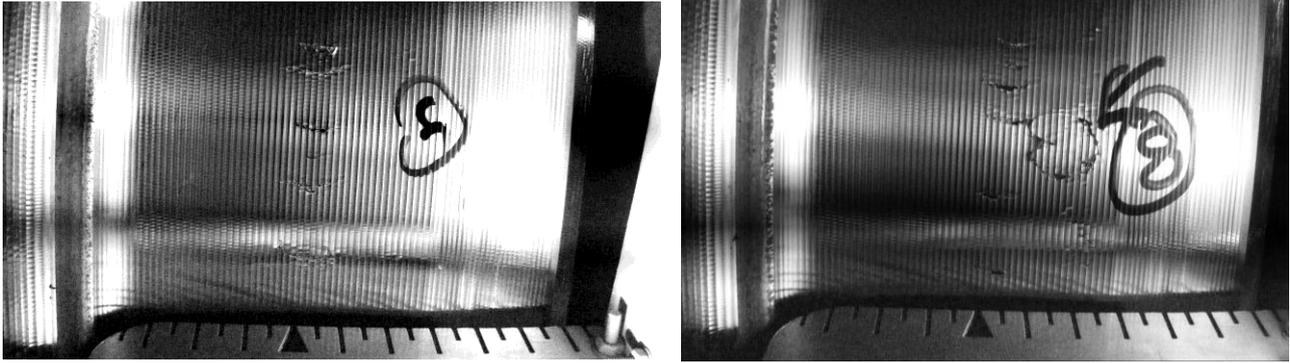
This portion of both leading and trailing wheels is used when running on straight track, which is the most common running condition. The trailing wheelset often contacts in this region on curves as well. There are many cycles with moderate normal stresses. The relatively small tangential forces associated with traction or braking mean that the peak stress tends to occur below the surface, as shown in Figure 6(b). Unlike the other regions of the wheel, the running band experiences a similar number of stress cycles in each rolling direction. On the observed (disc-braked) fleet, surface damage in this region is limited to mild wear; sub-surface transverse cracks have been observed on individual wheels; these may be influenced by material quality. Examples of this type of crack are shown in Figure 7.

Fig. 7 Sub-surface cracks in centre of wheel tread, observed during turning of wheel on lathe: 2 images from different parts of the same wheel. Cracks not visible on surface, although there was an unusual 0.4mm out-of-roundness identified by the lathe in this region. Numerous curved transverse cracks appeared after 1.5mm of material was removed from the surface; some appeared circular. Flange to left hand side, tread datum 70mm from flangeback is indicated by the arrow-shape at the bottom of the image, with scale in 5mm increments.

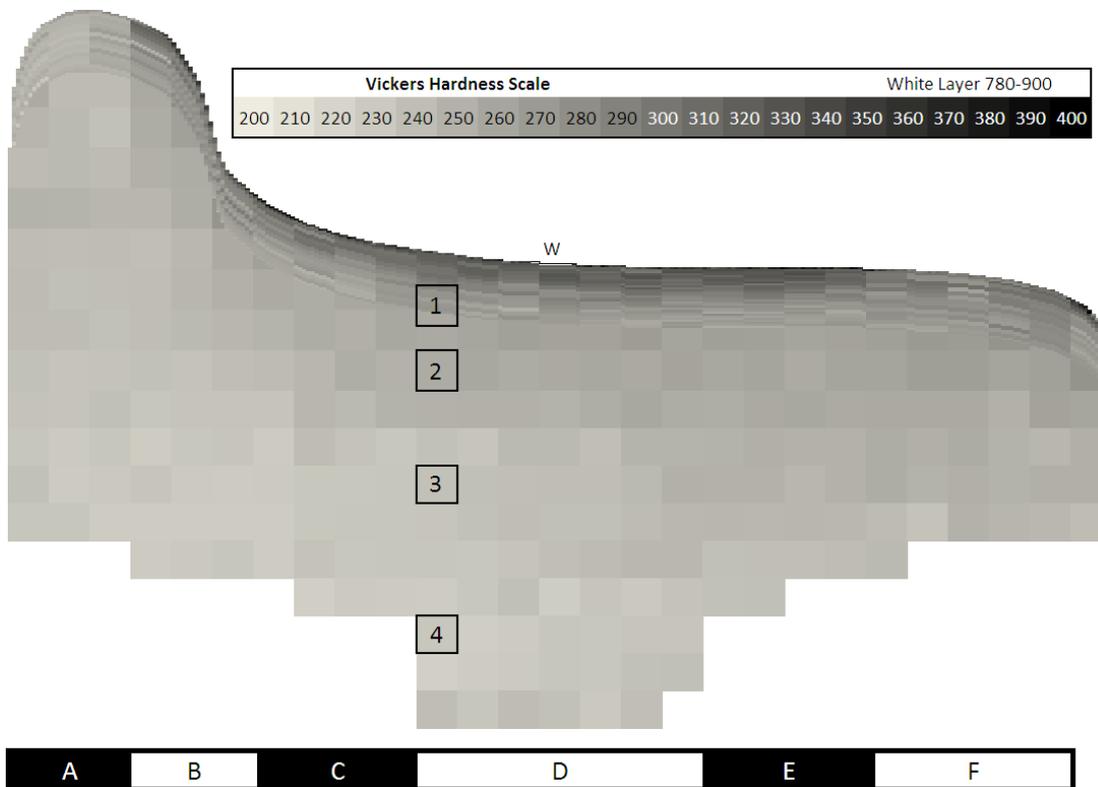
One notable observation in the surface layer of the regional DMU wheel was a region of 'white etching layer', in the centre of the running band (marked 'W' on Figure 8). This was approximately 5 mm wide and 0.15 mm deep, with hardness in the range 780HV to 900HV. This appears to be associated with a prolonged wheel-spin incident, which was recorded by the on-train systems during low adhesion conditions two days before the wheel was taken out of service. The hardness values from this layer have been excluded from the results presented here. This incident does not appear to have had a significant influence on the material properties in the wheel beyond the immediate vicinity of the white layer; wheels without the white layer tested by the authors show an otherwise similar pattern of hardness.

Fig. 8. Hardness map for end-of-life regional DMU wheel. The numbers indicate locations of microstructure images shown in Figure 19.

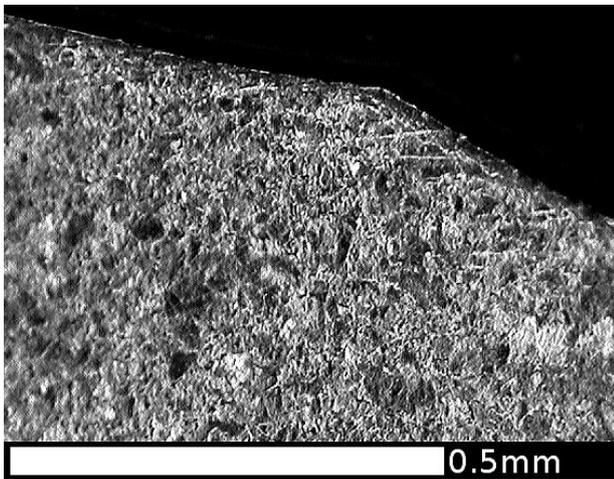
Fig. 11: OM image of microstructure on the flange tip (A); this region does not contact the rails, and the surface shape retains the machining marks from the last turning on the lathe. There is no obvious shearing of the microstructure.

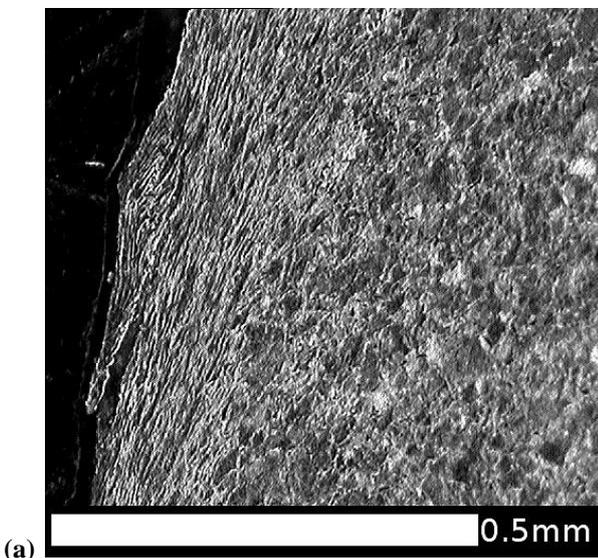
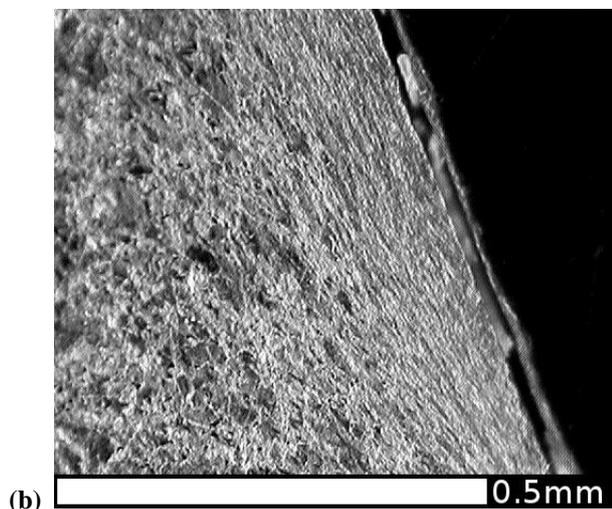
The flange face (Region B) experiences less frequent contacts, often lubricated but with high creep velocity and therefore high shear forces. The average surface hardness is around 340HV. The microstructure in Figure 12 suggests that the direction of shear is predominantly circumferential (normal to the section). The wear rate is more significant in this region.

Figure 12: OM images of microstructure (a) flange back (FB) and (b) flange face (B); These region experiences rubbing contacts with checkrails or the outer running rail on sharp curves. The predominant direction of the shear forces is circumferential (normal to the cross-section in the figure), and the microstructure is affected to a depth of approximately 0.2mm..

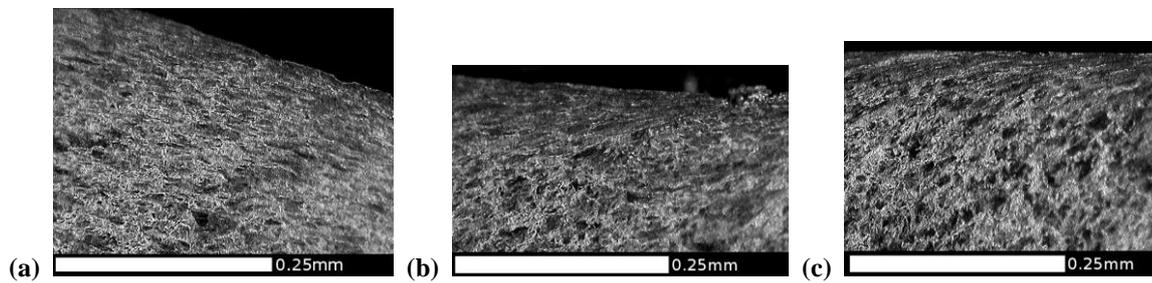
Fig. 13: OM images of microstructure in the flange root area: (a) Region C1, (b) Region C2 and (c) Region C3. These show the microstructure sheared to the right (toward the centre of the tread) which is consistent with the direction of tangential forces on this part of the wheel (Figure 4). The depth of shearing is about 0.1mm. A crack is visible in Region C2, at the same angle as the sheared microstructure, about 0.2mm long. Cracks are also visible on the surface here (see Figure 3).

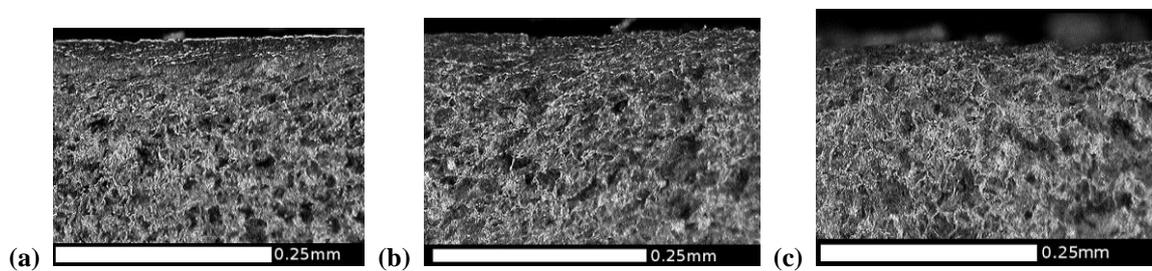
Fig. 14: OM images of microstructure in the running band (centre of the tread): (a) Region D1, (b) Region D2, (c) Region D3. The tangential forces are generally lower in this region, and typically circumferential (normal to these sections). There is no obvious shearing of the microstructure here.

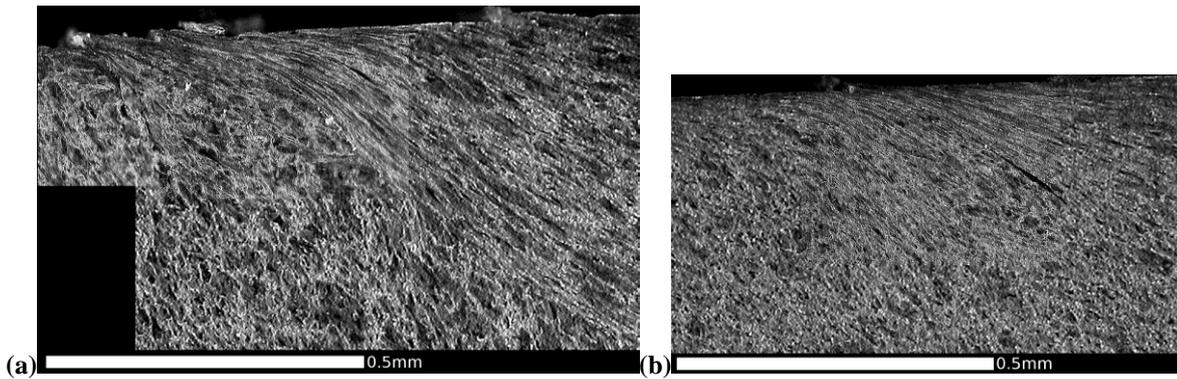
Figures 15 and 16 show the deformed microstructure in Region E; again this is sheared toward the centre of the tread, but the deformation is deeper, typically at least 0.5mm. Figure 15(a) shows a location where two small RCF cracks have joined together about 0.3mm below the surface; this could lead to the intervening material becoming detached and forming a small cavity. Figure 16 shows a more significant RCF crack which has propagated to a depth of 2mm (below the sheared region) and has started to branch at that depth. Evidence from the wheel lathe suggests that the cracks in this region of the wheel are often deeper than 2mm and in severe cases can be greater than 6mm deep. They often join with other cracks and resulting in large cavities on the tread. It is possible that fluid entrapment contributes to the propagation of these deep cracks in Region E ^{[1], [2]}. The presence of such cracks provides crack shielding so the shear stresses are carried by the material above the crack, which consequently shears more than the material below the cracks, as can be seen in Figure 16.

Fig. 15: OM images of microstructure in the RCF band, (a) Region E1 and (b) Region E2. This region experiences high tangential forces, typically toward the centre of the tread (left) as shown in Figure 4, and these cause significant surface cracking (Figure 3). The microstructure is sheared in the same direction, and the influence extends to a depth of about 0.3mm. Cracks are visible in this section, including two that have joined sub-surface in Region E1.

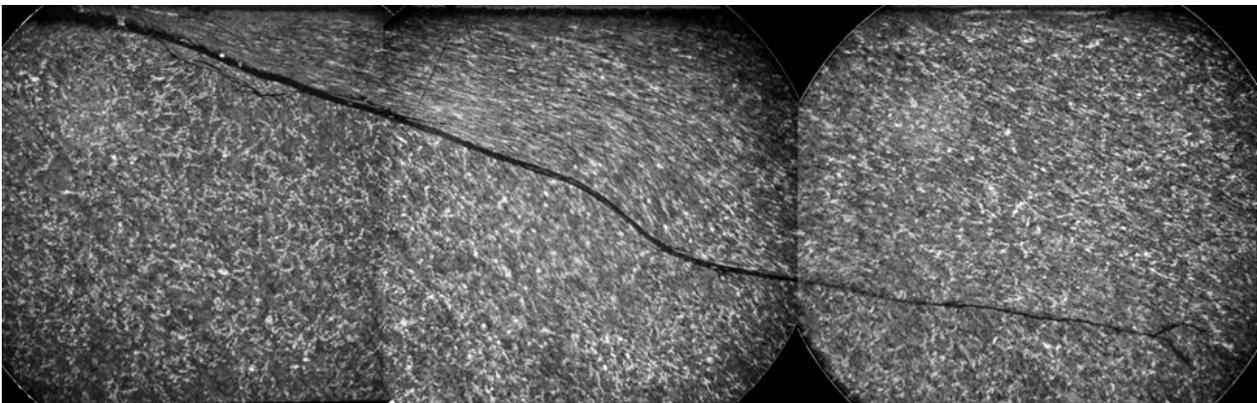
Fig. 16. Composite OM image showing RCF crack in Region E3, viewed in a circumferential direction on a cross-section. Running surface at top of image, field side to right. Crack length 6.2mm, depth 2mm. Note branching at crack tip, and deformed microstructure above crack. This image is from a different cross-section of the same wheel shown in Figure 14, selected to show a longer crack.

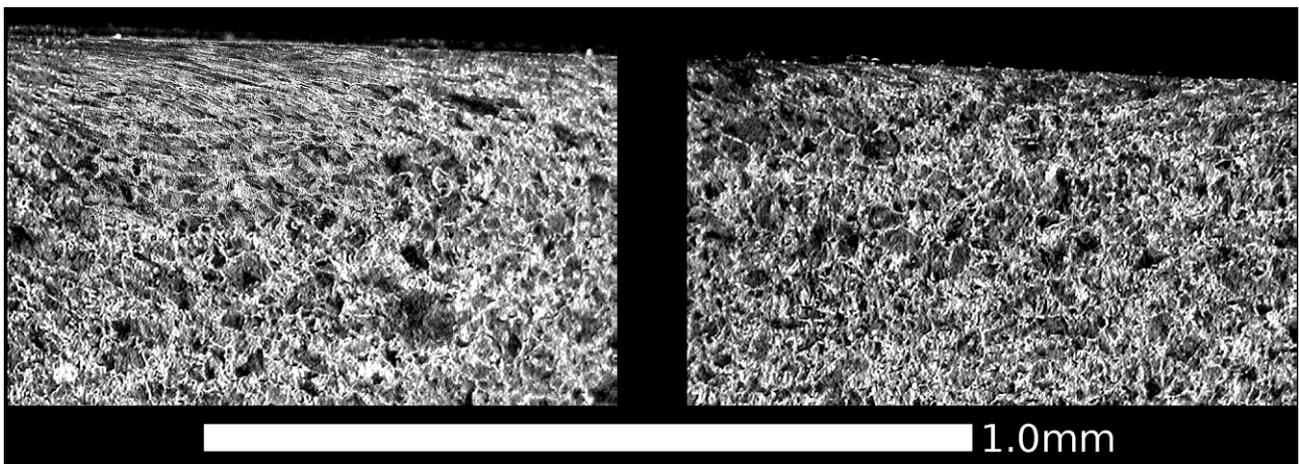
Fig. 17 OM images of microstructure toward the field side of the tread (Region F1), showing the transition from sheared material (left, bordering the RCF band) to unsheared material in the region that is rarely in contact with the rails. The majority of Region F does not exhibit shearing of the microstructure.

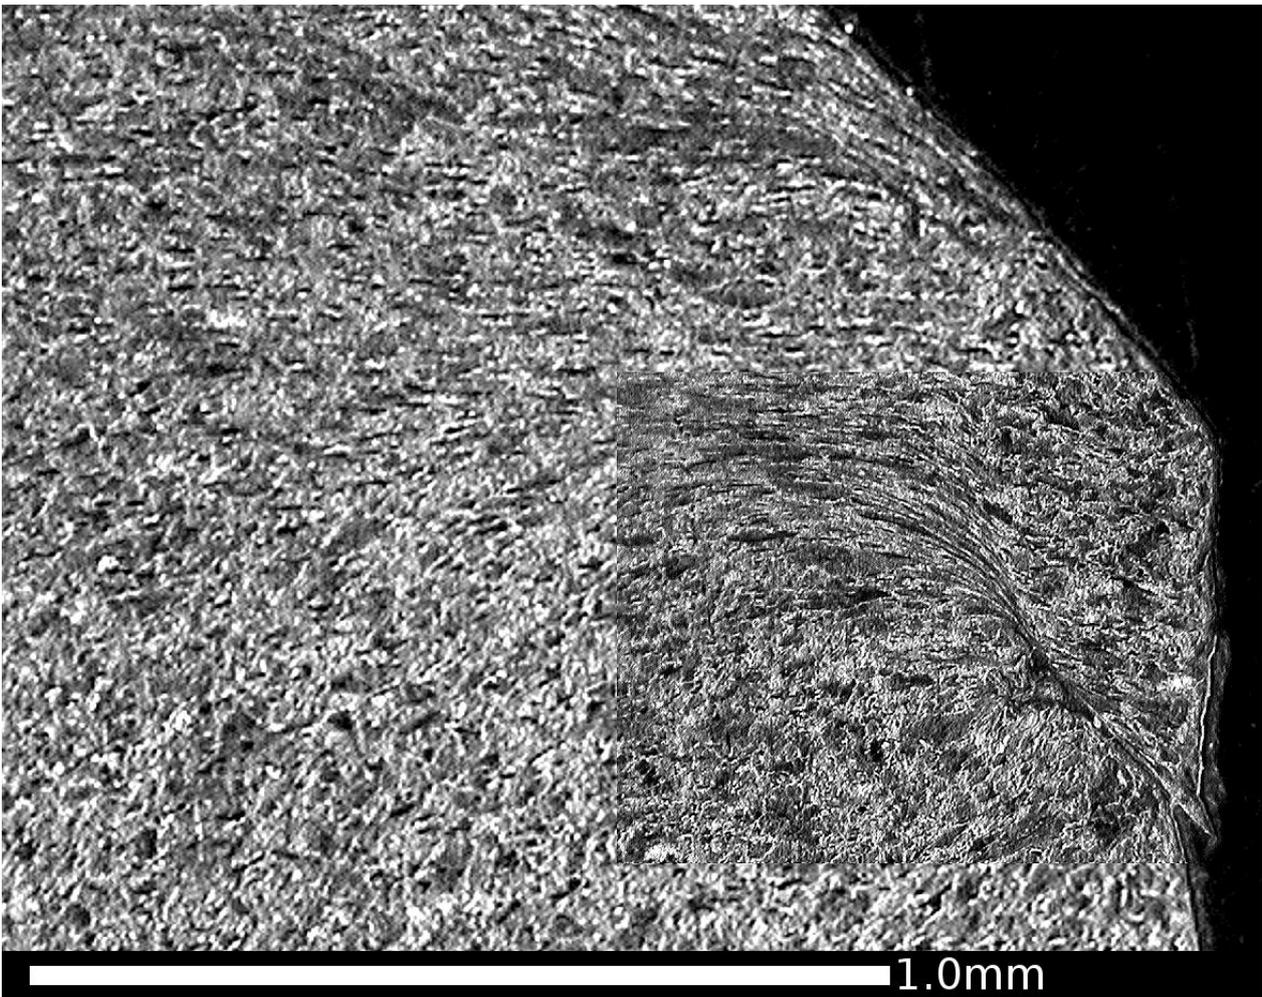
A similar effect is visible in the surface hardness in Figure 8. Previous work based on twin-disc tests ^[3] indicates how the number of stress cycles influences the near-surface hardening and accumulated shear strain; a few thousand cycles under the conditions tested had a relatively small hardening effect. On the field-side chamfer, there is another region of high hardness in Figure 8; examining the microstructure in this region (Figure 18) confirms significant localised plastic flow.

Fig. 18: OM image of microstructure on the field side tread chamfer, showing localised plastic flow (Region F2). Together with the lack of microstructural shear in the majority of Region F, this suggests that material ‘roll-over’ on the field side of this wheel is a localised phenomenon, and not associated with material flow from other parts of the wheel tread.

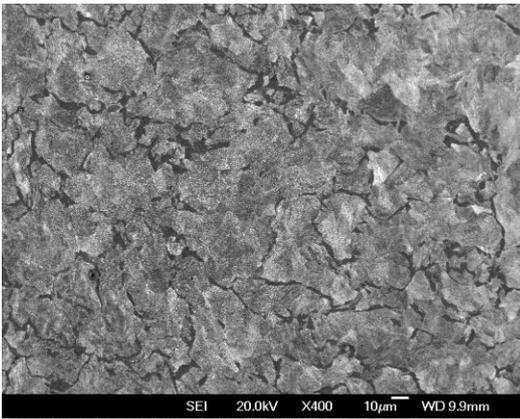
Fig. 20(a) SEM image of microstructure, Locn 1 on Fig.8. PE Ferrite 8.8%, 271 HV.

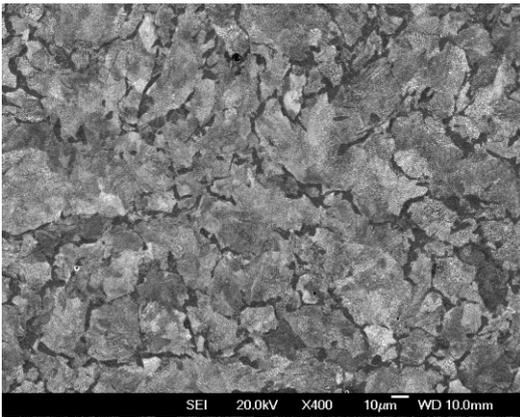
Fig. 20(b) SEM image of microstructure, Locn 2 on Fig.8. PE Ferrite 9.8%, 255 HV.

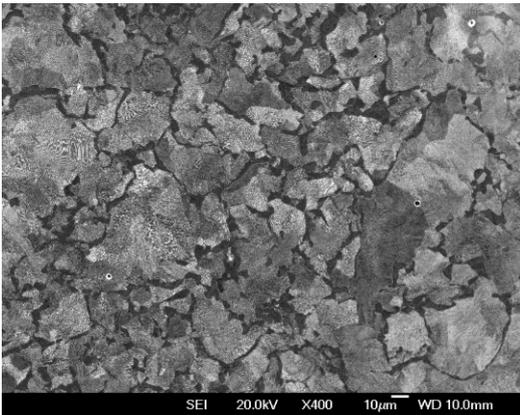
Fig. 20(c) SEM image of microstructure, Locn 3 on Fig.8. PE Ferrite 16.9%, 237 HV.

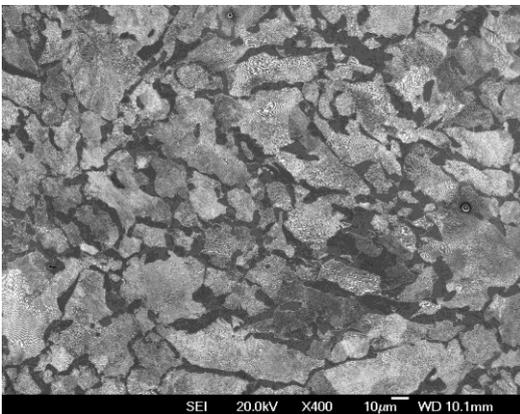
Fig. 20(d) SEM image of microstructure, Locn 4 on Fig.8. PE Ferrite 20.9%, 232 HV.

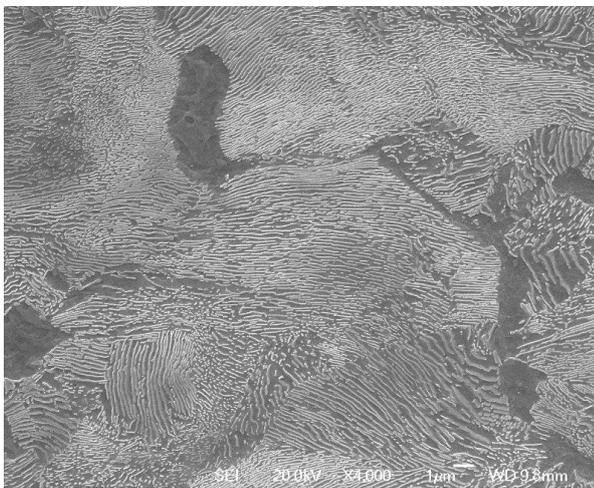
The local cooling rate of the material during the manufacturing process may also influence the spacing of the pearlite lamellae, with a smaller spacing corresponding to a higher hardness. Figure 22 shows the pearlite lamellae in location 1 on Figure 8. There is some variability in the apparent spacing, but much of this is due to the oblique orientation of many grains relative to the observed surface. The smallest spacing observed is an approximation of the true value^[35], and is approximately 0.10µm on Figure 22. Considerable work has been undertaken to relate the lamellar spacing to mechanical properties, e.g.^[36]. The relationship between lamellar spacing and hardness of this wheel sample is broadly in line with those quoted for rail steels^[37].

Fig. 22 SEM image of pearlite lamellae in Region 1 of the wheel.
