Detailed Inspection of Metal Implants

Hothi, Harry, Berber, R, Whittaker, Robert, Bills, Paul J., Skinner, John and Hart, A. J. (2015) Detailed Inspection of Metal Implants. *Hip International*, 25 (3). pp. 227-231. ISSN 1120-7000

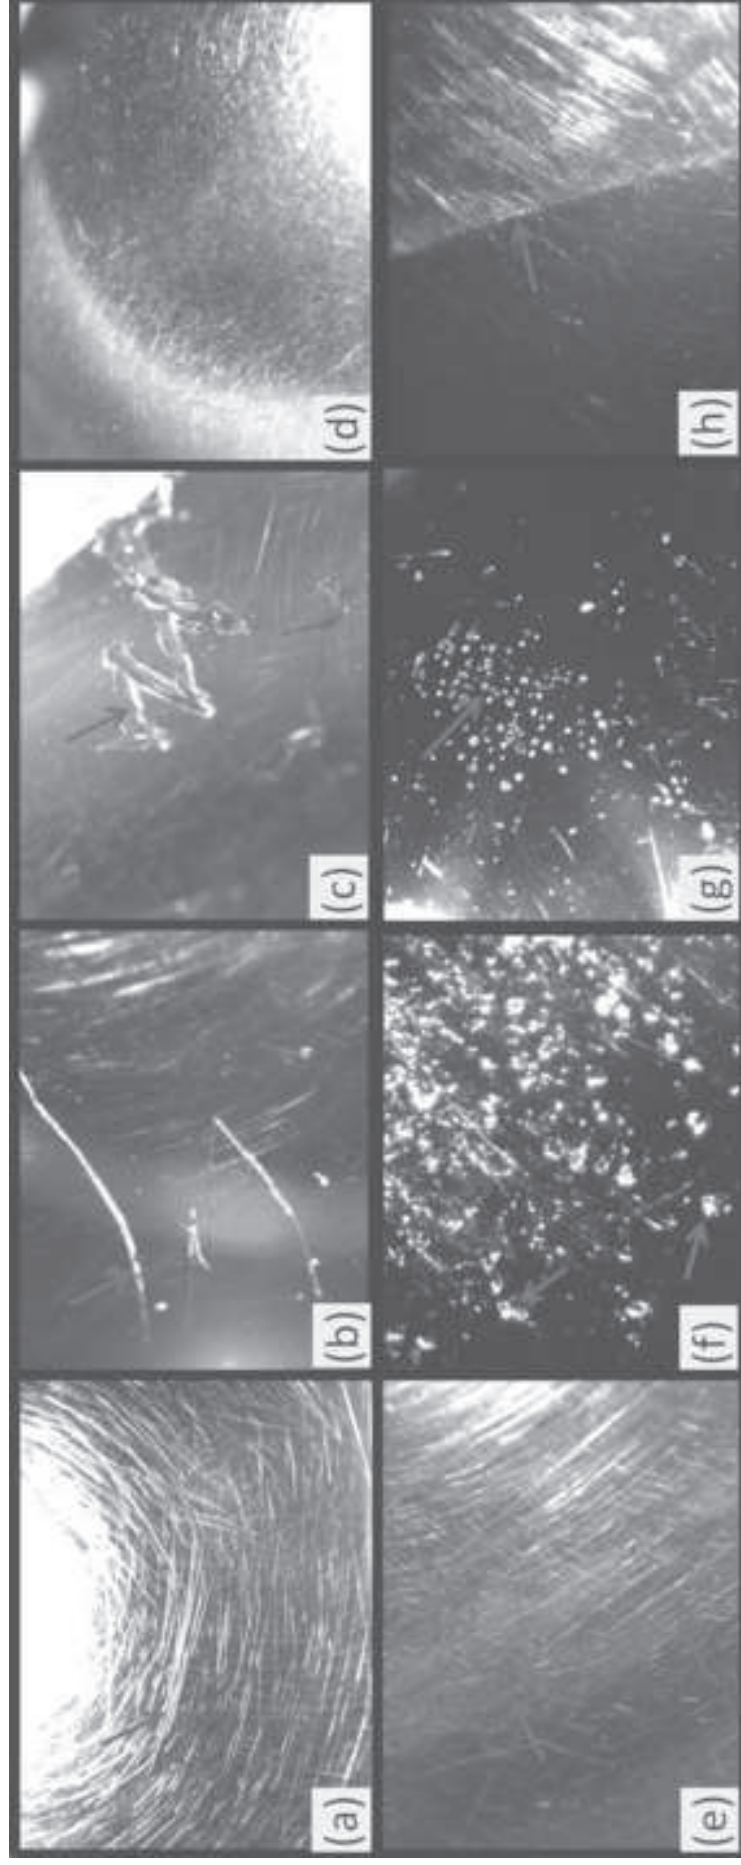
Figure 1  
[Click here to download high resolution image](#)

The presence of 8 specific features relating to changes in the visual appearance of the surfaces was recorded. In this study these features are referred to as: (1) light scratches; (2) moderate scratches; (3) heavy scratches; (4) haziness; (5) discolouration; (6) embedded particles; (7) pitting; (8) presence of a visible wear scar, Figures 1. Table 1 describes the criteria used to define each feature.

<b>Image</b>	<b>Surface feature</b>	<b>Description</b>
a	Light Scratching	Visible scratches that are not detectable under a fingernail run across the surface.
b	Moderate Scratching	Visible scratches that can be detected under a fingernail run across the surface.
c	Heavy Scratching	Scratches with depth clearly visible and that will catch a fingernail running across the surface.
d	Haziness	A change in the surface appearance whereby surface scratches are so densely packed together that one scratch is indistinguishable from the next. This will often result in a reduction in the reflectivity of the surface.
e	Discolouration	A change in the appearance, commonly observed as a 'staining' of the surface.
f	Embedded Particles	Hard, third-body particles that have become embedded in the surface.
g	Pitting	Indentations in the surface that have dimensions similar in length and width.
h	Wear Scar	A region (or regions) on the bearing surface that has a distinct boundary marking the transition from one feature to another. This will often be observed as an abrupt change from a discoloured and lightly scratched region to one which is notably less scratched or discoloured.

**Figure 1:** Examples of bearing surface features observed microscopically: **(a)** Light scratches, **(b)** Moderate scratches, **(c)** Heavy scratches, **(d)** Haziness, **(e)** Discolouration, **(f)** Embedded particles, **(g)** Pitting and **(h)** Clear wear scar
