Solano-Alvarez, Wilberth, Bevan, Adam, Jaiswal, Jay and Bhadeshia, Harry (2016) Soft novel form of white-etching matter and ductile failure of carbide-free bainitic steels under rolling contact. *Acta Materialia*, 121. pp. 215-226. ISSN 1359-6454

Soft novel form of white-etching matter and ductile failure of carbide-free bainitic steels under rolling contact stresses

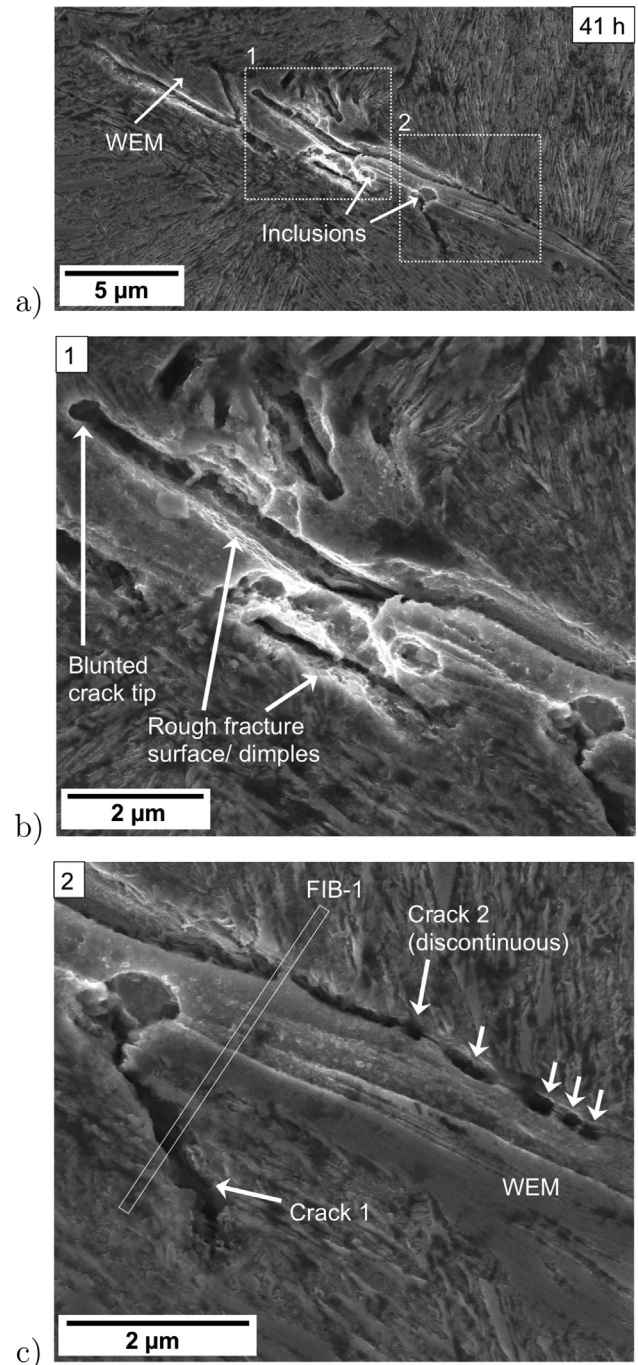
Fig. 2. Secondary electron SEM image of a) butterfly studied in the sample that ran for 41 h with b) detail of cracks in area 1 and c) location of the extracted lamella (FIB-1) in area 2.

The annotated images of the butterflies studied in the nanostructured bainite after rolling contact fatigue testing are presented in Figs. 2 and 3. In the butterfly present in the sample that lasted 41 h, a few different inclusions were observed but none of them seemed to be the origin of the butterfly cracks. It is likely that the main inclusion was either ground away during preparation or located further inside the material. Nonetheless, suspected WEM areas due to their distinct topography were still found along those cracks and a region was selected for FIB extraction (FIB-1). Despite etching artefacts, the shape of the first butterfly in the 948 h sample (Fig. 3a) is more conventional with just two cracks at opposite sides of the main inclusion. However, the total crack length and amount

A few important aspects to note about the cracks formed around inclusions are that they are discontinuous (Fig. 2c), have a misshapen appearance (Fig. 3c), possess dimples at the fracture surface, and have blunted tips (Fig. 2b). These features indicate ductile failure, unlike the well-documented brittle cracking at inclusions in conventional 1C-1.5Cr steels (Fig. 4a) [14]. The

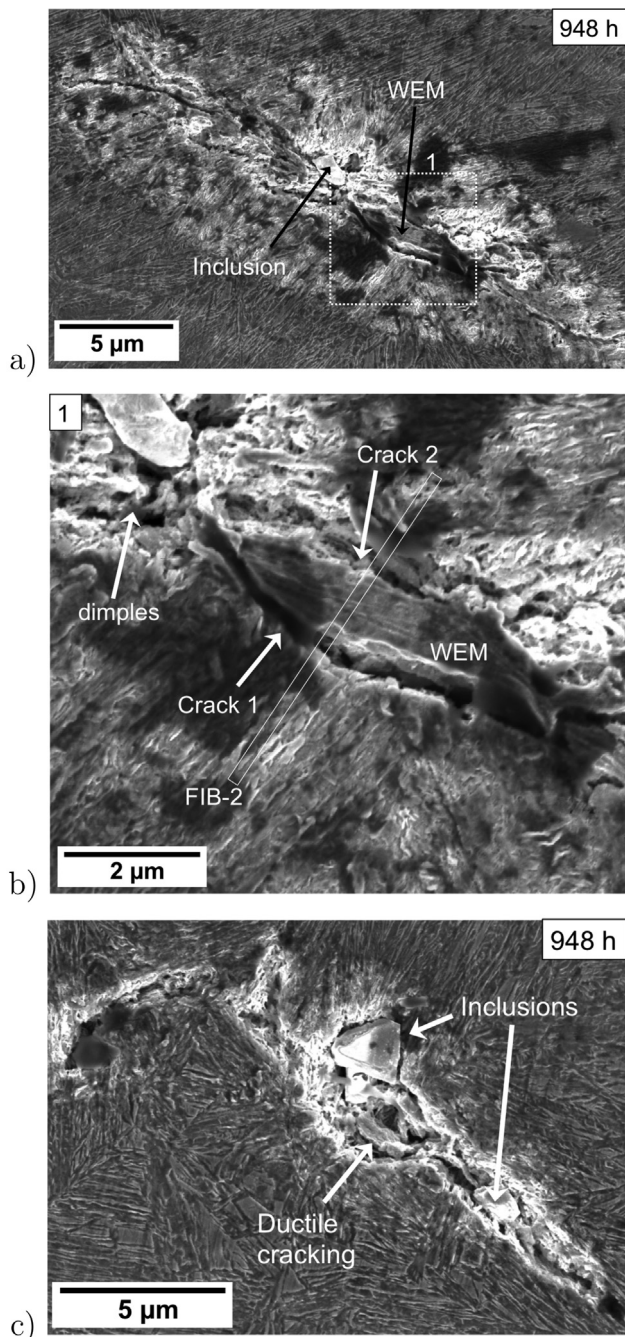
of WEM is similar to the one in the 41 h sample, possibly suggesting no progressive damage evolution due to the presence of WEM, a fact that could be attributed to its softness with respect to the matrix.

Fig. 3. Secondary electron SEM image of two butterflies (a and c) found in the sample that ran for 948 h with b) location of the extracted lamella (FIB-2) in area 1.

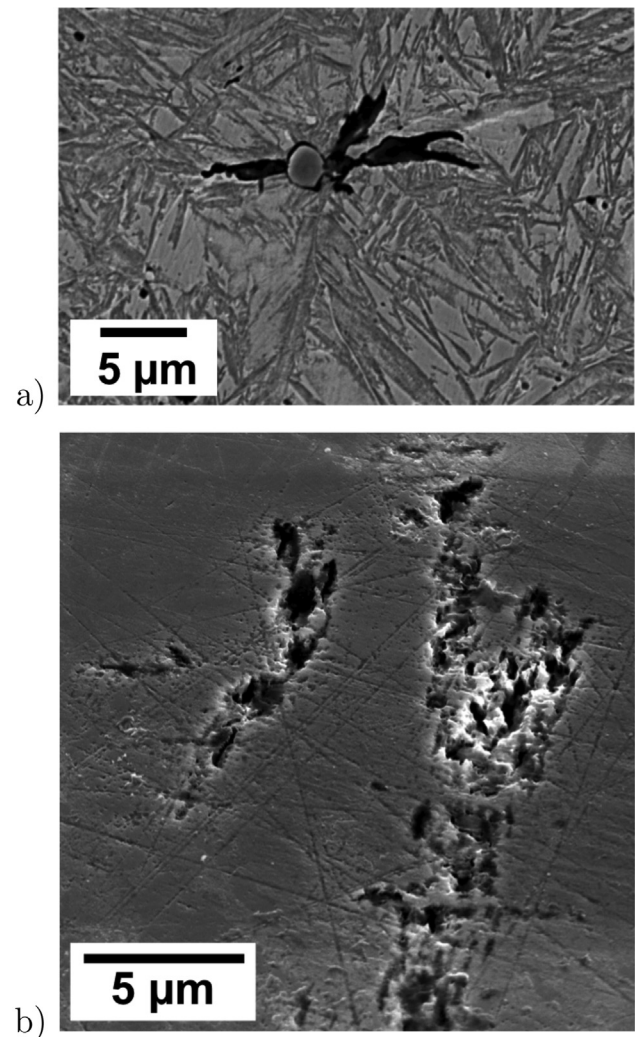
Fig. 4. Secondary electron SEM images of a) brittle butterfly cracks with sharp tips in a martensitic 1C-1.5Cr steel tested at 3.5 GPa using the same rod-ball RCF machine and b) void-coalesced crack in the nanostructured bainite sample that clocked 948 h showing ductile void formation and a lack of surrounding WEM. The sample was tilted 52° with respect to the electron beam to distinguish more clearly the misshapen appearance of the damaged region.

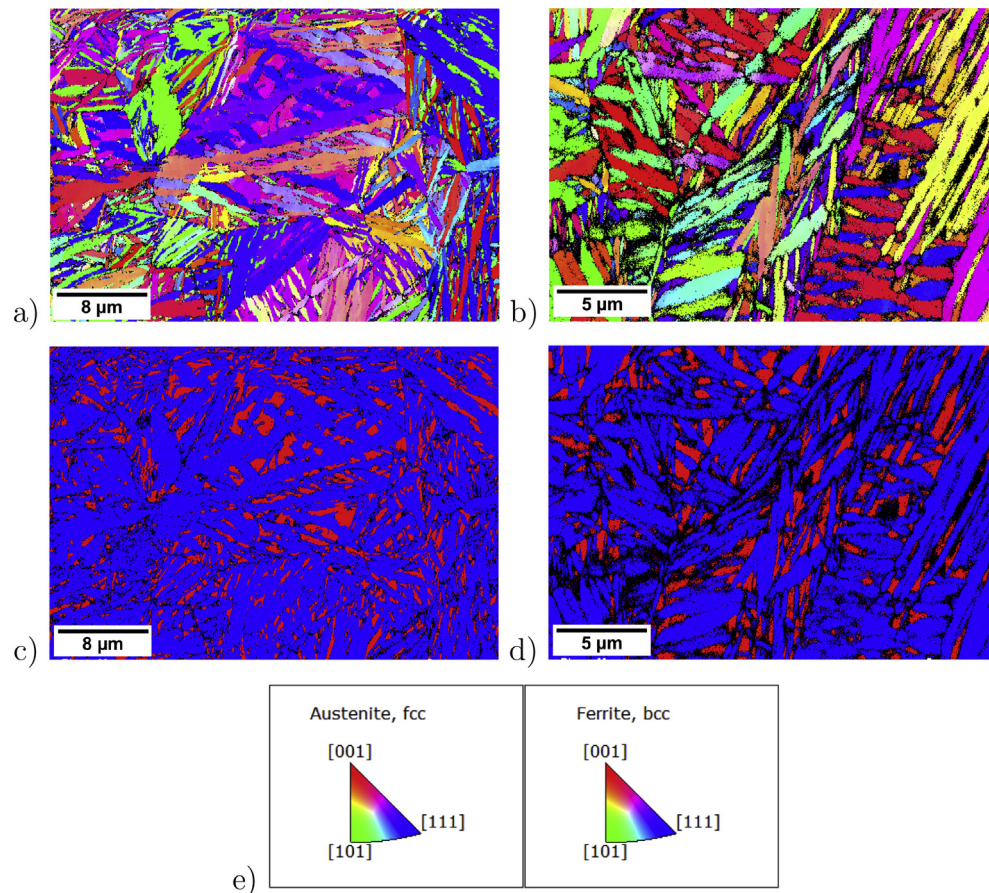
EBSD patterns performed at two different locations within the depth of maximum subsurface orthogonal shear stress in the 948 h sample after polishing with colloidal silica are presented in Fig. 5. The resolution is naturally limited by the technique (not sufficient to assess nanostructural changes) but the images nevertheless show that there is no major disruption of the structure in spite of the voiding damage mechanism caused by the subsurface shear stresses due to prolonged rolling contact. Likewise, the phase maps shown in Fig. 5c and d are evidence of the stability of the larger carbon-enriched retained austenite regions (which should be less mechanically stable than the films [28,29]) and agree with X-ray diffraction data [6] that revealed a fraction 0.21 ± 0.01 of retained austenite persisting after RCF. Both the integrity of the nanostructure and stability of the retained austenite (due to its volumetric expansion in the event of martensitic transformation) are important factors when considering a steel for bearing

Fig. 5. EBSD maps of two different regions: region 1 (a and c) acquired with a step size of 67 nm, a voltage of 20 kV and a working distance of 15 mm, and region 2 (b and d) using a step size of 42 nm, a voltage of 20 kV and a working distance of 14.9 mm (a and b) are standard inverse pole figure maps (key in e) and (c and d) show phase maps with bainitic ferrite coloured blue and retained austenite in red. (For interpretation of the references to colour in this figure legend, the reader is referred to the web version of this article.)

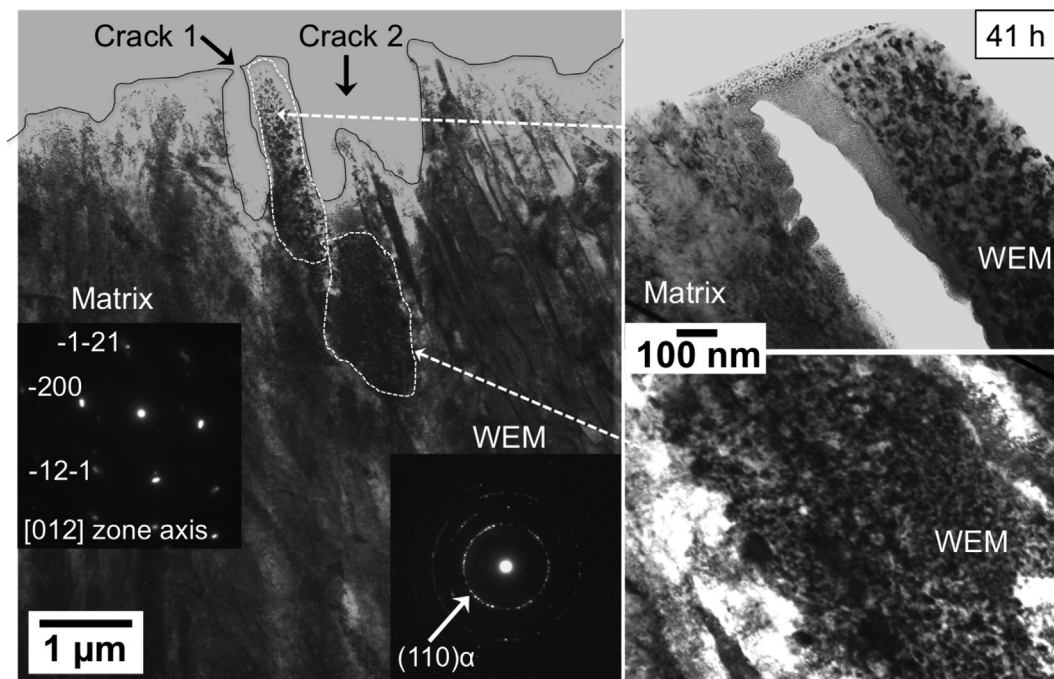
The TEM bright field images and associated electron diffraction patterns of the extracted lamellae are presented in Figs. 6 and 7. Due to contrast artefacts in Fig. 6, the borders of the lamella in the low magnification frame as well as the suspected WEM regions are outlined with a black solid and dashed white line respectively. Cracks are marked to show correspondence to the SEM images. Despite the already nanostructured pattern of the bainitic ferrite matrix, the suspected WEM regions show a very distinct dotted morphology consisting of fine equiaxed ferrite grains, 20–40 nm in diameter, and a characteristic ring-like powder diffraction pattern due to its fine scale, which confirms they are indeed white-etching matter. In the case of the 948 h sample, the electron diffraction pattern indicates the development of a preferred crystallographic orientation or texture of the nanosized ferritic grains. It is worth mentioning that although the matrix does show progressive microstructural degradation after 948 h of RCF, it is not related to the presence of white-etching matter since the same degradation was observed in the WEM-free void coalesced cracks in the original study [6].

Fig. 6. Bright field TEM images of lamella FIB-1 (41 h sample) and associated selected area electron diffraction patterns.

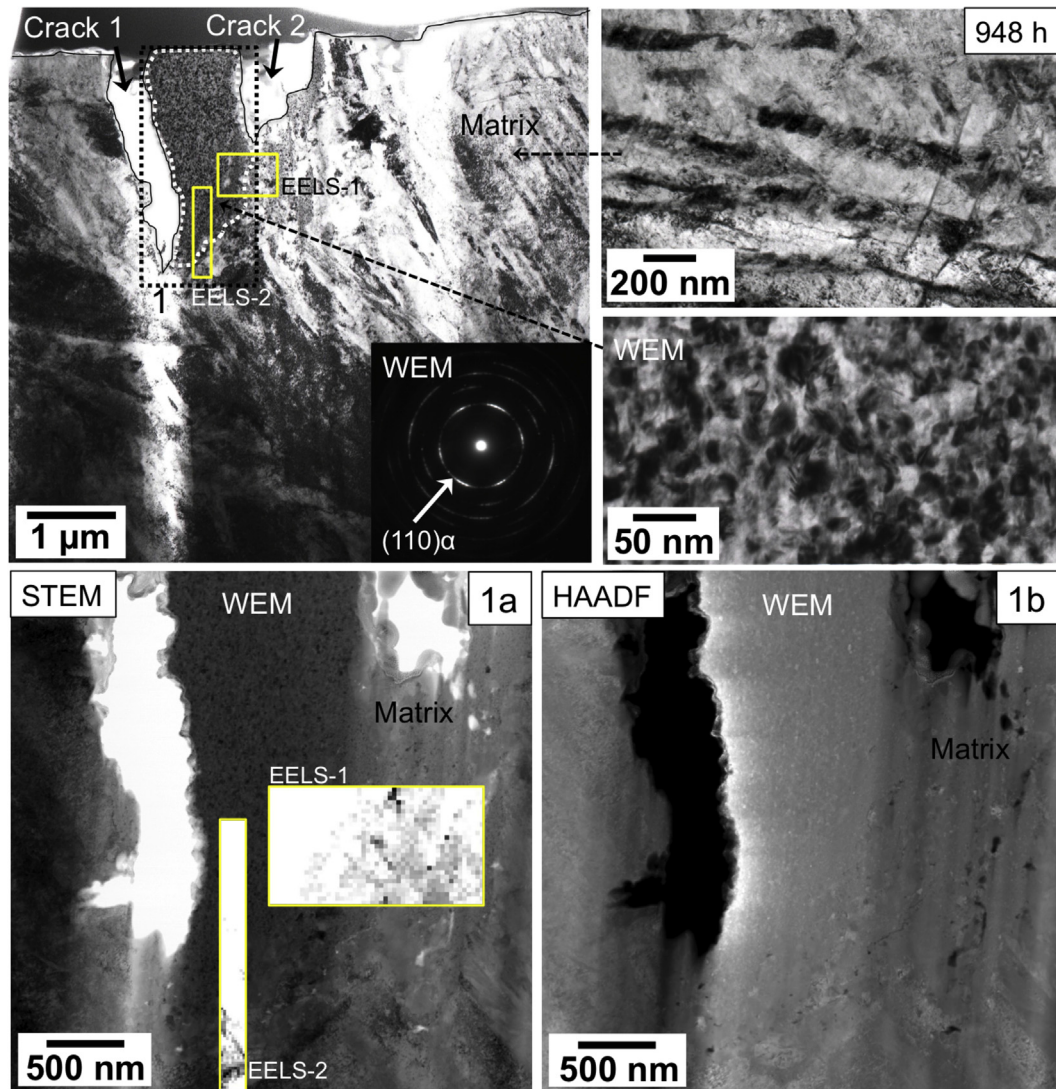
Fig. 7. Bright field TEM images of lamella FIB-2 (948 h sample) with high magnification frames of the matrix and WEM with an associated selected area electron diffraction pattern. The WEM and its vicinity are also shown using STEM in 1a for higher resolution and HAADF imaging in 1b for chemical contrast. The EELS maps marked with yellow rectangles were obtained using 200 kV, ~1000 pixels, step sizes of 17–31 nm, a pixel dwell time of 0.5 s, and filtering a K edge energy of 284 eV for carbon by adjusting the low and high-loss levels to achieve a representative contrast. (For interpretation of the references to colour in this figure legend, the reader is referred to the web version of this article.)

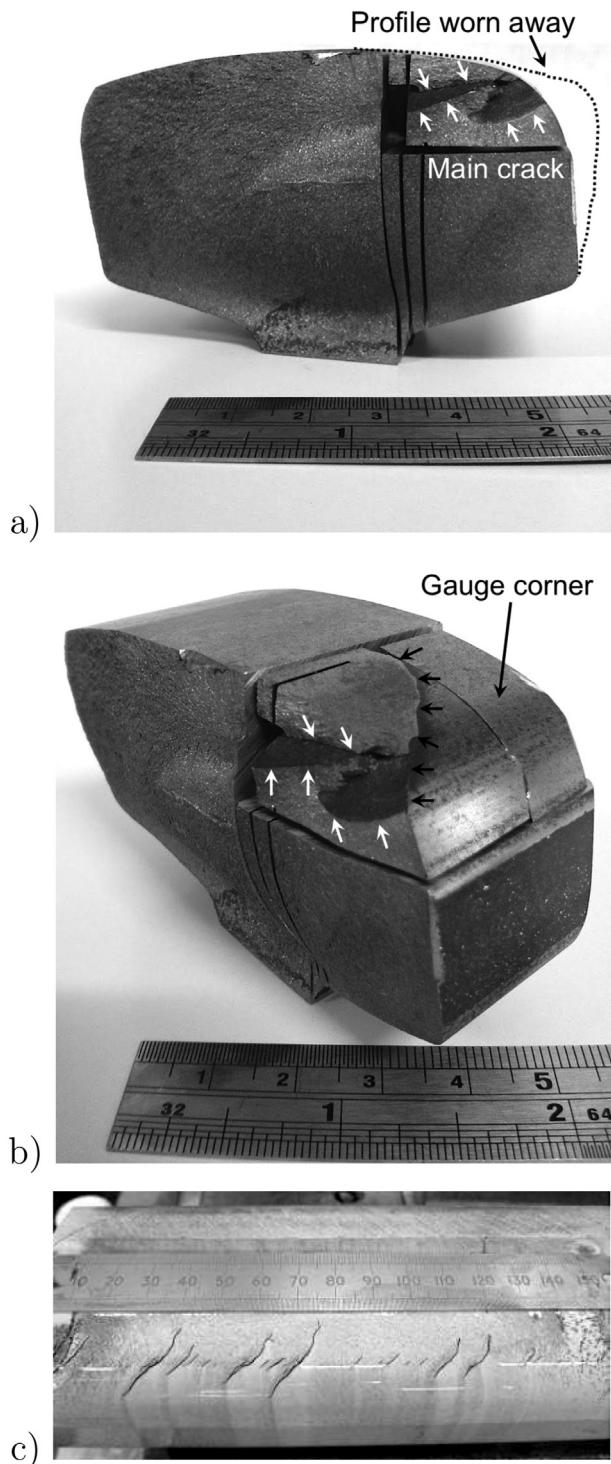
Macroscopic images of the serviced carbide-free bainitic rail are shown in Fig. 8. Annotated SEM images of the crack studied are shown in Fig. 9. The crack shown in Fig. 9a is a minor branched crack located ~500 μm deep under the gauge corner along the length of the rail, although the true depth is most likely to be around 5 mm due to the loss of rail profile caused by wear and grinding operations (Fig. 8a) [32]. The abrupt upper edge of the steel in image Fig. 9a corresponds to the bottom surface of the main surface-breaking RCF crack, presumably caused by plastic flow and ductility exhaustion [33,34] although coarse grinding during maintenance operations could have also led to ridges being folded over to form a ledge, which then acts as a crack initiation site. In Fig. 9b, distinct areas of homogeneous topographical contrast, suspected to be white-etching matter (later corroborated through TEM), can be seen running along both sides of the length of the crack. In rails, the shear stresses due to rolling contact fatigue have a maximum at the surface and at a depth of ~2 mm or deeper for decreasing friction coefficients due to an elliptical contact patch in rail/wheel contact, as opposed to a strip contact in the case of laboratory RCF tests [35]. The depth of this crack indicates a prolonged propagation stage from the surface rather than a high

Fig. 8. Serviced carbide-free bainitic rail showing: a) the original profile shape marked with a dotted black line and the subsurface edges of the main surface-breaking crack (white arrows), b) the gauge corner where the RCF crack breaks the surface (black arrows) and the crack edges under the surface (white arrows), and c) sample extracted from track after rust removal using fine SiC paper where the running direction is along the length of the ruler used for scale.

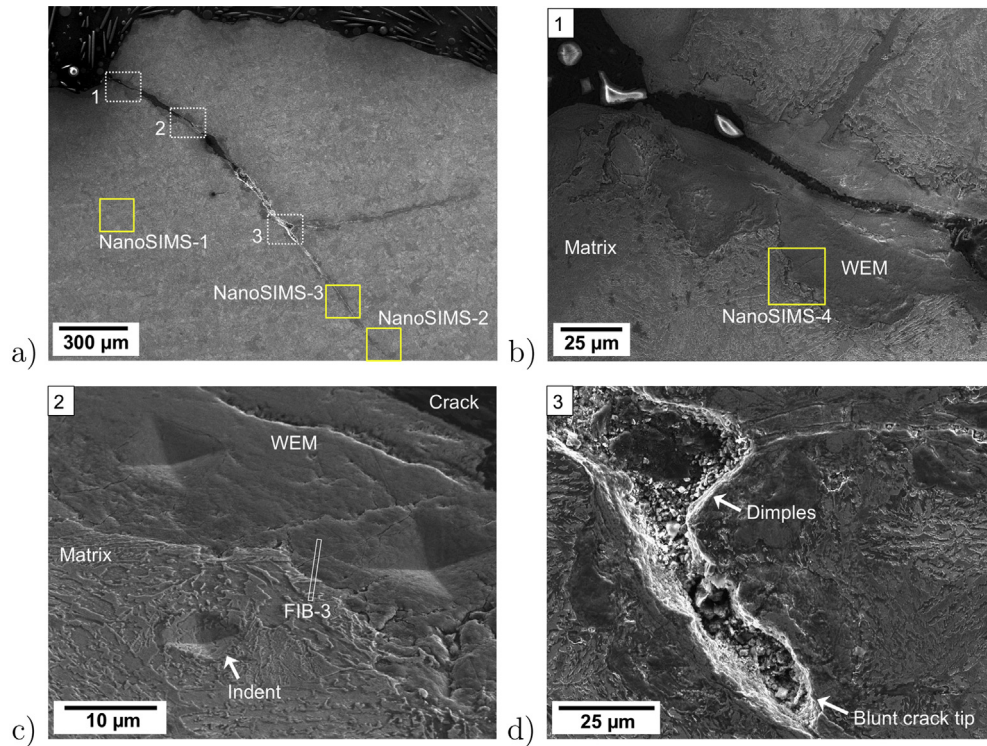
friction coefficient since it is a branch and not a subsurface initiated crack. The long propagation stage allowed sufficient crack face rubbing, which is manifested by the large portions of suspected WEM observed. It is also worth noting that this crack shows the same signs of ductile failure as the butterfly cracks presented previously, such as dimples and blunted tips (Fig. 9d) despite the bainitic matrix not being nanostructured, suggesting that the ductility originates from the lack of carbides in the bainite rather than the refinement of the structure.

Fig. 9. Secondary electron SEM images of serviced carbide-free bainitic rail showing a) an overview of the crack, b) the crack mouth showing large areas of surrounding WEM, c) position of extracted lamella FIB-3 observed at 52° with respect to the electron beam to show also the relative difference of indent size between the WEM and matrix, and d) crack tip showing signs of ductile failure. The yellow solid line squares denote some areas analysed with NanoSIMS. (For interpretation of the references to colour in this figure legend, the reader is referred to the web version of this article.)

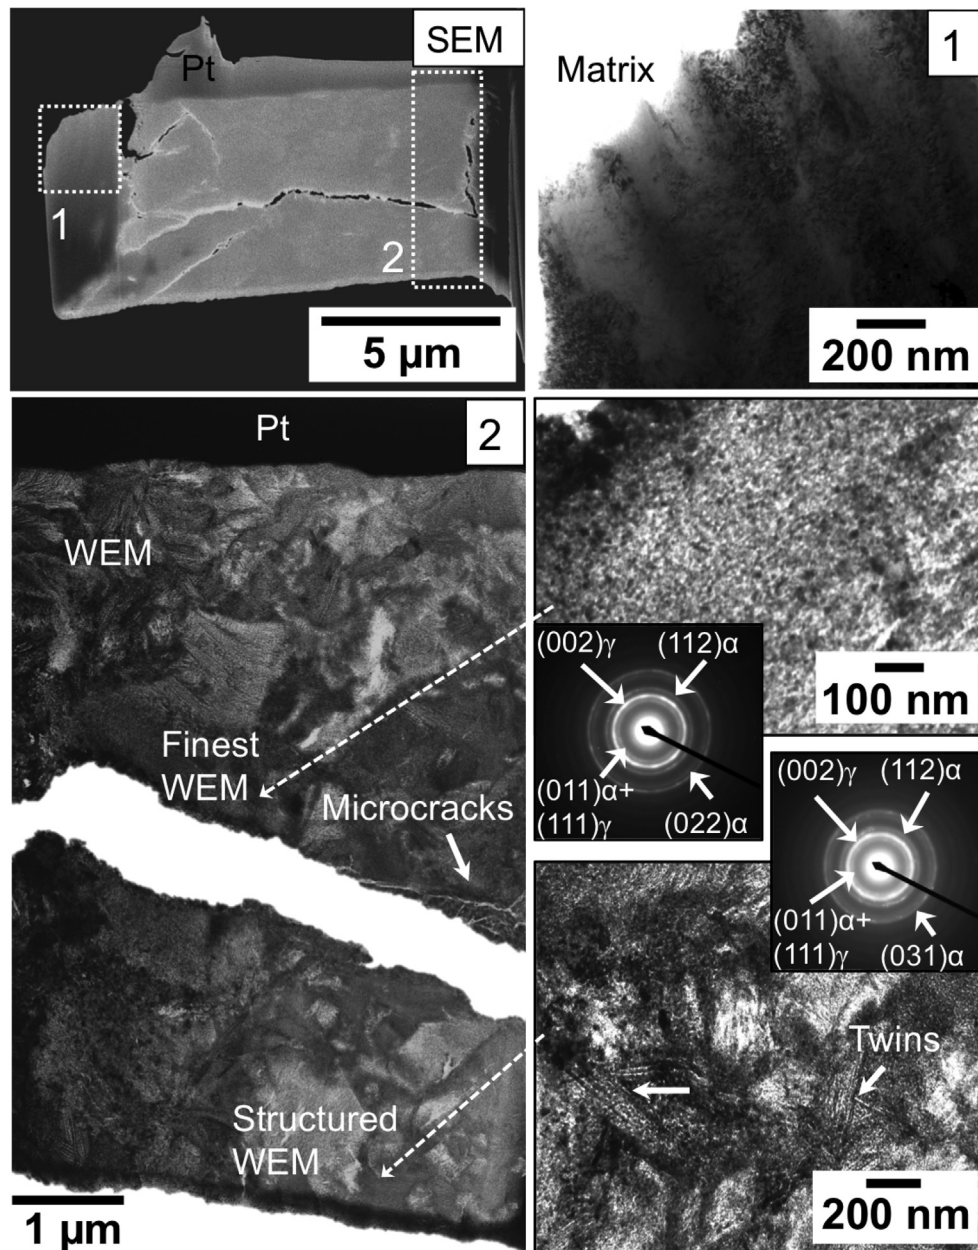
The TEM images and electron diffraction patterns of the lamella extracted from the suspected WEM regions of the serviced rail (FIB-3) are presented in Fig. 10. As opposed to the WEM found in butterflies, which has a dotted pattern distinguishable even at low TEM magnifications, this one is much finer and can only be distinguished as such at very high magnifications and in close proximity to cracks. Otherwise, a low magnification overview of region 2 shows how this WEM has a structure reminiscent of the bainitic matrix once present before deformation.

Fig. 10. Lamella FIB-3 extracted from the serviced rail as seen during the last thinning stage inside the focused ion beam SEM (secondary electron image) and bright field TEM images of the matrix in area 1 and WEM in area 2 with high magnification images and respective selected area electron diffraction patterns of regions adjacent and distant from a crack.

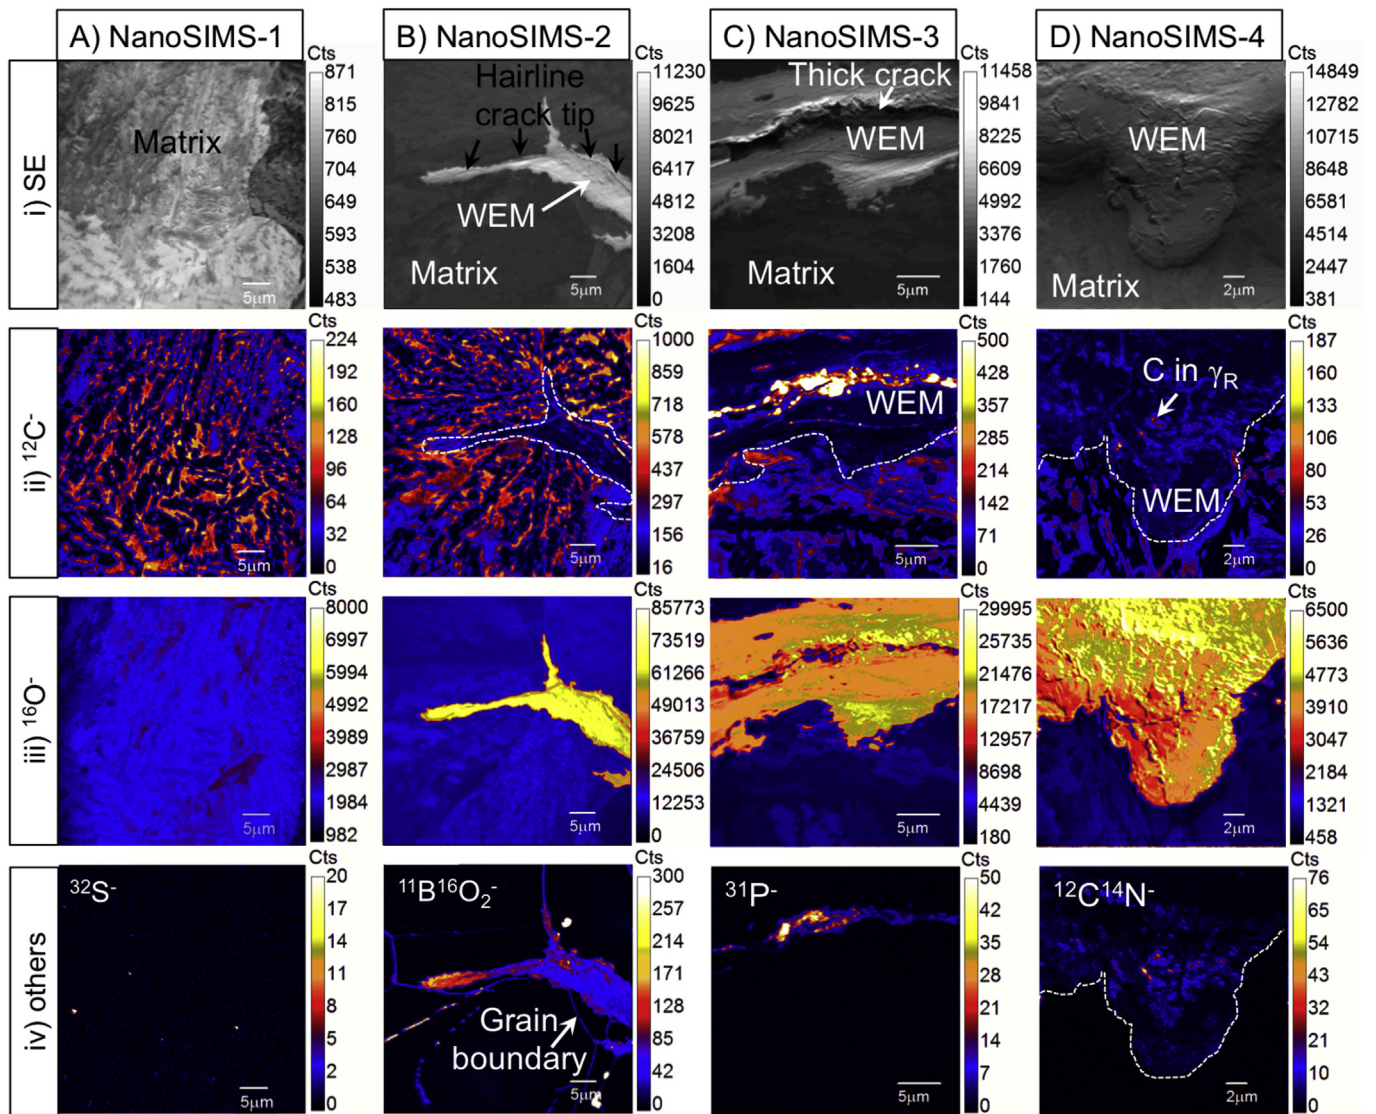
A surprising finding in the NanoSIMS results was the relatively high signal of oxygen, measured as $^{16}\text{O}^-$ ions, in the WEM in comparison with the matrix (Fig. 11-iii). Due to the fact that the crack analysed broke the surface, it is speculated that the beating action of the crack faces incorporated oxygen and nitrogen (Fig. 11D-iv) into the WEM. It is worth mentioning that rails run without lubrication so it is unlikely the oxygen enrichment originates from lubricant breakdown. An alternative mechanism responsible for some of the carbon depletion of the WEM could be the possible formation of CO at the surface due to the ingress of oxygen into the deformed region. Although NanoSIMS could not be performed on the nanobainitic RCF samples due to the difficulty of finding small and scarce butterflies in unetched samples, it would not be expected to find oxygen incorporated into the WEM butterfly wings since butterfly cracks are subsurface initiated and normally do not break the surface. An analysis of sulphur ($^{32}\text{S}^-$) in the matrix revealed the potential presence of sulphides, most likely MnS, in the matrix (Fig. 11A-iv), although the counts obtained were too few to reach any definite conclusions. Phosphorous was expectedly found to match the path of the crack due to its embrittling effect (Fig. 11C-iv), whilst boron, despite its small concentration in this alloy, was found to decorate the prior austenite grain boundaries (Fig. 11B-iv) [44–46].

Fig. 11. NanoSIMS maps from A) the matrix (NanoSIMS-1), B) the very tip of the branched crack (NanoSIMS-2), C) a region next to a wider section of the crack (NanoSIMS-3), and D) region around the crack mouth (NanoSIMS-4), as shown in secondary electron (SE) images. Different elements such as carbon (C), oxygen (O), nitrogen (N), sulphur (S), boron (B), and phosphorous (P) were mapped as respectively indicated. Some borders between the matrix and WEM are marked with a white dashed line for clarity. (For interpretation of the references to colour in this figure legend, the reader is referred to the web version of this article.)
