The Influence of Wheel/Rail Contact Conditions on the Microstructure and Hardness of Railway Wheels

Paul Molyneux-Berry,¹ Claire Davis,² and Adam Bevan¹

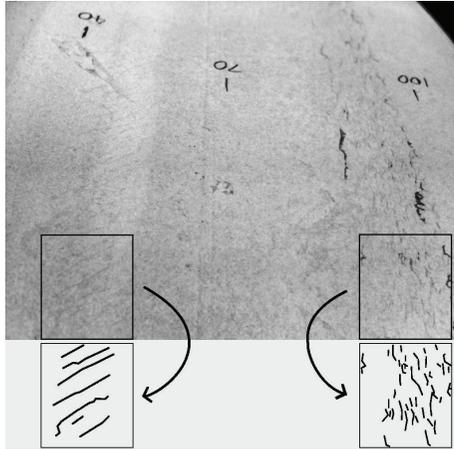
FIGURE 4: Two bands of cracks on surface of wheel, highlighted with dye penetrant. The flange is to the left and the field side to the right. Inverted numerals (40, 70, and 100) indicate distance from the back of the flange in millimetres. A manually enhanced sample of each crack band is shown below the original in the boxes. Flange root (Region C, left) has long angled surface cracks. Field side band (Region E, right) has circumferential cracks; some of these are longer and penetrate more deeply.

The selected wheel was from a powered axle, with a stress history consistent with that presented in Figure 3 and Table 2. The wheel had run for 4.5 years and 800,000 miles ($\approx 1,300,000$ km), being reprofiled four times, and had been renewed on reaching the minimum permissible diameter. It had run nearly 170,000 miles ($\approx 270,000$ km) since last being turned on the wheel lathe. Some circumferential RCF cracking was apparent towards the field side of the tread, and a few fine surface cracks were just visible in the flange root area (as shown in Figure 4).

5.5. Comment on RCF Crack Propagation. The previous section focused on RCF crack initiation in wheels. Fine surface cracks are often seen on wheels, but if they do not propagate below the near-surface region, they do not have a significant influence on the costs and risks associated with wheel tread damage. For example, the cracks in Region C, Figures 4 and 13(b) are of no concern in practice.

In Region E, cracks can propagate to a depth of several millimetres (Figures 4 and 16). Frequent turning of wheelsets

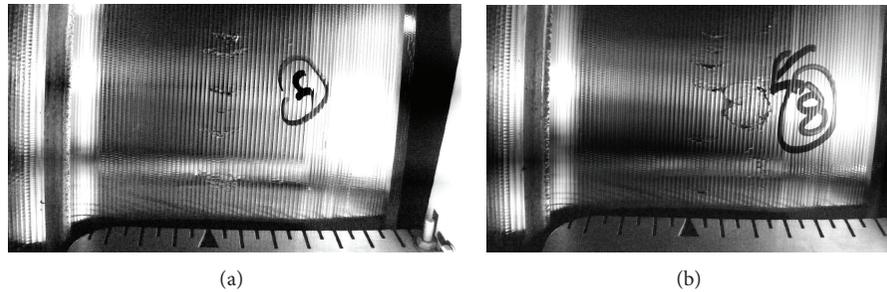
FIGURE 7: Subsurface cracks in centre of wheel tread, observed during turning of wheel on lathe: 2 images from different parts of the same wheel. Cracks were not visible on surface, although there was an unusual 0.4 mm out of roundness identified by the lathe in this region. Numerous curved transverse cracks appeared after 1.5 mm of material was removed from the surface; some appeared circular. Flange to left-hand side, tread datum 70 mm from flange back, is indicated by the arrow shape at the bottom of the image, with scale in 5 mm increments.

The peak of the stress distribution in Region D is subsurface as shown in Figure 6(b) but generally of sufficiently low magnitude that it does not cause significant damage. Exceptionally, some individual wheels on the observed fleet of trains exhibit sub-surface transverse cracks in this region as shown in Figure 7. Following removal of the damaged material by turning, this has been found to recur on the same wheel. Because this is a rare but recurrent effect on the observed fleet and has not been observed on the opposite wheel of the same axle as an affected wheel, it is more likely to be influenced by a manufacturing or material defect in the wheel than by operating conditions or bogie setup.

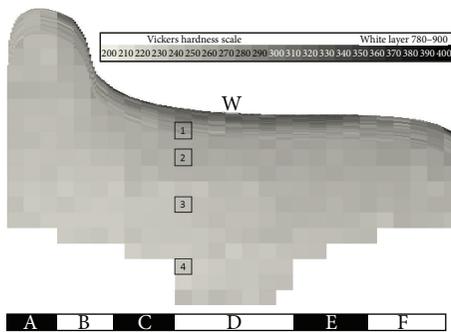
FIGURE 8: Hardness map for end-of-life regional DMU wheel. The numbers indicate locations of microstructure images shown in Figure 19.

One notable observation in the surface layer of the regional DMU wheel was a region of “white etching layer,” in the centre of the running band (marked “W” on Figure 8). This was approximately 5 mm wide and 0.15 mm deep, with hardness in the range from 780 HV to 900 HV. This appears to be associated with a prolonged wheel-spin incident, which was recorded by the on-train systems during low adhesion conditions two days before the wheel was taken out of service. The hardness values from this layer have been excluded from the results presented here. This incident does not appear to have had a significant influence on the material properties in the wheel beyond the immediate vicinity of the white layer;

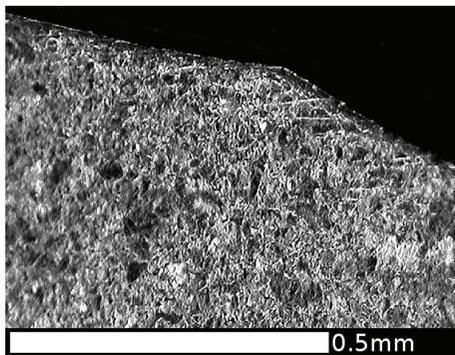
FIGURE 11: OM image of microstructure on the flange tip (A); this region does not contact the rails, and the surface shape retains the machining marks from the last turning on the lathe. There is no obvious shearing of the microstructure.

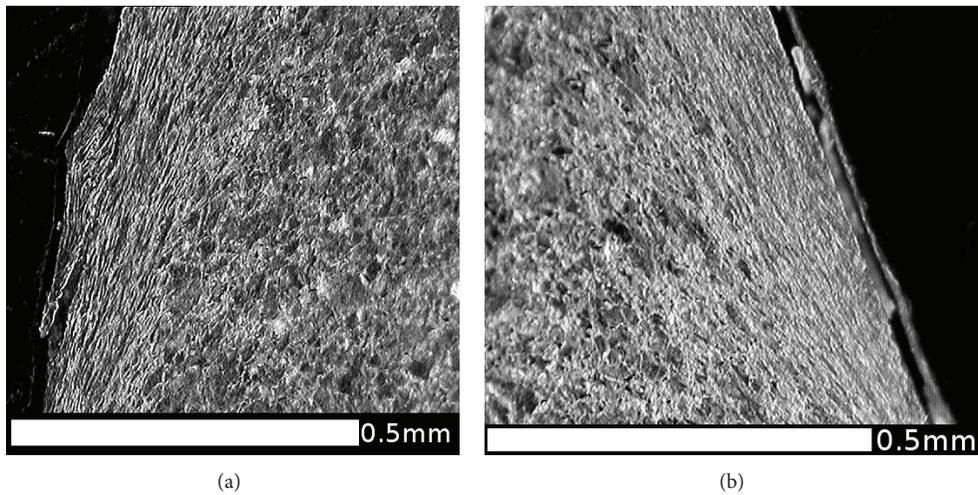
The flange face (Region B) experiences less frequent contacts, often lubricated but with high creep velocity and therefore high shear forces. The average surface hardness is around 340 HV. The microstructure in Figure 12 suggests that the direction of shear is predominantly circumferential (normal to the section). The wear rate is more significant in this region.

FIGURE 12: OM images of microstructure: (a) flange back (FB) and (b) flange face (B); These regions experience rubbing contacts with checkrails or the outer running rail on sharp curves. The predominant direction of the shear forces is circumferential (normal to the cross section in the figure), and the microstructure is affected to a depth of approximately 0.2 mm.

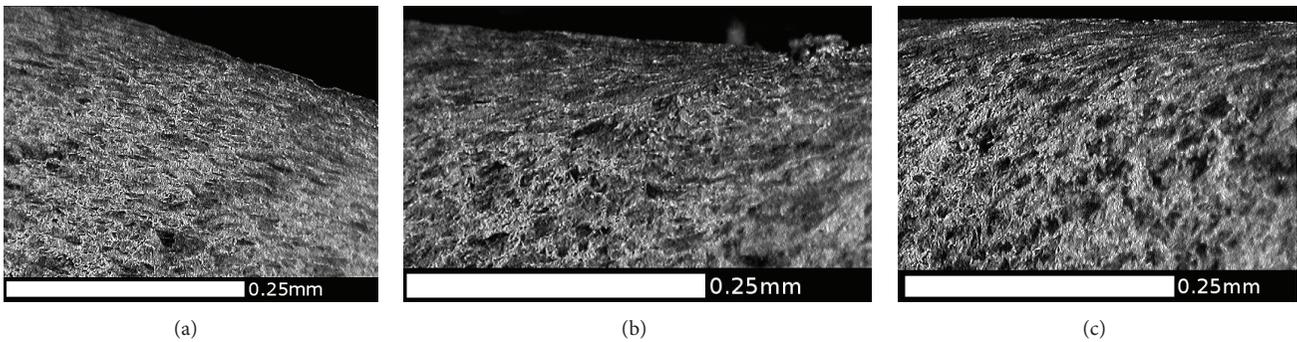
This effect is most significant in the regions of the wheel where there are frequent high tangential forces when the wheelset is in the leading position in the bogie (C and E). In these regions, the highest shear stresses are at the running surface, in a direction generally toward the centre of the wheel tread as shown in Figure 5. The average surface hardness in this region is around 360 HV, with local maxima close to 400 HV. This compares to the as-manufactured hardness in this region of approximately 260 HV. Figure 13 shows the microstructure in Region C, which is sheared to a depth of about 0.1 mm. One of the fine surface cracks visible in this region on Figure 14 is also apparent on the cross section in Figure 13; this crack does not extend below the sheared region. Evidence from the wheel lathe suggests that the cracks in this region of the wheel are shallower than 1 mm.

FIGURE 13: OM images of microstructure in the flange root area: (a) Region C1, (b) Region C2, and (c) Region C3. These show the microstructure sheared to the right (toward the centre of the tread) which is consistent with the direction of tangential forces on this part of the wheel (Figure 4). The depth of shearing is about 0.1 mm. A crack is visible in Region C2, at the same angle as the sheared microstructure, about 0.2 mm long. Cracks are also visible on the surface here (see Figure 3).

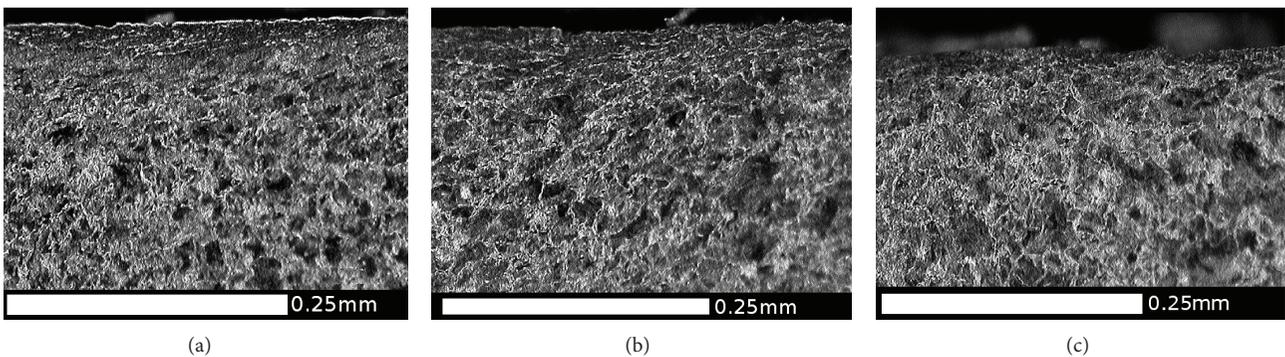
the circumferential forces are also similar in both directions. There is no significant shearing of the microstructure visible in Figure 14 (note that shearing in a circumferential direction on the flange face was visible in Figure 12). It is possible that the tangential forces associated with traction and braking are insufficient to shear the microstructure, but it is also possible that any shearing in one direction is cancelled by an equivalent opposite shearing when the wheel is rotating in the opposite direction. Twin-disc tests where the rolling direction was reversed showed this effect [7, 8]. The average surface hardness here is rather less than in Regions C and E, around 340 HV.

FIGURE 14: OM images of microstructure in the running band (centre of the tread): (a) Region D1, (b) Region D2, and (c) Region D3. The tangential forces are generally lower in this region and typically circumferential (normal to these sections). There is no obvious shearing of the microstructure here.

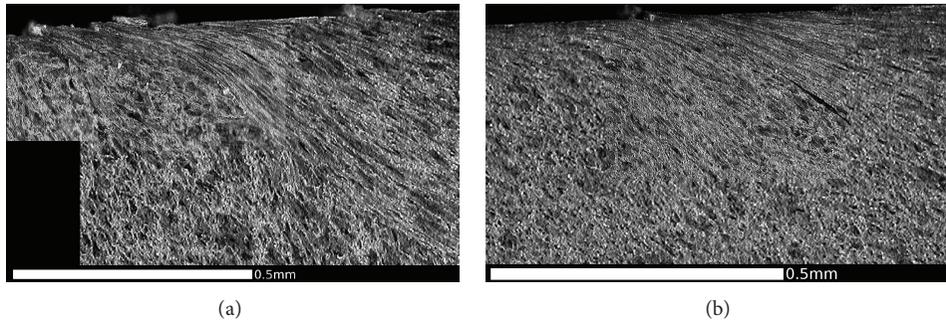
Figures 15 and 16 show the deformed microstructure in Region E; again this is sheared toward the centre of the tread, but the deformation is deeper, typically at least 0.5 mm. Figure 15(a) shows a location where two small RCF cracks have joined together about 0.3 mm below the surface; this could lead to the intervening material becoming detached and forming a small cavity. Figure 16 shows a more significant RCF crack which has propagated to a depth of 2 mm (below the sheared region) and has started to branch at that depth. Evidence from the wheel lathe suggests that the cracks in this region of the wheel are often deeper than 2 mm and in severe cases can be greater than 6 mm deep. They often join with other cracks resulting in large cavities on the tread. It is possible that fluid entrapment contributes to the propagation of these deep cracks in Region E [1, 2]. The presence of such cracks provides crack shielding so the shear stresses are carried by the material above the crack, which consequently shears more than the material below the cracks, as can be seen in Figure 16.

FIGURE 15: OM images of microstructure in the RCF band, (a) Region E1, and (b) Region E2. This region experiences high tangential forces, typically toward the centre of the tread (a) as shown in Figure 4, and these cause significant surface cracking (Figure 3). The microstructure is sheared in the same direction, and the influence extends to a depth of about 0.3 mm. Cracks are visible in this section, including two that have joined sub-surface in Region E1.

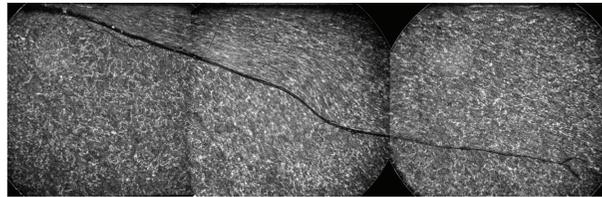
FIGURE 16: Composite OM image showing RCF crack in Region E3, viewed in a circumferential direction on a cross section. Running surface at top of image, field side to right. Crack length 6.2 mm, depth 2 mm. Note branching at crack tip and deformed microstructure above crack. This image is from a different cross section of the same wheel shown in Figure 14, selected to show a longer crack.

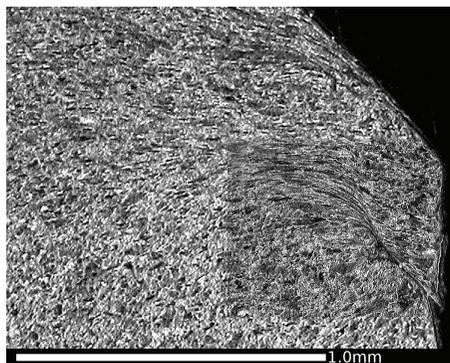
FIGURE 18: OM image of microstructure on the field side tread chamfer, showing localised plastic flow (Region F2). Together with the lack of microstructural shear in the majority of Region F, this suggests that material “rollover” on the field side of this wheel is a localised phenomenon and not associated with material flow from other parts of the wheel tread.

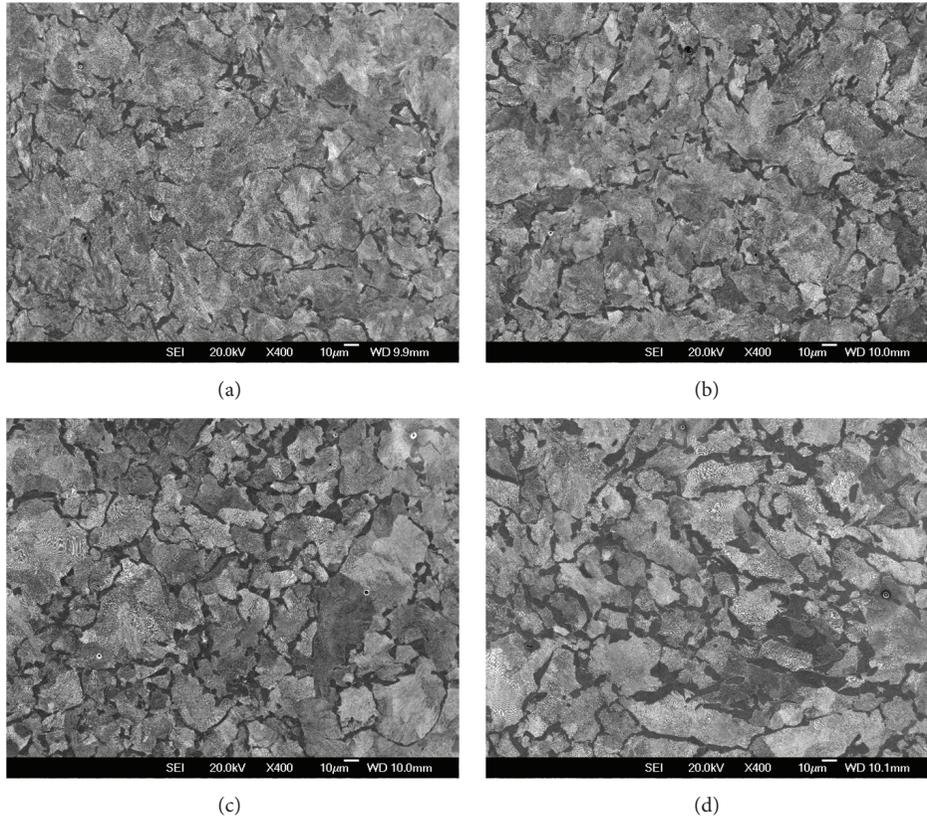
Figure 20 shows the microstructure at the locations 1 to 4 marked on Figure 8, covering the range of the underlying trend in hardness. The carbon content is usually fairly consistent through the rim [29]. The dark areas in Figure 20 represent proeutectoid (PE) ferrite, and the area fraction (equivalent to volume fraction) of PE ferrite increases with depth. Previous work [18, 32] has correlated hardness measurements in this portion of railway wheels with observed PE ferrite fraction. Figure 21 shows how the results from the regional DMU wheel correlate well with those for similar steel grades by Wagner et al. [32] and Walther and Eifler [18].

FIGURE 20: (a) SEM image of microstructure, Loen 1 on Figure 8. PE Ferrite 8.8%, 271 HV. (b) SEM image of microstructure, Loen 2 on Figure 8. PE Ferrite 9.8%, 255 HV. (c) SEM image of microstructure, Loen 3 on Figure 8. PE Ferrite 16.9%, 237 HV. (d) SEM image of microstructure, Loen 4 on Figure 8. PE Ferrite 20.9%, 232 HV.

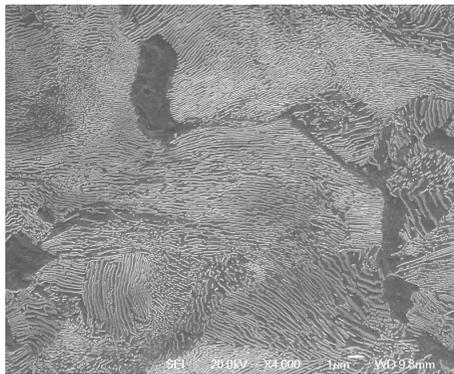
spacing, but much of this is due to the oblique orientation of many grains relative to the observed surface. The smallest spacing observed is an approximation of the true value [35], and is approximately $0.10 \mu\text{m}$ on Figure 22. Considerable work has been undertaken to relate the lamellar spacing to mechanical properties, for example, [36]. The relationship between lamellar spacing and hardness of this wheel sample is broadly in line with those quoted for rail steels [37].

FIGURE 22: SEM image of pearlite lamellae in Region 1 of the wheel.
