Evaluation of fretting wear on the femoral stem surface

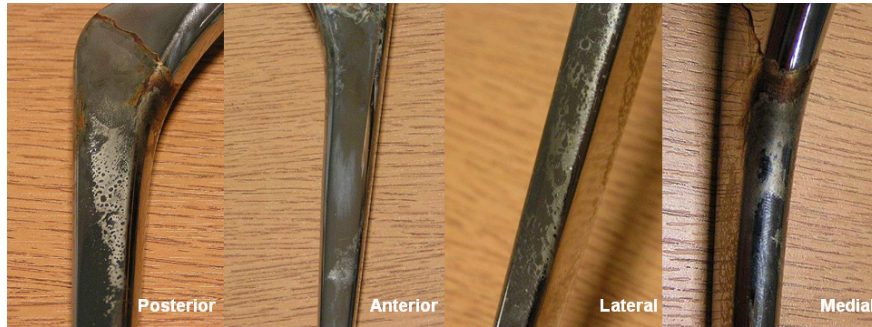
The femoral stem showed typical evidence of worn areas on the surface, which primarily concentrated on anterolateral, posteromedial, and under-neck zones of the stem surface, figure 3. The other areas were smooth and appeared undamaged. No formation of bone cement transfer film was observed. Detection of the wear damage based on the technique developed using grey scale threshold is shown in figure 4, from which it was clear that many undamaged islands were located within the worn areas. These undamaged islands were irregular in shape and surrounded by fretting damage. The coverage of the worn areas in each Gruen zone on the stem surface is

shown in table 1, and it was evident that Gruen zone 6 and 7 illustrate the most severe of wear damage.

Figure 3. *Reproduction of fretting wear on the stem surface*

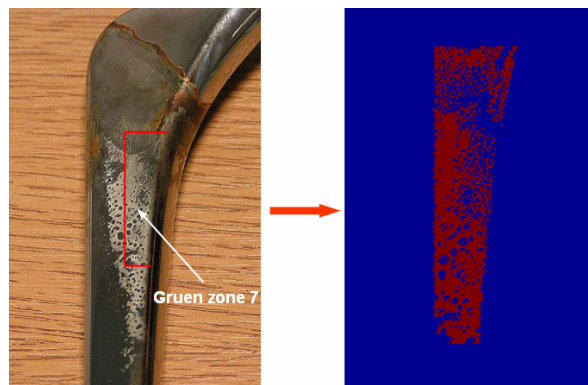
Figure 4. *Detection of worn areas on the stem surface based on grey scale threshold*

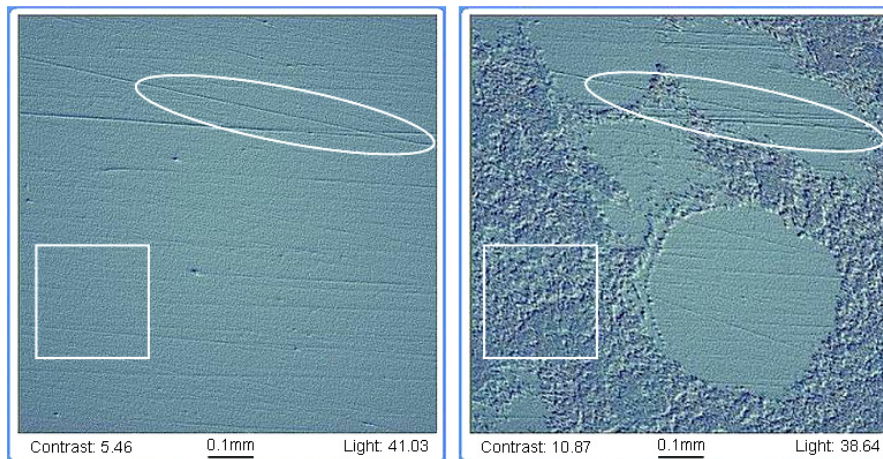
Figure 5 shows the comparison of the same position on the stem surface utilising the relocation system pre and post simulation. From the figure it was clear that some areas (shown in white square) were severely roughened by the fretting process at the stem–cement interface, whereas the other areas (shown in white ellipse) remained relatively unchanged. Additionally, a total of 20 measurements were performed on Gruen 6 of the posterior surface of the stem, using the Talysurf CCI interferometer. The mean values of the 3D surface parameters S_q and S_z were calculated as $0.42\mu\text{m}$ and $5.67\mu\text{m}$ respectively, which showed a significant increase in comparison with the values obtained before simulation ($0.04\mu\text{m}$ and $1.52\mu\text{m}$). Figure 6 illustrates one typical measurement, which shows comparison of surface topography between the

Figure 5. Comparison of the same measurement position on the stem surface pre and post simulation

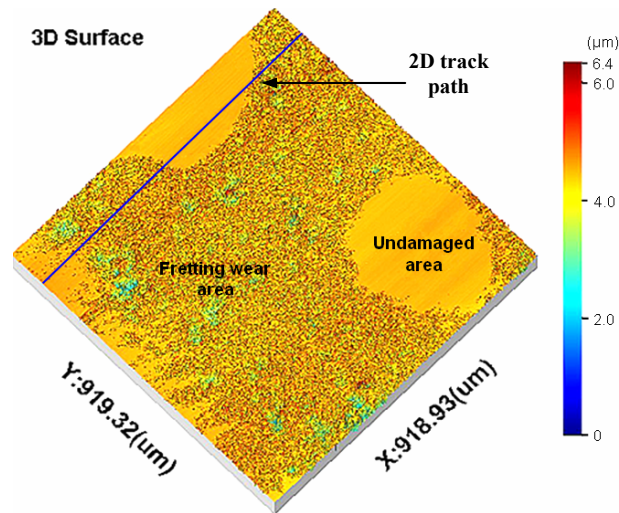
Figure 6. Comparison of fretting wear area and undamaged area on the stem

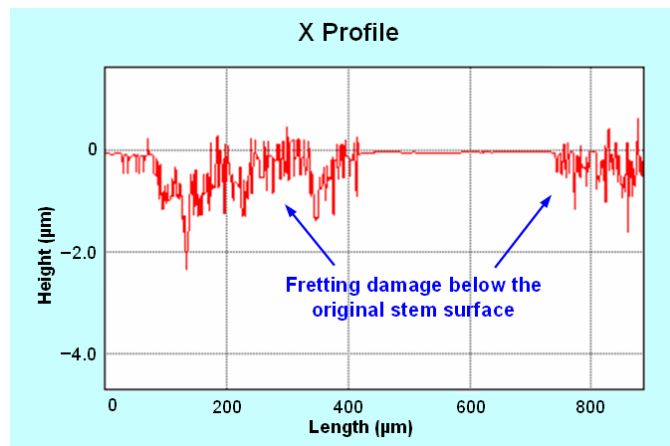
worn area and the undamaged area. Figure 7 shows the 2D profile of the worn area, from which it was confirmed that the wear damage occurred below the original stem surface. This is considered as one distinctive feature of fretting wear.

Figure 7. 2D surface profile of the worn areas on the stem surface
