Evaluation of fretting wear on the femoral stem surface

Hongyu Zhang*, Leigh Brown*, Liam Blunt*, Simon Barrans**

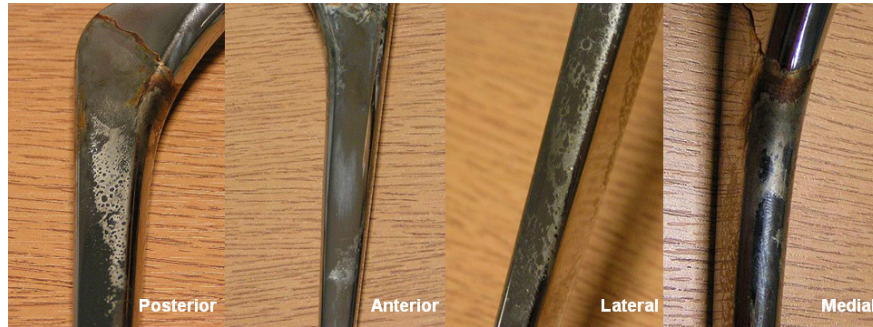
The femoral stem showed typical evidence of worn areas on the surface, which primarily concentrated on anterolateral, posteromedial, and under-neck zones of the stem surface, figure 3. The other areas were smooth and appeared undamaged. No formation of bone cement transfer film was observed. Detection of the wear damage based on the technique developed using grey scale threshold is shown in figure 4, from which it was clear that many undamaged islands were located within the worn areas. These undamaged islands were irregular in shape and surrounded by fretting damage. The coverage of the worn areas in each Gruen zone on the stem surface is

shown in table 1, and it was evident that Gruen zone 6 and 7 illustrate the most severe of wear damage.

Figure 3. *Reproduction of fretting wear on the stem surface*

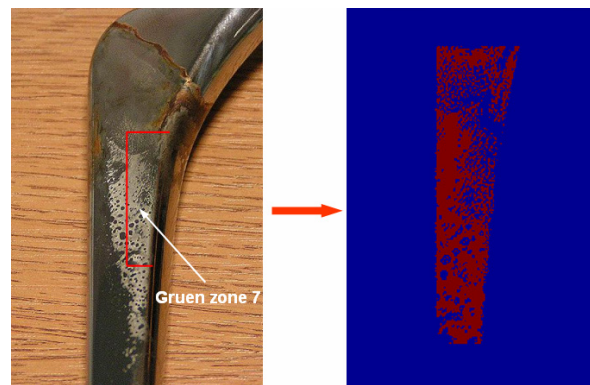
Figure 4. *Detection of worn areas on the stem surface based on grey scale threshold*
