Evaluation of fretting wear on the femoral stem surface

Zhang, Hongyu, Brown, L., Blunt, Liam and Barrans, Simon (2009) Evaluation of fretting wear on the femoral stem surface. In: International Conference on Bioengineering & Biomaterials, 18-29 March, Meknes, Morocco.

# Evaluation of fretting wear on the femoral stem surface

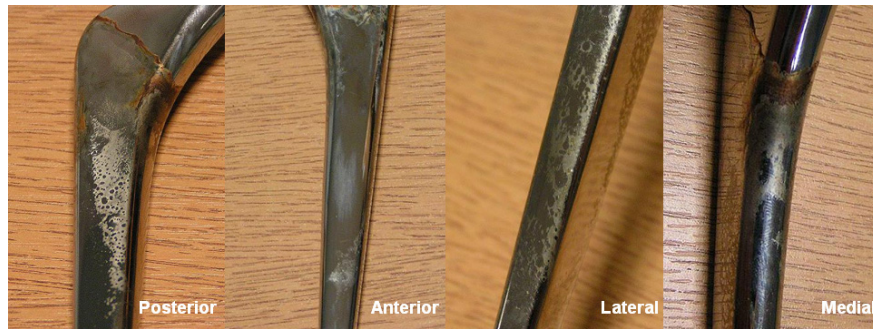
The femoral stem showed typical evidence of worn areas on the surface, which primarily concentrated on anterolateral, posteromedial, and under-neck zones of the stem surface, figure 3. The other areas were smooth and appeared undamaged. No formation of bone cement transfer film was observed. Detection of the wear damage based on the technique developed using grey scale threshold is shown in figure 4, from which it was clear that many undamaged islands were located within the worn areas. These undamaged islands were irregular in shape and surrounded by fretting damage. The coverage of the worn areas in each Gruen zone on the stem surface is

shown in table 1, and it was evident that Gruen zone 6 and 7 illustrate the most severe of wear damage.

**Figure 3.** *Reproduction of fretting wear on the stem surface*

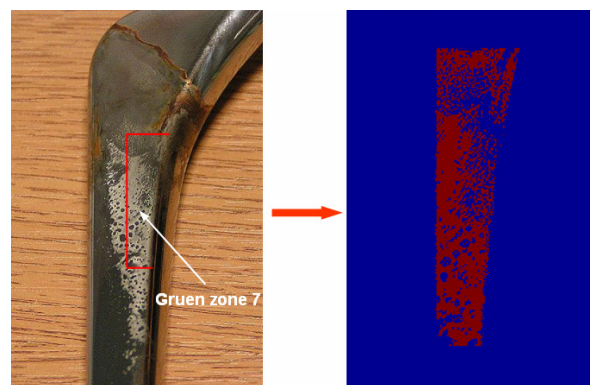
**Figure 4.** *Detection of worn areas on the stem surface based on grey scale threshold*

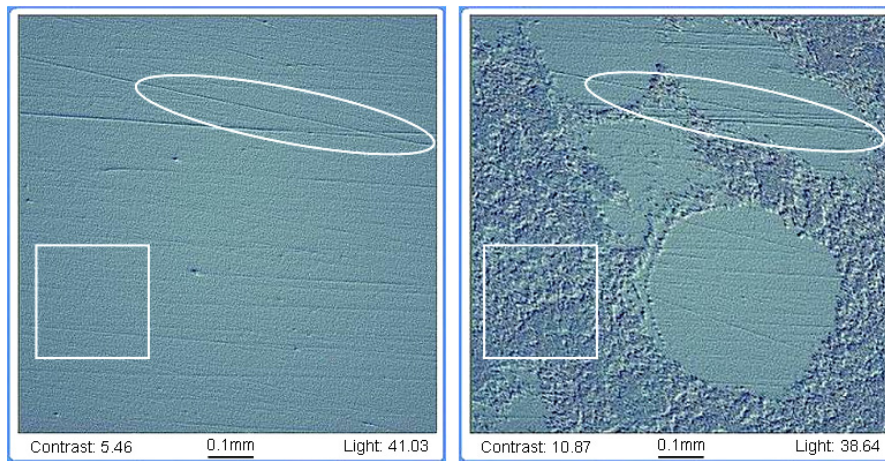
Figure 5 shows the comparison of the same position on the stem surface utilising the relocation system pre and post simulation. From the figure it was clear that some areas (shown in white square) were severely roughened by the fretting process at the stem–cement interface, whereas the other areas (shown in white ellipse) remained relatively unchanged. Additionally, a total of 20 measurements were performed on Gruen 6 of the posterior surface of the stem, using the Talysurf CCI interferometer. The mean values of the 3D surface parameters  $S_q$  and  $S_z$  were calculated as  $0.42\mu\text{m}$  and  $5.67\mu\text{m}$  respectively, which showed a significant increase in comparison with the values obtained before simulation ( $0.04\mu\text{m}$  and  $1.52\mu\text{m}$ ). Figure 6 illustrates one typical measurement, which shows comparison of surface topography between the

**Figure 5.** Comparison of the same measurement position on the stem surface pre and post simulation

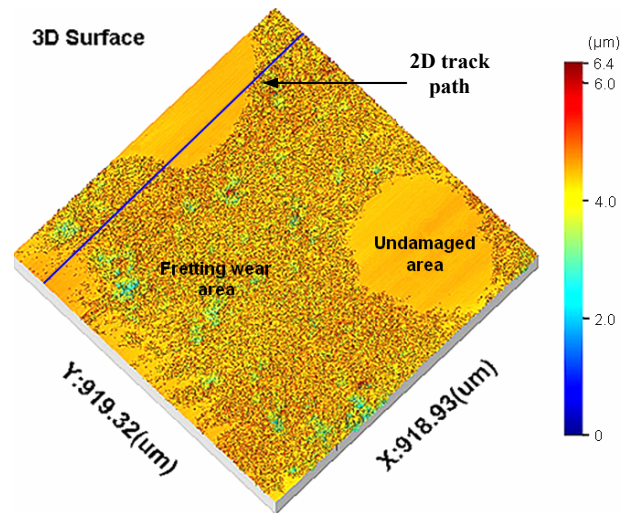
**Figure 6.** Comparison of fretting wear area and undamaged area on the stem

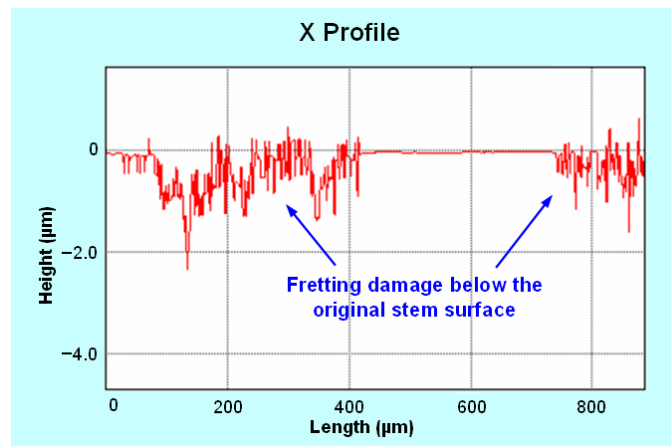
worn area and the undamaged area. Figure 7 shows the 2D profile of the worn area, from which it was confirmed that the wear damage occurred below the original stem surface. This is considered as one distinctive feature of fretting wear.

**Figure 7.** 2D surface profile of the worn areas on the stem surface

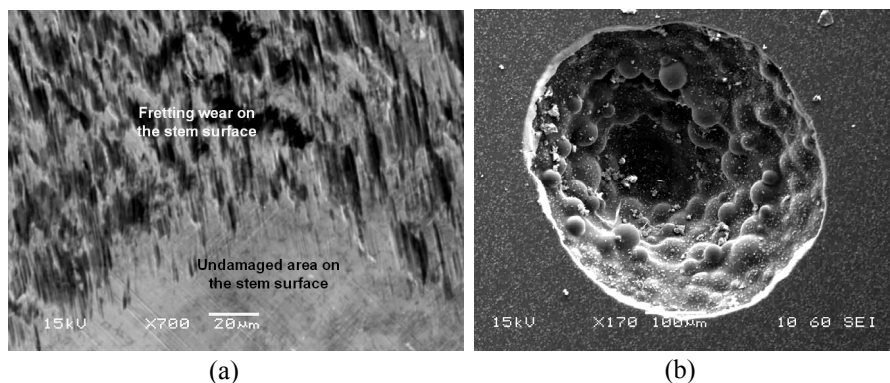
The surface topography of the worn areas on the stem surface measured through scanning electron microscopy is displayed in figure 8 (a). The pitting and crater features again confirmed that the wear reproduced on the stem through the *in vitro* simulation was fretting wear. Figure 8 (b) shows the scanning electron micrograph of the bone cement surface, from which it was clear that the cement surface was dominated by many micropores. Additionally, there was an amount of wear debris

located in the micropores, which was considered to be liberated from either the stem or the cement surface due to the fretting process at the stem–cement interface. Furthermore, no fatigue cracks were observed across the cement mantle.

**Figure 8.** Scanning electron micrographs showing (a) fretting wear on the stem surface and (b) wear debris located in the micropores in the cement surface
