CORROSION IS THE MAIN MECHANISM OF MATERIAL LOSS AT THE TAPER JUNCTION OF LARGE HEAD METAL ON METAL HIP REPLACEMENTS

A.K. Matthies¹, R. Racasan², P. Bills², A. Panagiotidou¹, L. Blunt², J. Skinner¹, G. Bluun^{1,3}, A.J. Hart^{1,3}

¹Royal National Orthopaedic Hospital, UK, ²University of Huddersfield, UK, ³University College London, UK

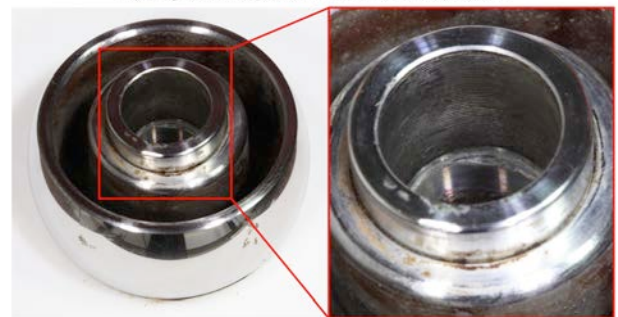
Figure 1: Photographs showing a case of severe taper corrosion with imprinting of the stem taper screw thread onto the head taper surface

Results: 81 out of 90 (90%) retrieved head and stem taper surfaces showed evidence of corrosion. Of these, 14 were classified as mildly corroded, 26 as moderately corroded, and 41 as severely corroded. Microscopy also revealed evidence in all cases that the machined thread of the stem taper had been transferred, or “imprinted” onto the head taper surface. An example of severe corrosion and “imprinting” is shown in Figure 1. SEM confirmed the presence of corrosion debris, pits and fretting damage. Volumetric wear of the taper surfaces was significantly lower than the combined volumetric wear of the bearing surfaces ($p = 0.015$).

Discussion and Conclusions: The taper junction contributes significantly less than the bearing surfaces to the total wear volume. Therefore the volume of material alone cannot explain the higher failure rate of LH-MOM when compared to MOM hip resurfacing. However, our results support corrosion as the main mechanism, and it is possible that ionic corrosion products are a more potent inflammatory stimulator than the particulate wear debris originating from the bearing surfaces. The mechanism is likely to involve galvanic and mechanically assisted corrosion. The taper junction provides an ideal crevice and the screw thread facilitates fluid movement to and from the joint. Imprinting of the stem taper surface supports the role of galvanic corrosion, whereby one surface (the head taper) is preferentially corroded.
