Elrawemi, Mohamed, Blunt, Liam, Fleming, Leigh, Sweeney, Francis and Robbins, David (2014) Defect Detection in Thin-film Photovoltaics; Towards Improved Efficiency and Longevity. In: 5th International Renewable Energy Congress. IREC 2014 . IEEE, Hammamet, Tunisia, pp. 524-528. ISBN 978-1-4799-2196-6

Defect Detection in Thin-film Photovoltaics; Towards Improved Efficiency and Longevity

M. Elrawemi, L. Blunt, L. Fleming, and F. Sweeney

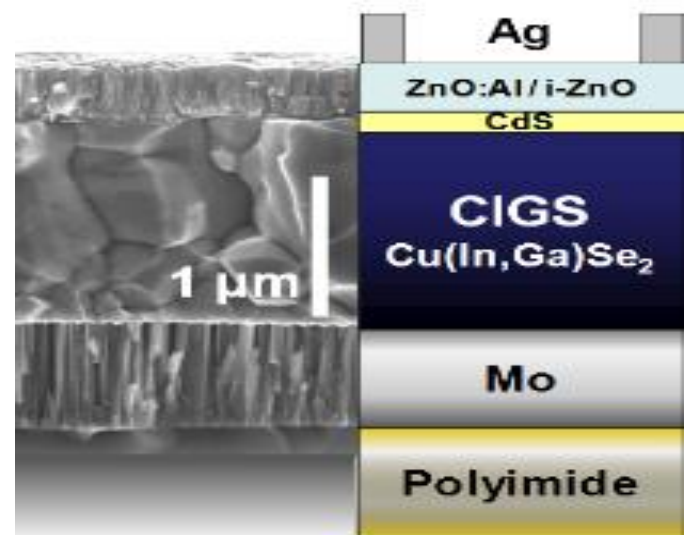
Fig. 1. Typical structure of flexible PV module (Courtesy of Flisom, Switzerland)

construction of Si solar cells hampers their economic integration into residential and commercial buildings; however, thin film solar cell technologies may prove to be most appropriate with respect to cost and ease of manufacture, and it is anticipated that the next generation of photovoltaic devices will be based entirely on thin film technologies. These cells are based on the material $\text{CuIn}_{1-x}\text{Ga}_x\text{Se}_2$ (CIGS) as the absorber layer (p-type) and they are the most efficient cells at the present time [2].

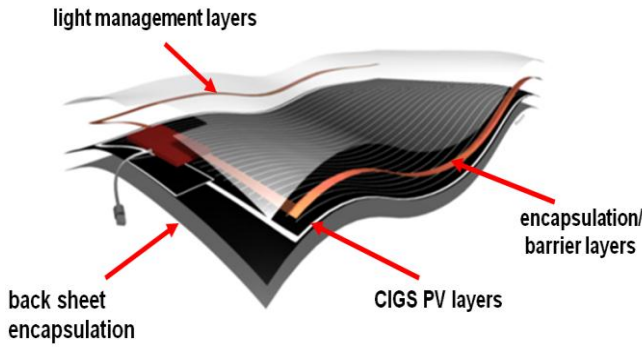
Fig. 2. Schematic of the flexible PV Module (Courtesy of Flisom, Switzerland)

Flexible solar modules comprise four functional layer groupings as shown in Fig 2. The main focus of the investigation in this paper is the barrier layer which is incorporated in the encapsulation layers. This layer is typically formed from a planarised Polyethylene Naphthalate (PEN) sheet with an amorphous Al_2O_3 barrier coating <50 nm thick. The Al_2O_3 barrier coating is produced by Atomic Layer Deposition (ALD). The ALD is a controlled layer-by-layer deposition technique that enables the deposition of thin, smooth, and highly conformal films with atomic layer precision and typical thickness ranges between 1 and 100 nm [4].

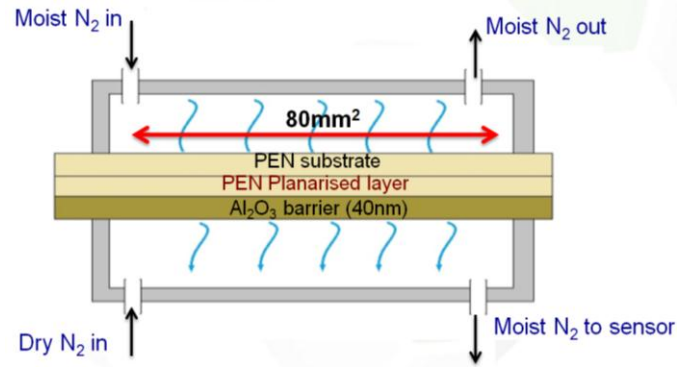
Fig. 3. Schematic representation of WVTR test

Prior to the surface measurements, the samples were measured for water vapour transmission rate (WVTR) using Isostatic standard test instrumentation (MOCON®) at specified conditions (38°C° and 90% RH respectively). This method involves the test specimen being held in a sealed chamber such that it separates two sides of the chamber as shown in the Fig 3.

On one side of the sample a highly saturated wet environment is maintained at a constant temperature, whilst on the other, a dry nitrogen carrier gas is passed to a coulometric phosphorous pentoxide sensor where water vapour which enters is converted to a measurable charge [5].

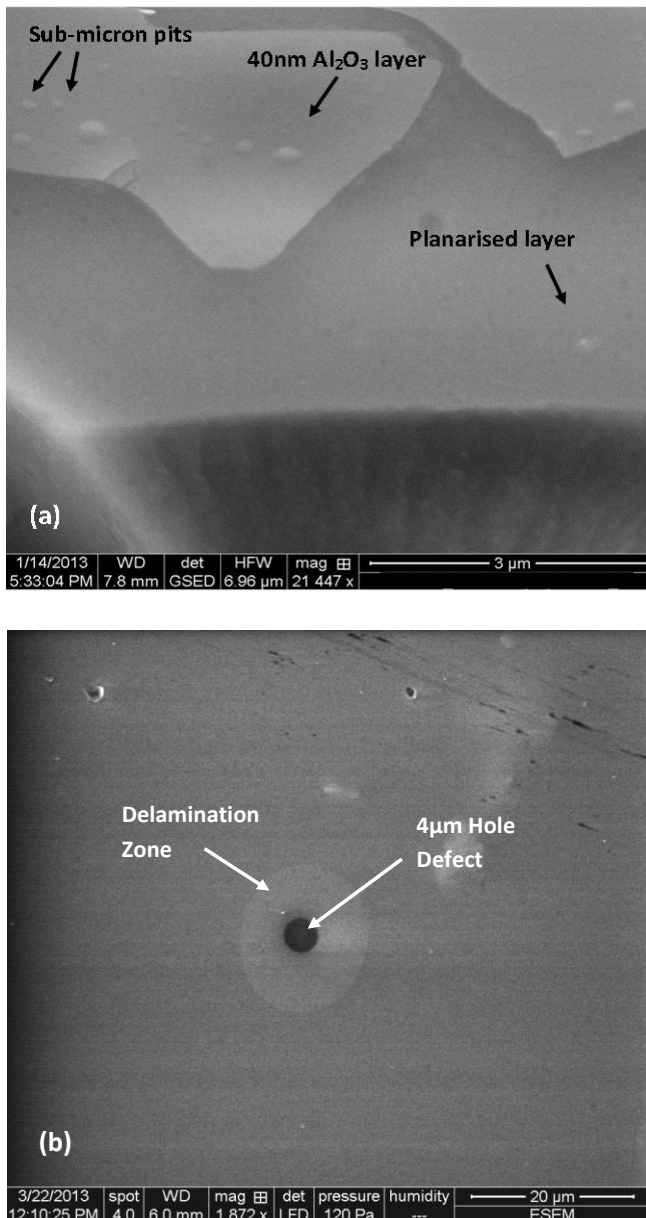
Fig. 4. ESEM of defects in Al_2O_3 barrier layer (a) Al_2O_3 /polymer cross-section, (b) typical hole type defect

investigate the Al_2O_3 /polymer structure, the low vacuum mode was employed using water vapour at pressures between 120 and 400 Pa. An off-axis large field detector was used to collect the amplified secondary electron signal emitted from the specimen; this detector has the advantage of providing images with a relatively large field-of-view. A cross-sectional electron micrograph was obtained near the edge of the Al_2O_3 /polymer structure as shown in Fig (4a). The image shows the 40-nm Al_2O_3 barrier layer that exhibits pit-like defects between 100 nm and 500 nm in diameter on the surface. In Fig (4b) an image of a typical hole defect, approximately 4 μm in diameter, in the Al_2O_3 layer is shown. A region of differing contrast is observed in the area surrounding this hole; this is attributed to the delamination of the Al_2O_3 layer from the underlying polymer structure due to water penetration.

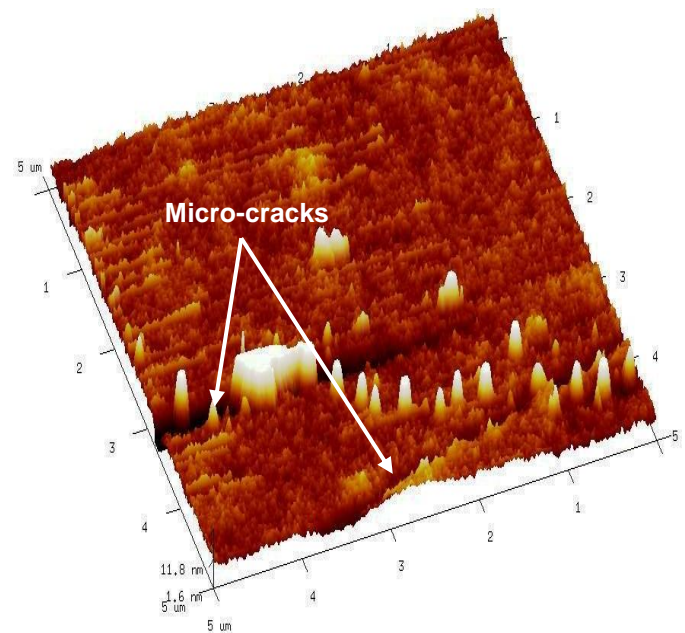
Fig. 5. AFM image-micro-crack type defect

Although the object targeting and the image acquisition can be more rapid using the SEM, polymers are difficult to examine as they have a tendency to rapidly charge, even with a conductive coating, resulting in beam divergence and image degradation. In contrast, AFM can analyse the samples with minimal sample preparation, thus preserving surface textures and allowing repeat analyses without the risk of charging. The AFM can produce an equal or higher data resolution image of an equivalent area, but with the addition of absolute X, Y and Z for any features. In this study, a Bruker Dimension Icon AFM was used as an independent measure of the Al_2O_3 ALD film. It allows much smaller defect sizes to be examined than would be possible by the SEM. It can also be used to determine the size of the cracks over the films which were not detectable by the CCI or the optical microscopy techniques. Fig 5 shows crack type defect captured by this technique.

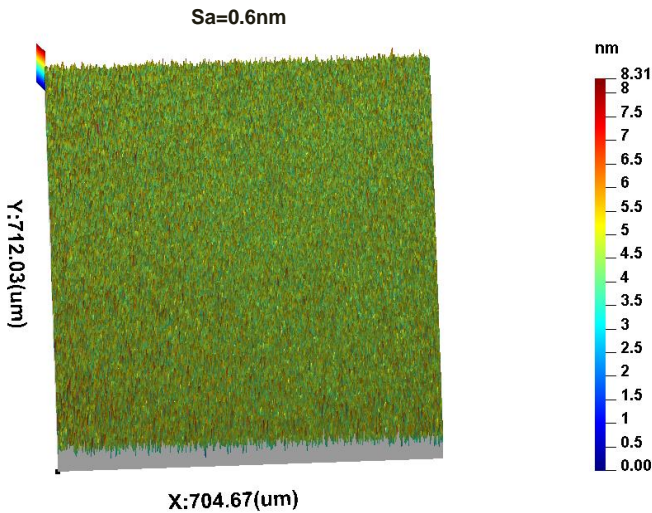
Fig. 6. Non-defective sample ($S_a = 0.6\text{nm}$)

The surface roughness average of a defect free sample Fig. 6 was measured to be ~0.6nm. Based on that, the Wolf Pruning method was conducted with prune conditions set for each sample in order to isolate only the largest defects. The criteria of being defined as a large defect was 6σ where $S_q = 0.6\text{nm}$ height and $15\mu\text{m}$ width. Effective discrimination of significant and non-significant defects was recorded.

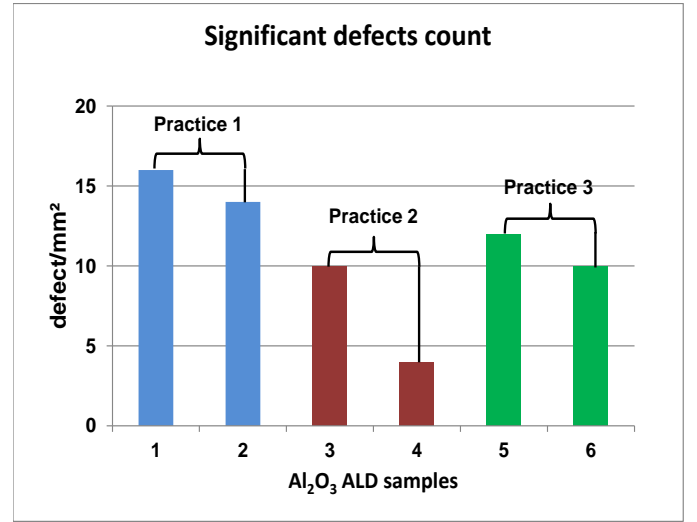
Fig. 7. Shows the significant defects count

The results in Fig 7. Showing significant defects count as analysed by the 'wolf pruning' method. Comparing each two sets of the samples results, feature segmentation analysis and the pruning condition of (6σ where $S_q = 0.6\text{nm}$ height and $15\mu\text{m}$ width) have provided a clear evidence for the correlation of surface defects size, defect density, and the transmission of water vapour through the barrier coating layers. The investigation concludes that large defects are the dominant factor for determining the WVTR.

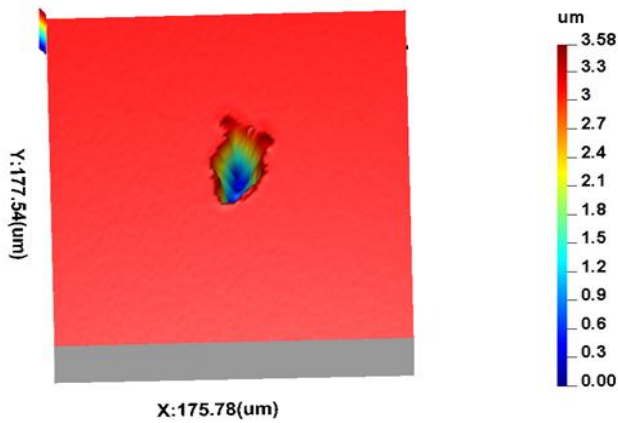
Fig. 8. shows a typical example of large defect

Sample 4 has less large defects recorded than the other samples. This is believed to be attributed to the nature of sample handling conditions. The procedure for sample handling and purging/cleaning of the ALD coating equipment was optimised for this sample. This ensured few or even no particles were present on the surface prior to the ALD process. Therefore, the WVTR value was very low (see section II). In contrast to this, sample 3 prepared with the same conditions as sample 4 demonstrated a lower large defect count than the other samples but still had the highest WVTR value $\approx 1 \times 10^{-3} \text{g/m}^2/\text{day}$. This sample has larger defects than the other investigated samples (typical example is shown in Fig. 8, which may have had a negative effect on the barrier properties thus giving an increase in the WVTR.
