Walton, Karl, Blunt, Liam, Fleming, Leigh, Goodhand, Martin and Lung, Hang (2014) A real parametric characterisation of ex-service compressor blade leading edges. *Wear*, 321. pp. 79-86. ISSN 00431648

Areal parametric characterisation of ex-service compressor blade leading edges

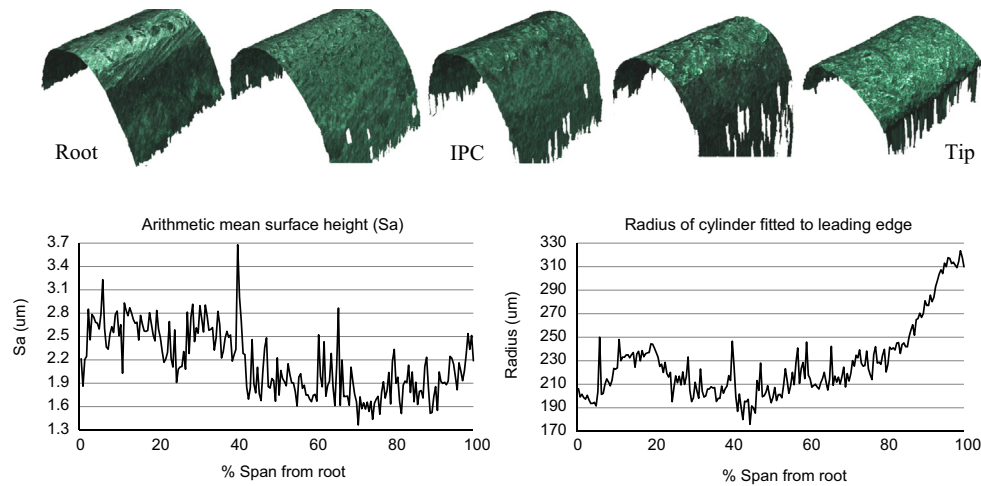
Fig. 7. Excerpted microscopic photographic images of a typical IPC blade, with charts detailing S_a (arithmetic mean surface height) [22] and fitted cylinder leading edge radius for each measurement field. Acquired with Alicona G4 IFM; X20 objective, lateral resolution $2.9\ \mu\text{m}$ (sample spacing $1\ \mu\text{m}$), vertical resolution (quantisation) $100\ \text{nm}$, Gaussian L filter nesting index 300 μm (high pass surface filter) [23].

Fig. 7 shows microscopic images of individual measurement fields for an example IPC blade spaced equally along the leading edge, and plots of S_a and fitted radius with % span from route. For proprietary reasons no comparative as manufactured edge half thickness values are quoted, though as a general trend these values decrease from root to tip. The data is plotted for individual captured fields $\sim 450\ \mu\text{m}$ of leading edge; this has the effect of showing the local variations due to the scale of impact features and deposits. This may or may not be desirable, and the data could be filtered or averaged to give a more general trend to suit another application. Fig. 7 illustrates the usefulness of fitted radius as a basic metric of leading edge profile change and hence the extent of wear; the tip region of this typical IPC blade is seen to have a significantly flattened profile and correspondingly elevated values of fitted radius in this region. Visual assessment confirms a positive correlation between deviation from the expected plot of a progressive reduction in fitted radius from root to tip and gross leading edge geometry change due to erosion. It was anticipated that a positive correlation would exist between peak leading edge wear and surface roughness. Fig. 7 clearly shows this not to be the case. Low wear (erosion) of the root half of the leading edge is seen to be associated with higher S_a values than the tip region which exhibits high wear. As a general rule abrasive particulates in the core flow tend to be centrifuged towards the blade tips [19] hence the characteristic tip biased wear pattern. It is noted that where erosion is the dominant in the IPC that a general positive correlation exists between peak regions 'Autocorrelation length' (S_{al}) [20] [21] and S_a , meaning, as might be expected, that larger particulate impacts produce surface features of larger amplitude and lateral length scale (wavelength). This is to some extent borne out by visual inspection of Fig. 7. When deposition becomes apparent and erosion less dominant from the late IPC onwards

this correlation is less notable. Thus it appears that the overall quantity and specific combination of particulate scales acting at a given leading edge location dictate the level of erosion and roughness character generated though the relationship between these effects is not straightforward.
