Understanding Why Dual-Taper Hips Fail

# Understanding Why Dual-Taper Hips Fail

## Dual-taper systems

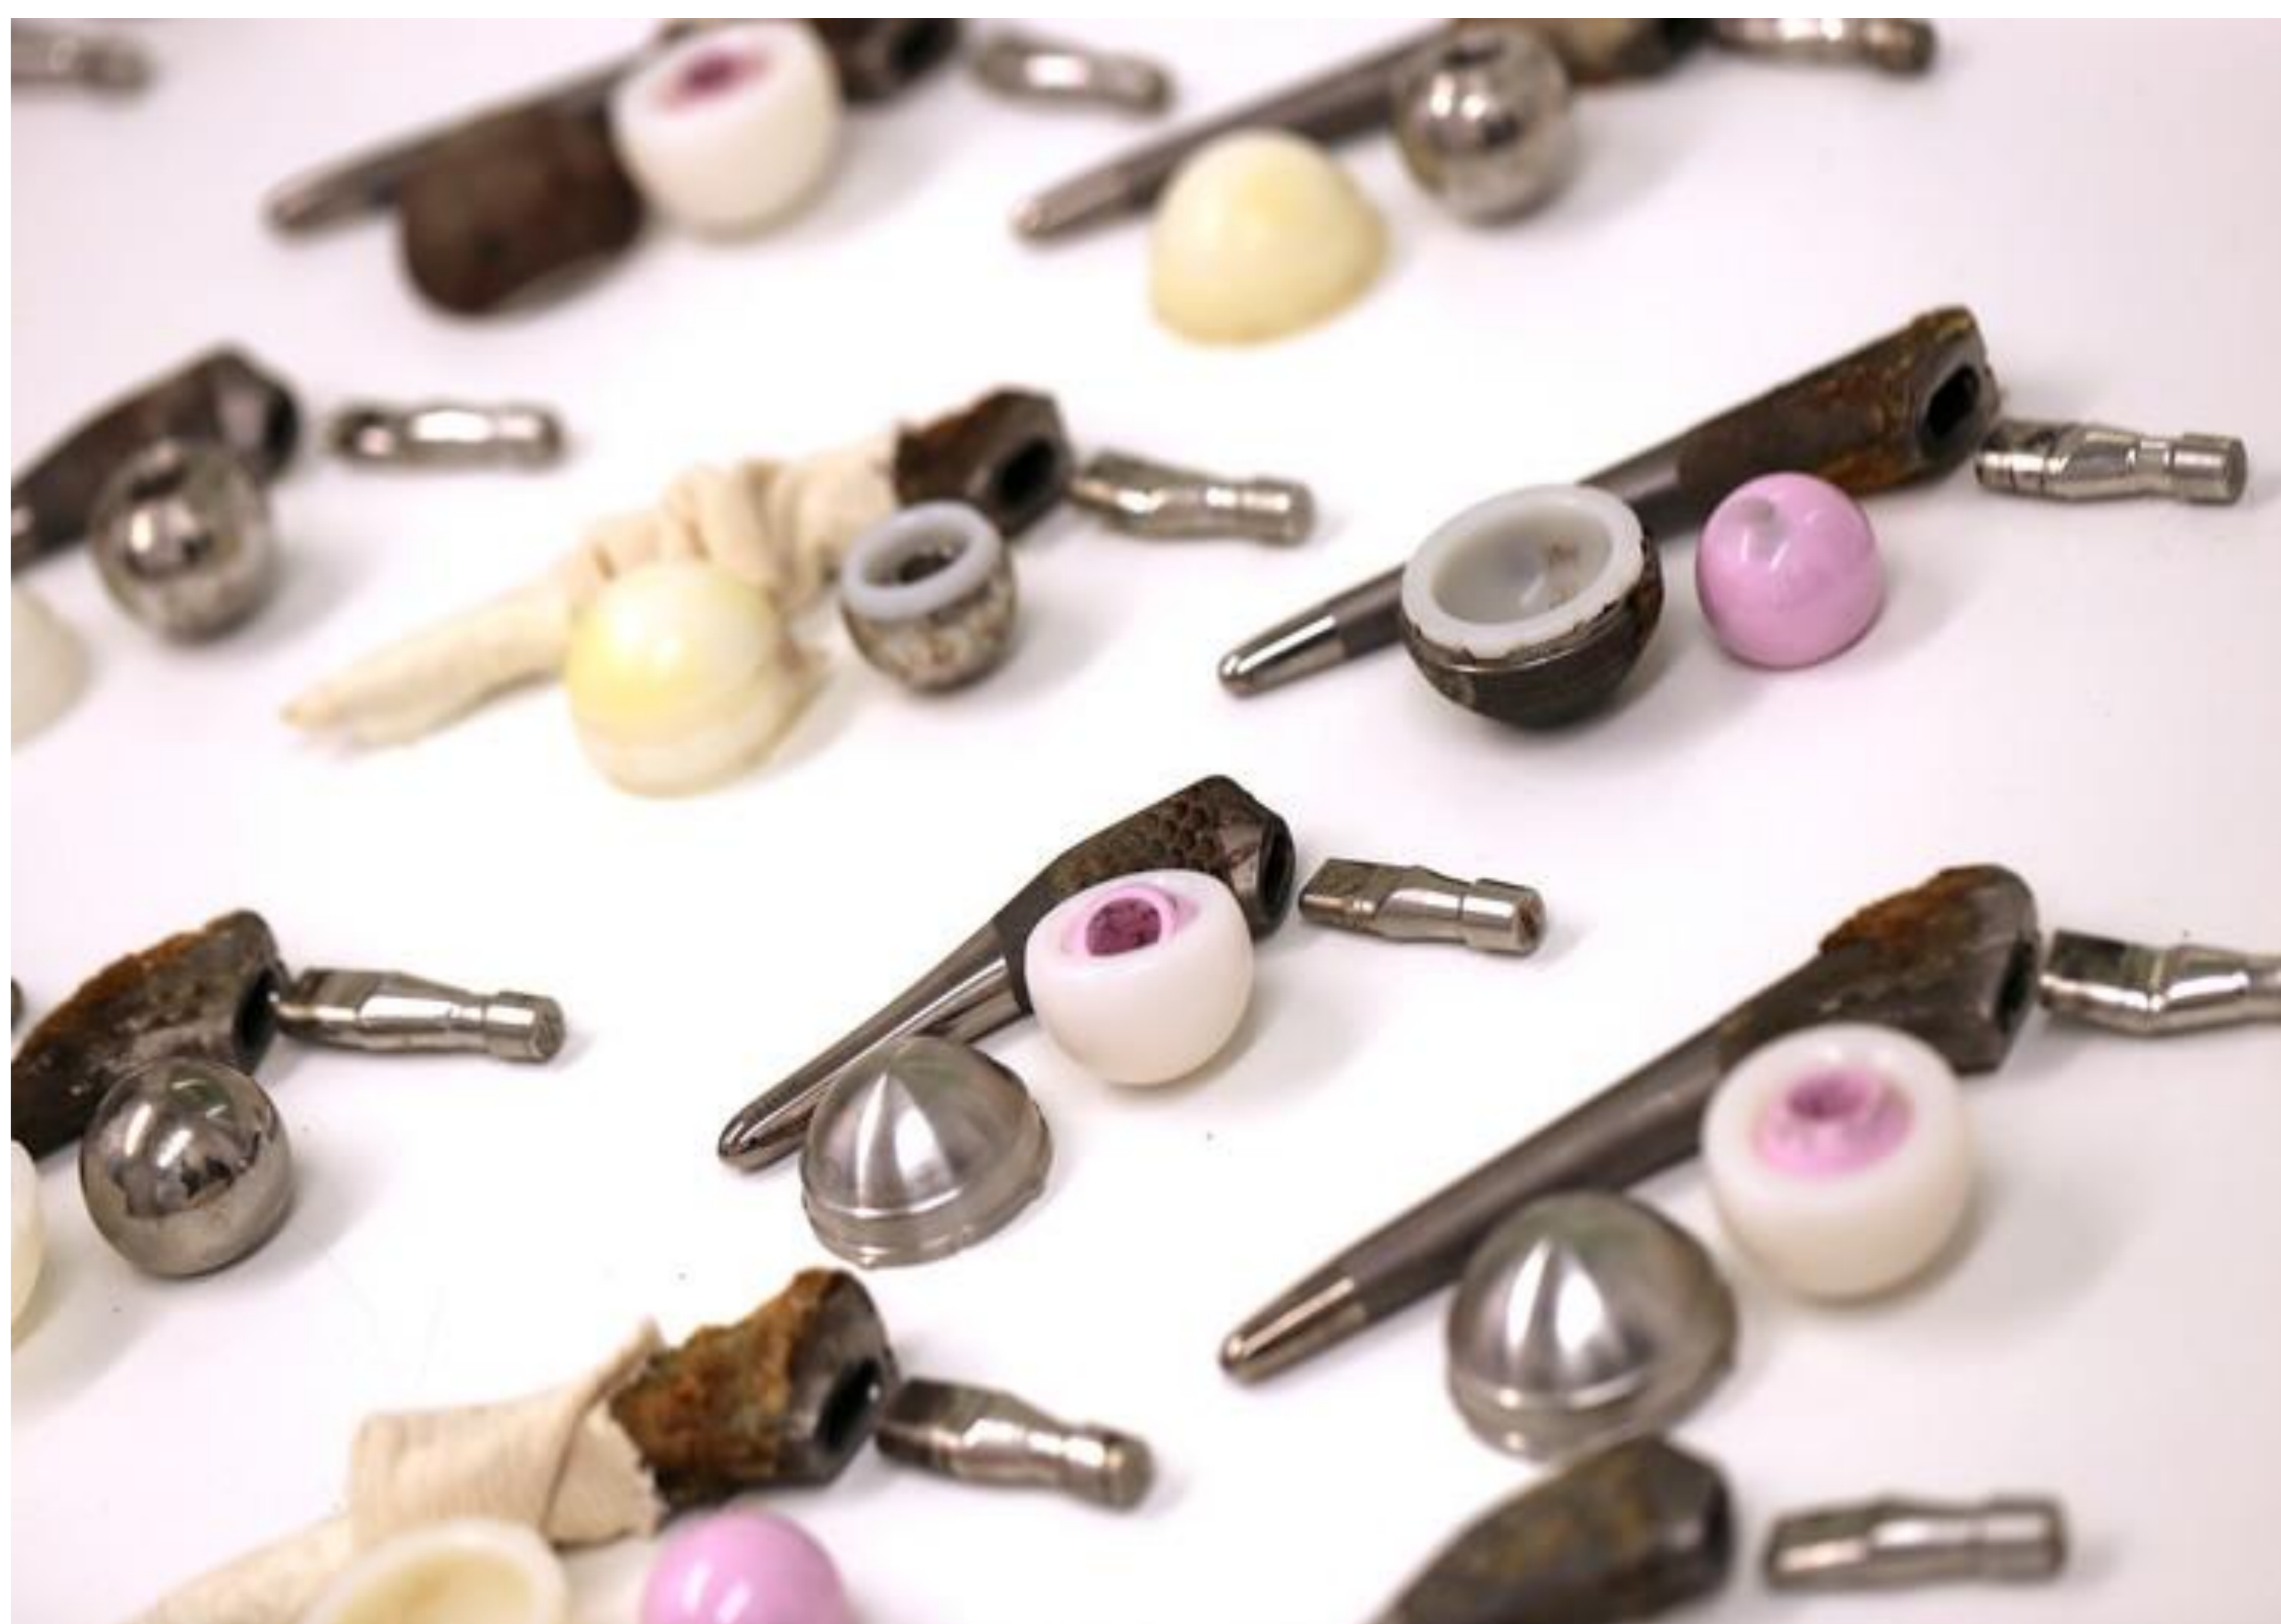
**Advantages:** biomechanical, mixing of materials, facilitation of revision arthroplasty [1];

**Disadvantages:** mechanical failure [2], metal ion release [3], corrosion at the modular interface [4], bony erosion [5].

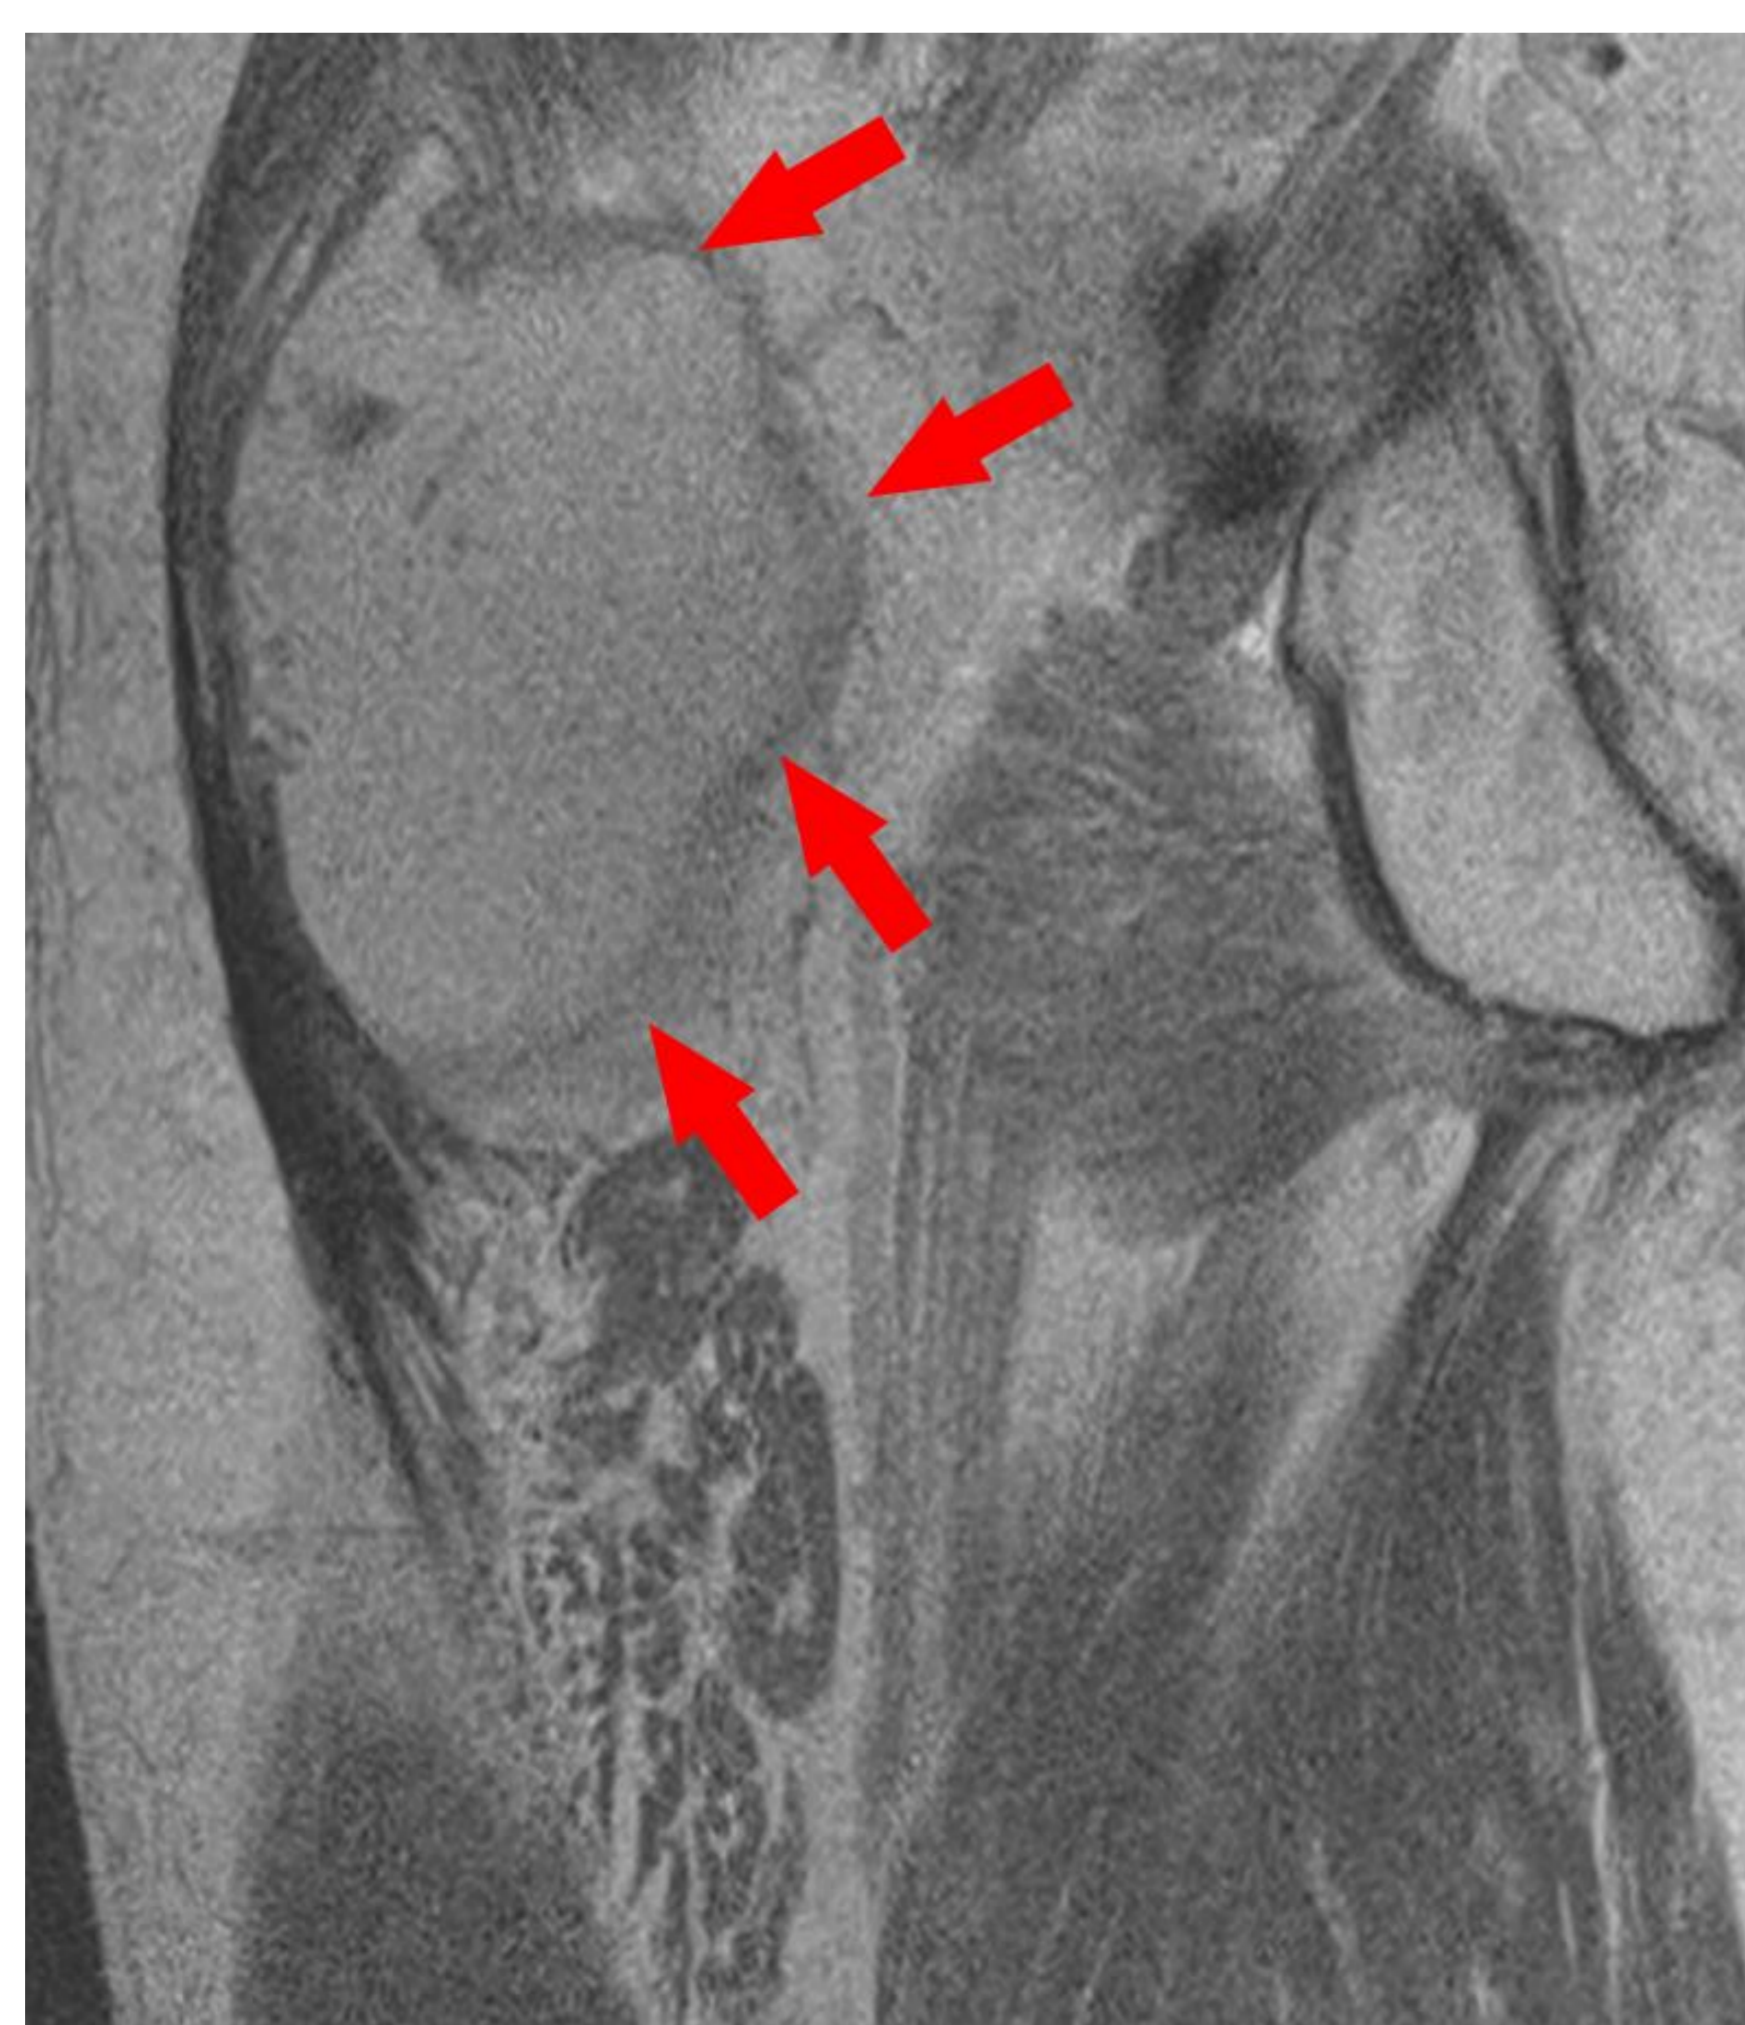
MARS MRI showing pseudotumor formation.

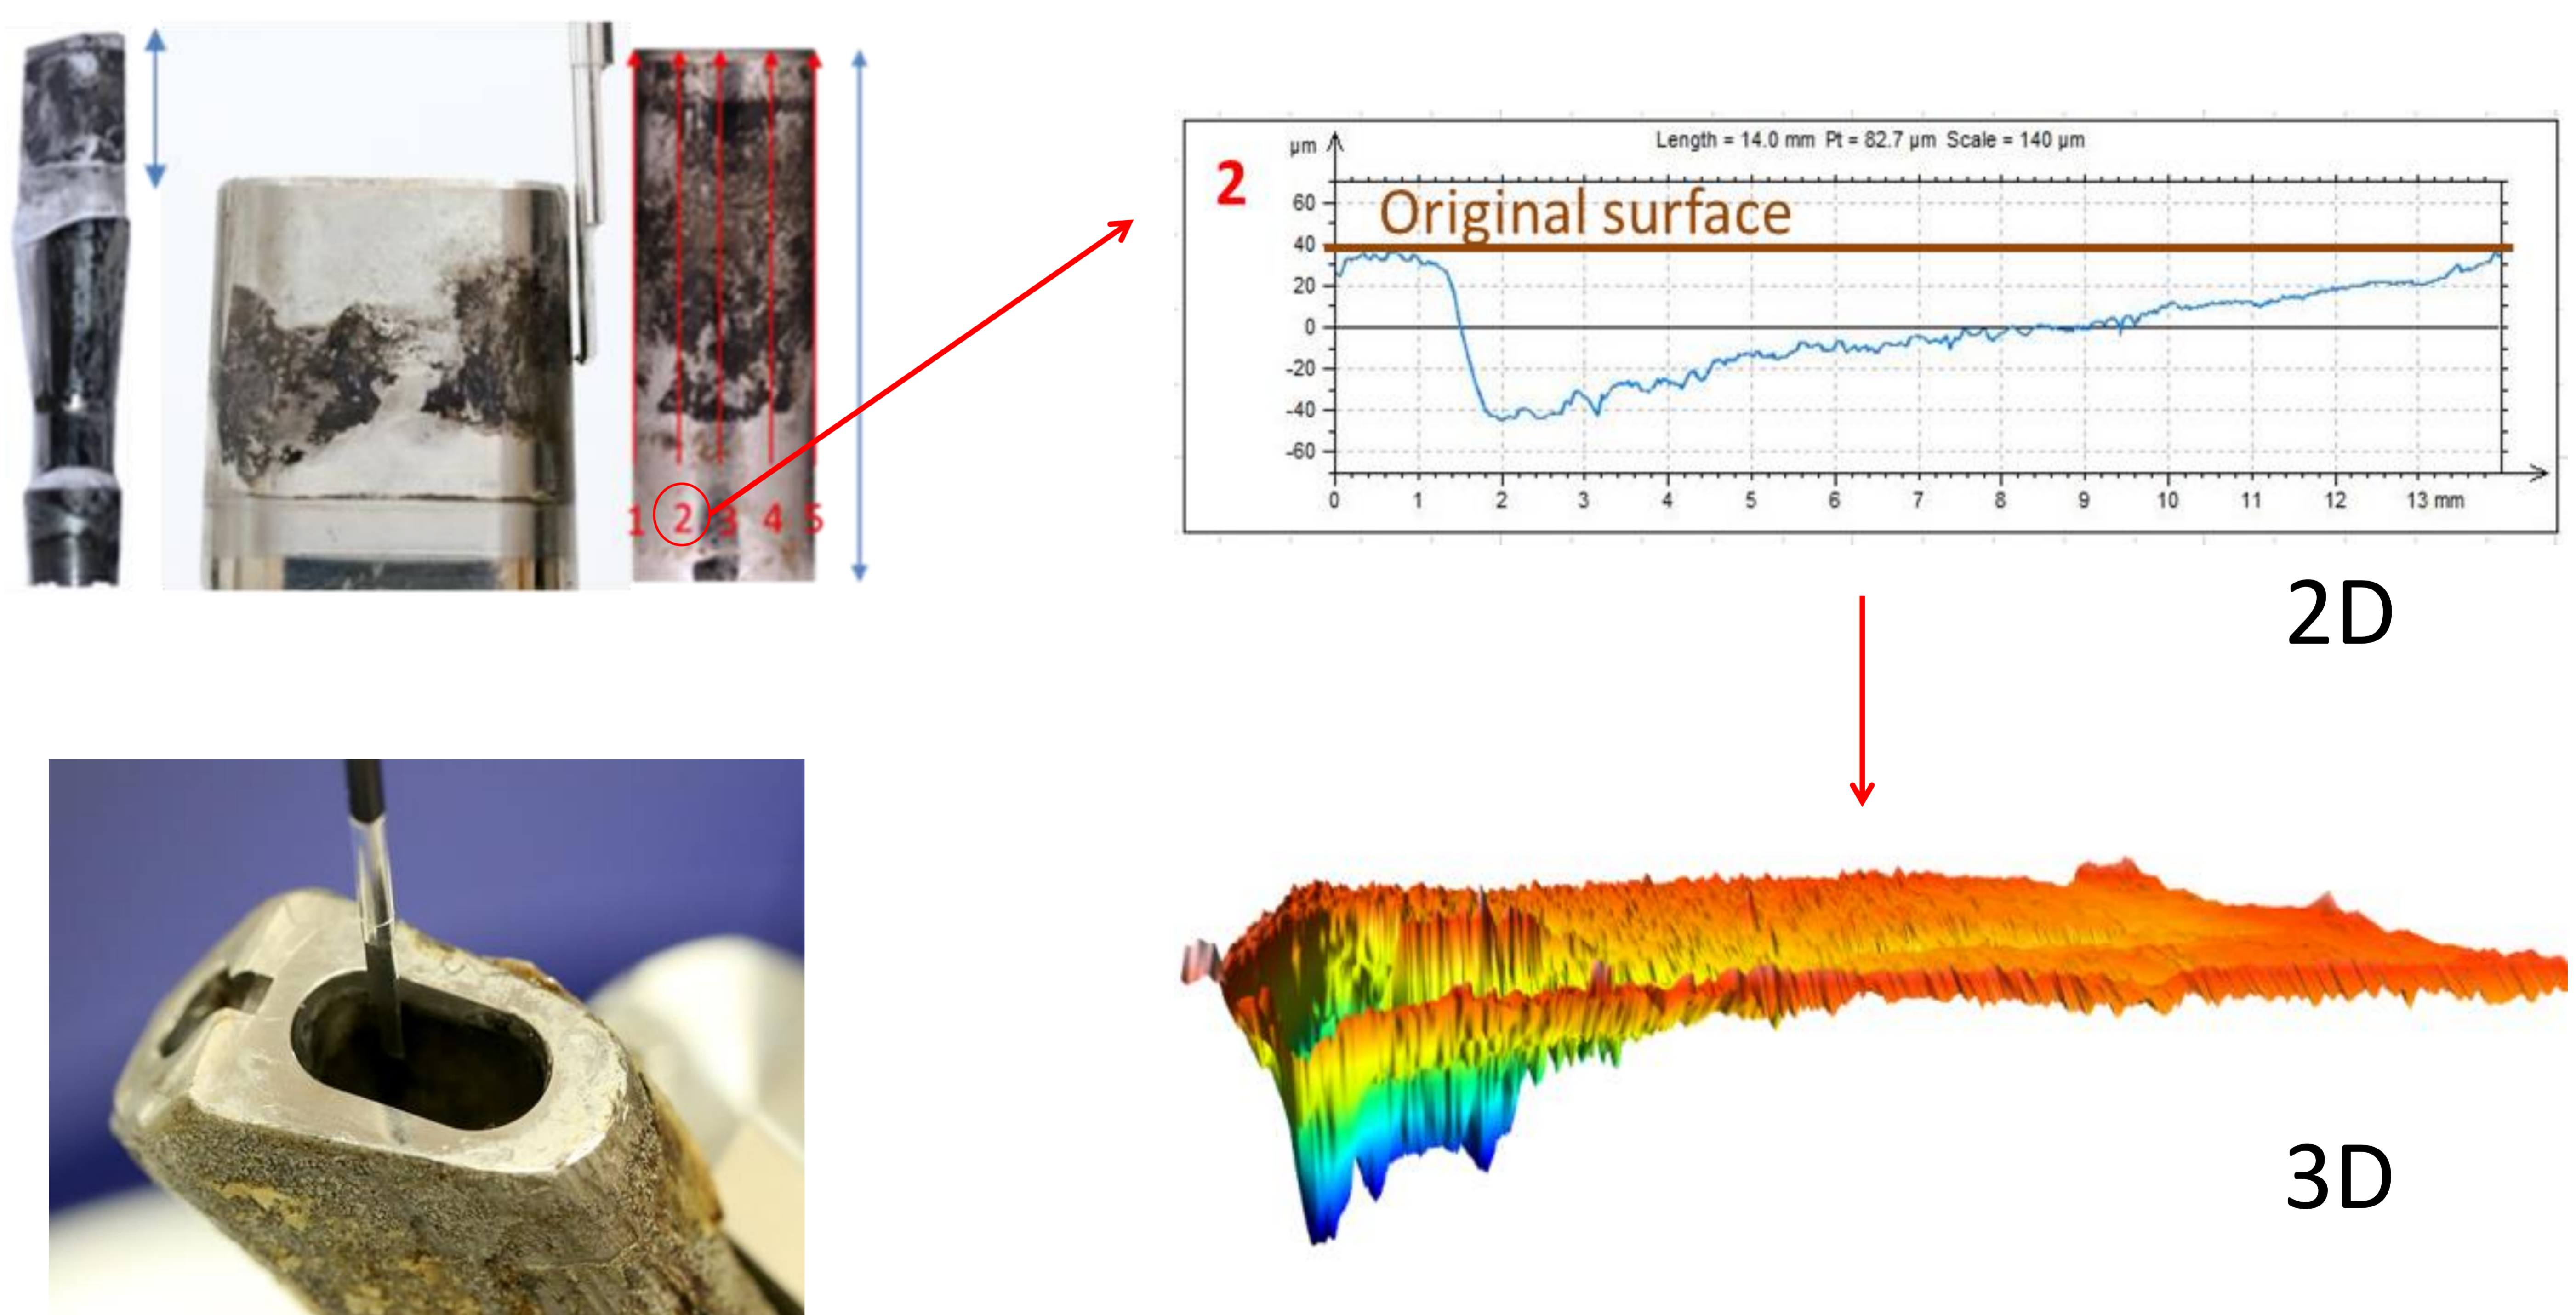
A measurement method, using a roundness measuring machine was developed to quantify the severity of the damage on round ends of the tapers. With this method five longitudinal traces were taken on each round section of the taper surface to compute the relative depth of damage.

These traces were normalised relative to unaffected surface of the taper and a sectional wear area was computed. Average area of these five traces provided a measure of surface damage for comparative purposes. The result obtained was normalised with time in situ.

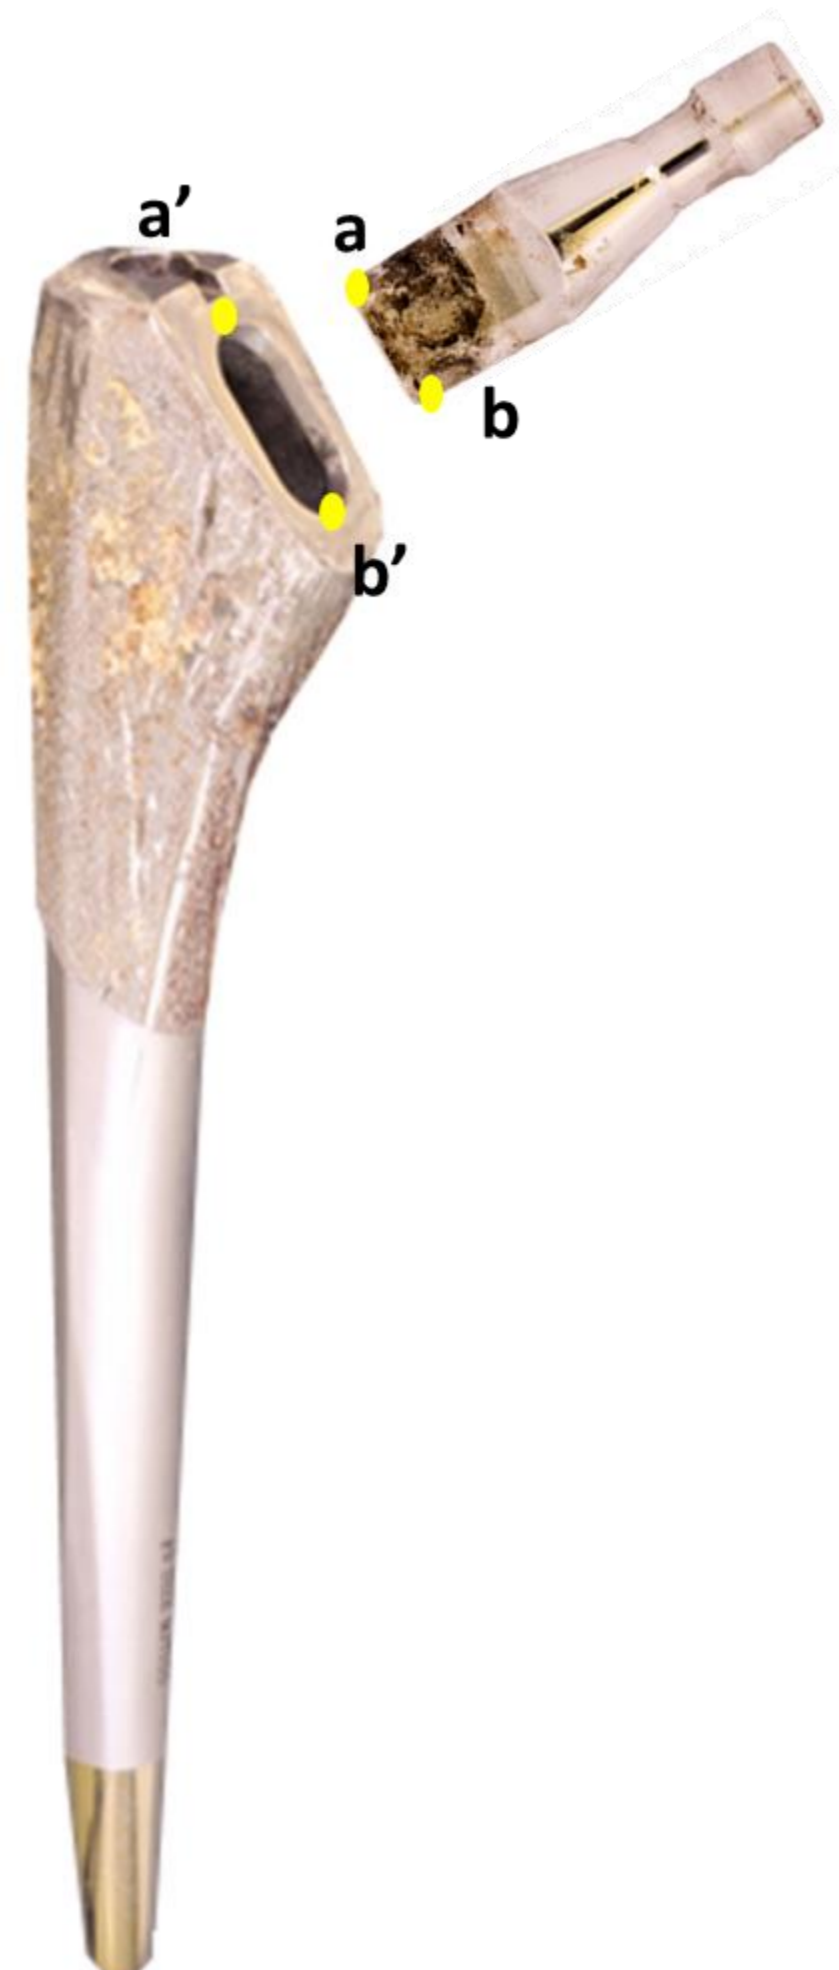
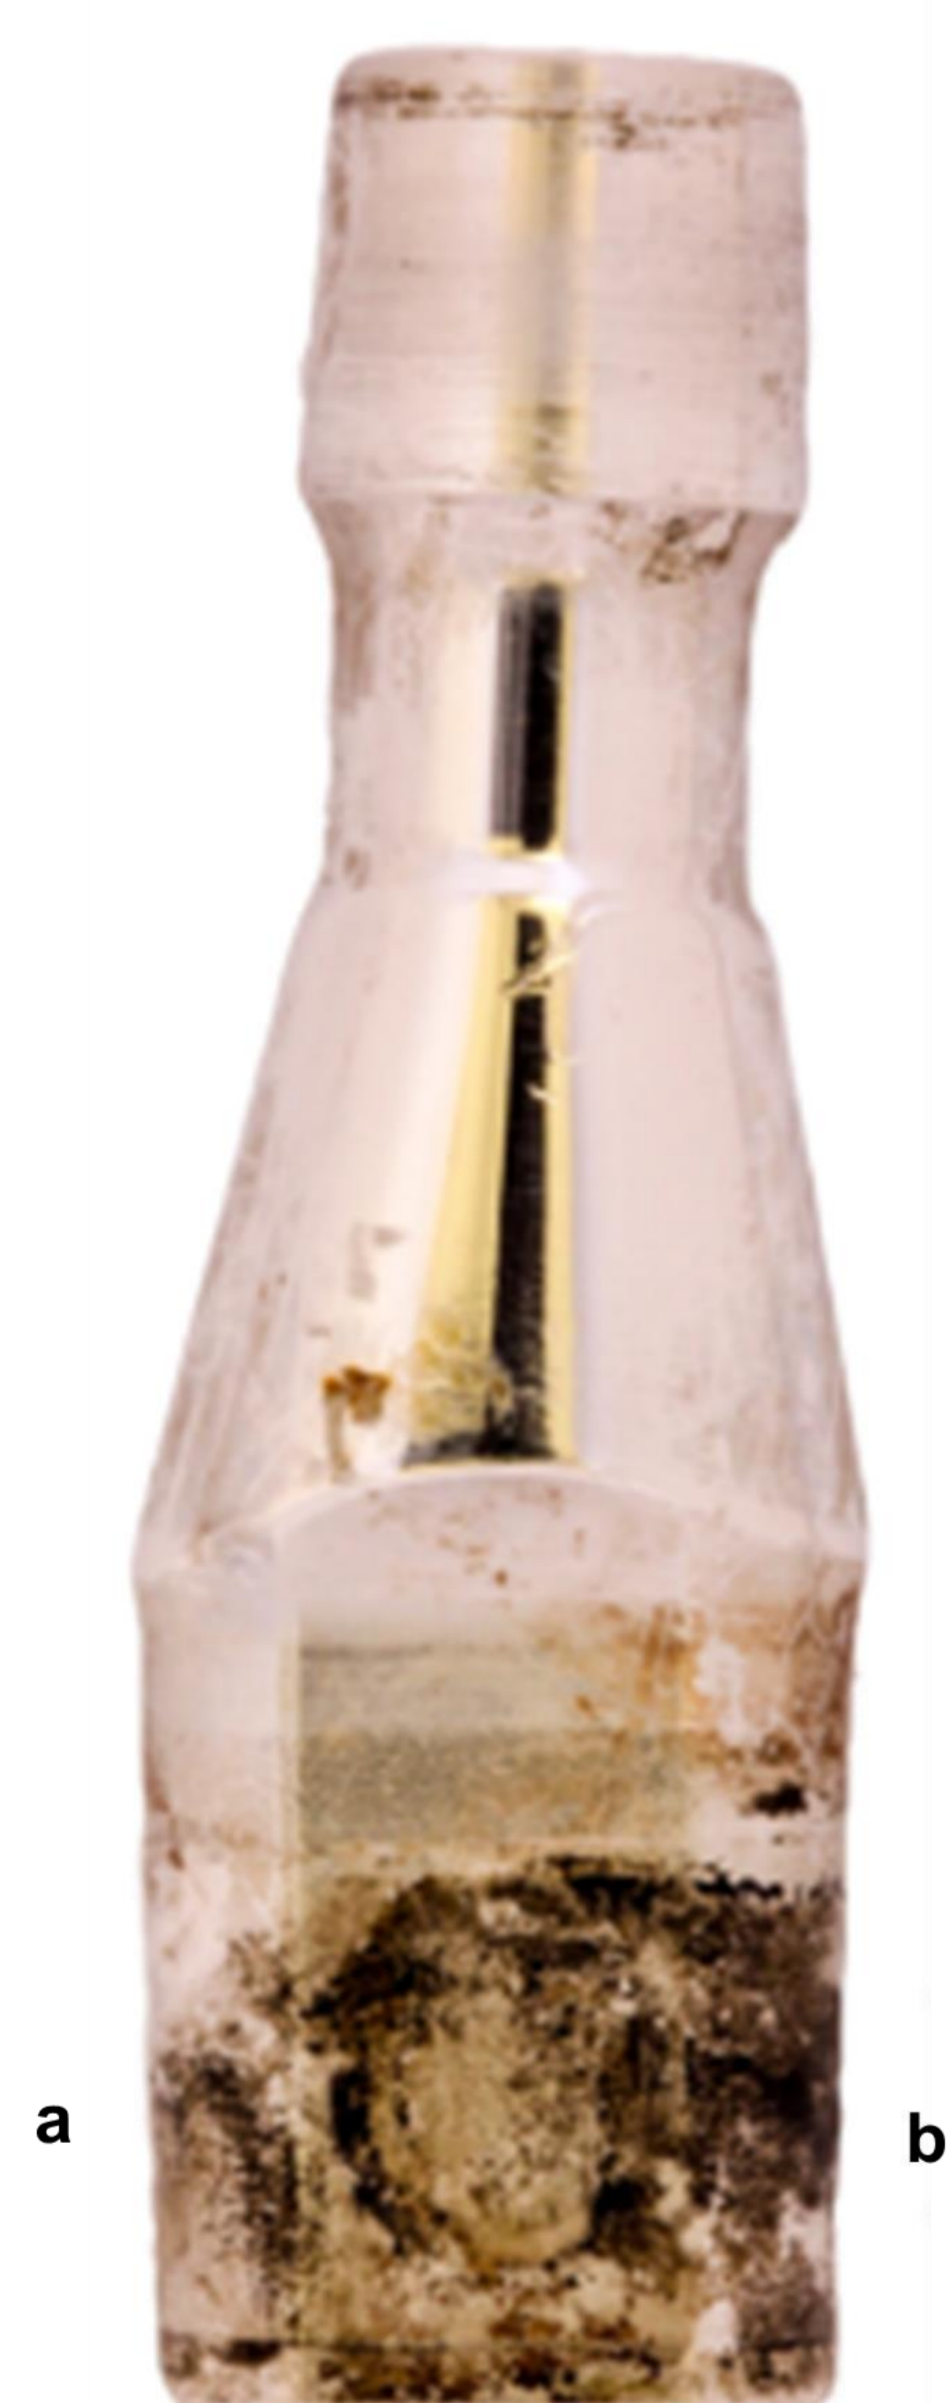
# What we See on the Neck

Deepest areas of damage were found on the inferior proximal and superior distal part of the neck, compatible with bending. Scanning Electron Microscopy with Energy Dispersive Spectroscopy revealed that the surface deposit was chromium orthophosphates indicative of corrosion processes and presence of metal transfer from the stem to the neck.

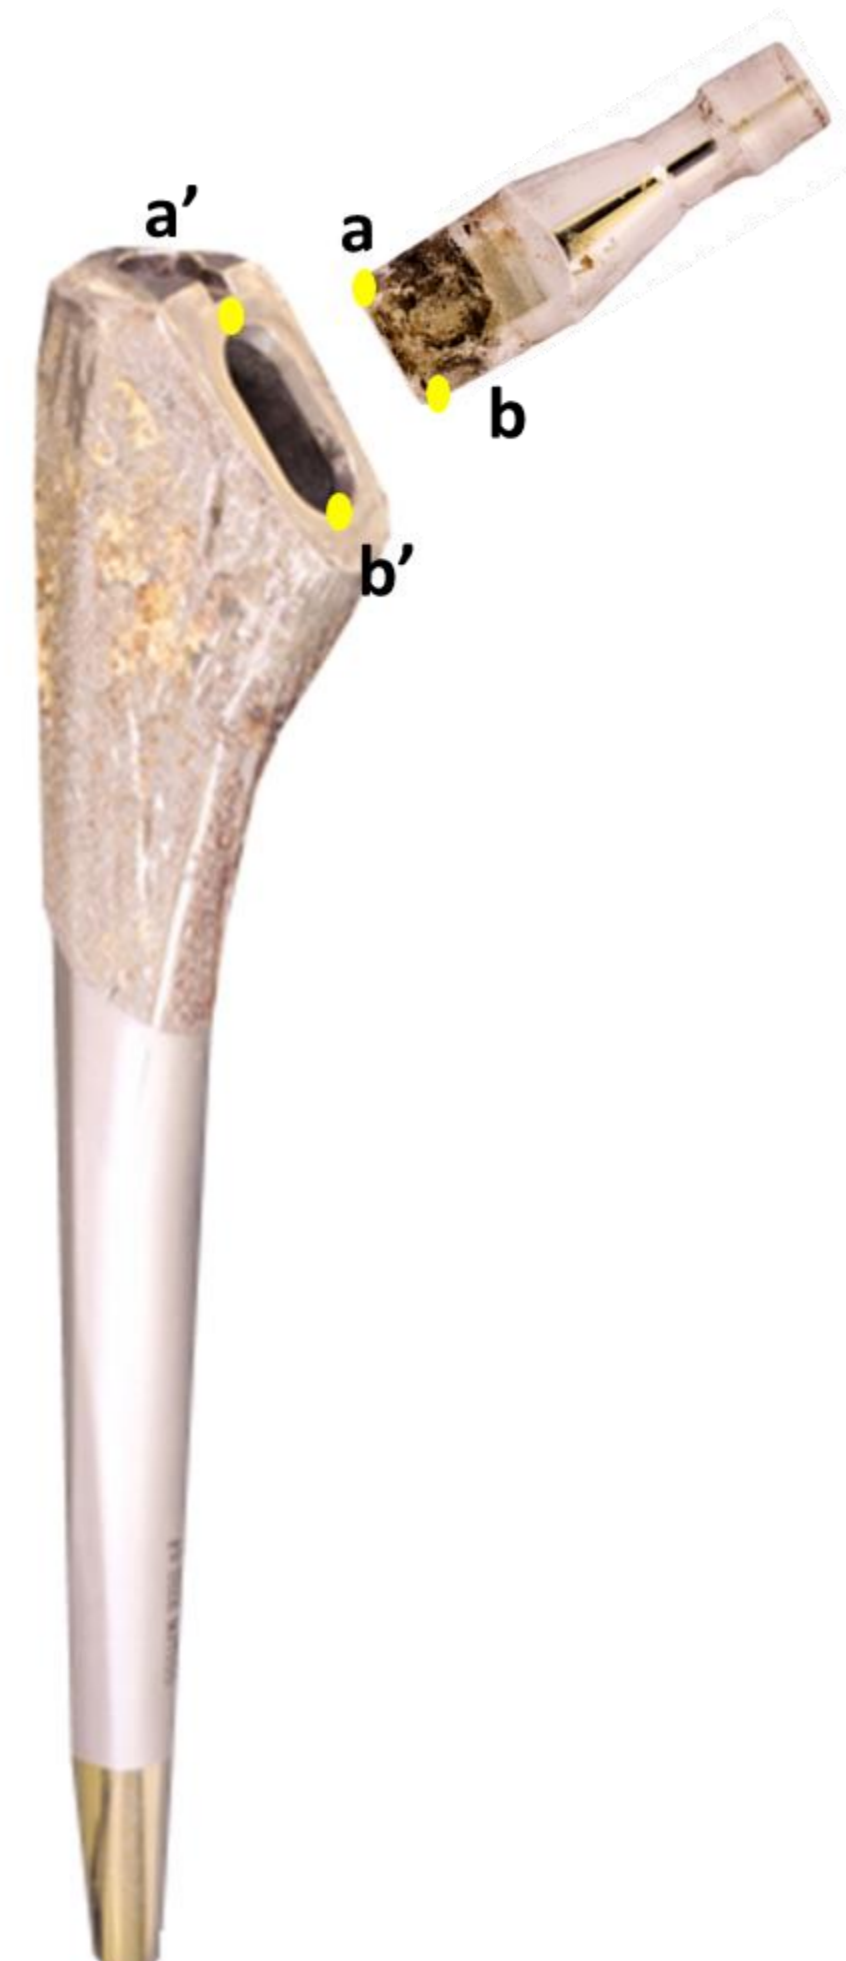
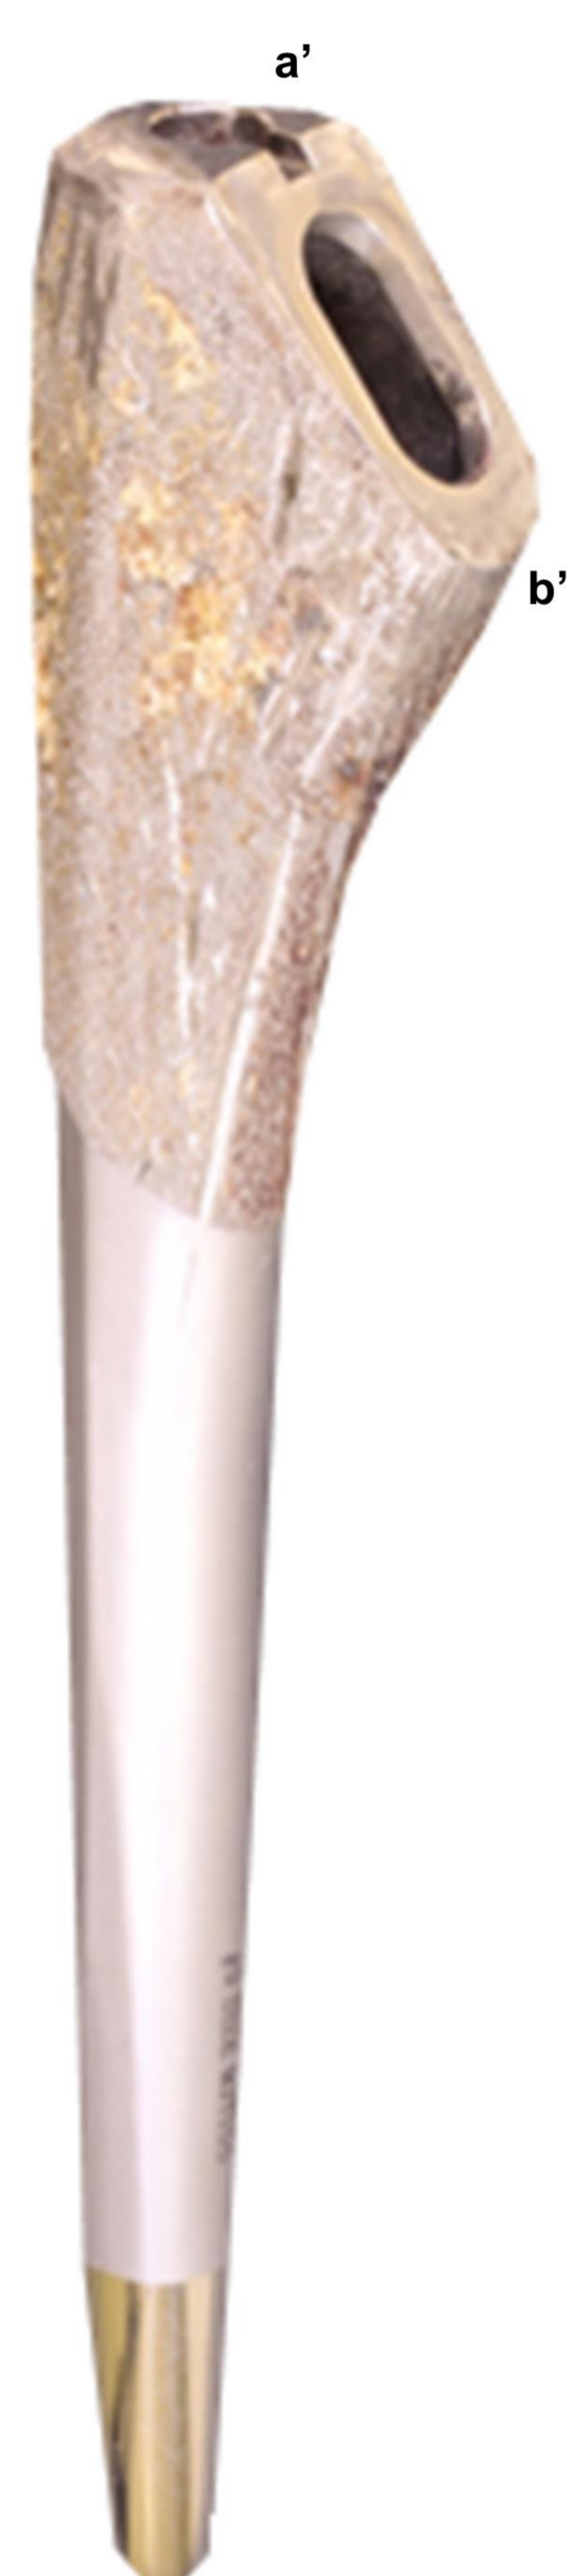
# What we See on the Stem

The symmetry of the patterns found on stem bore tapers confirms micromotion between the parts with subsequent material loss due to a cantilever bending effect which is sufficient to cause adverse tissue reactions.

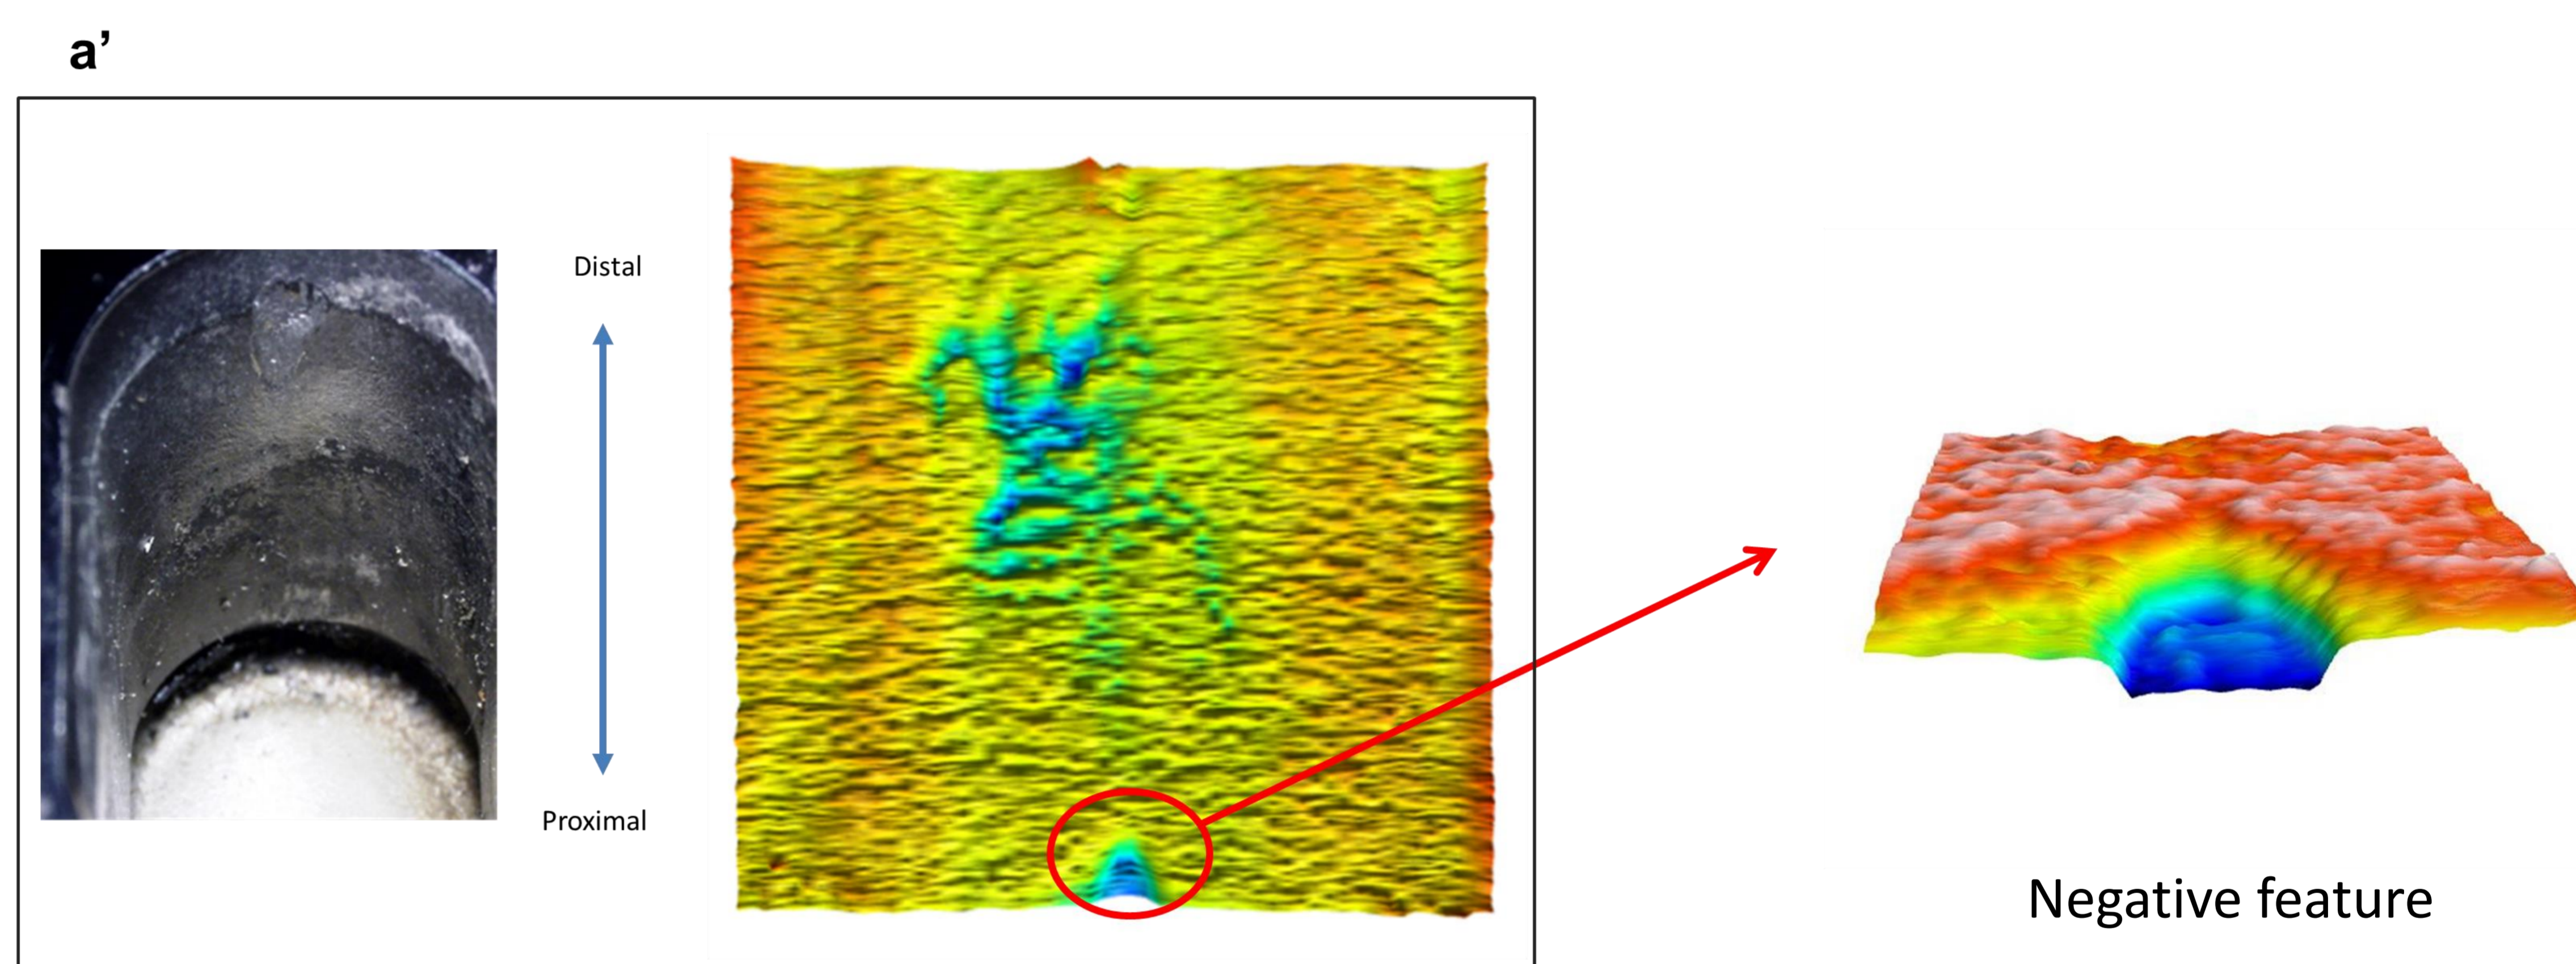
3-Dimensional map of the lateral round surface of the of the stem bore taper. Deepest area of damage in blue.

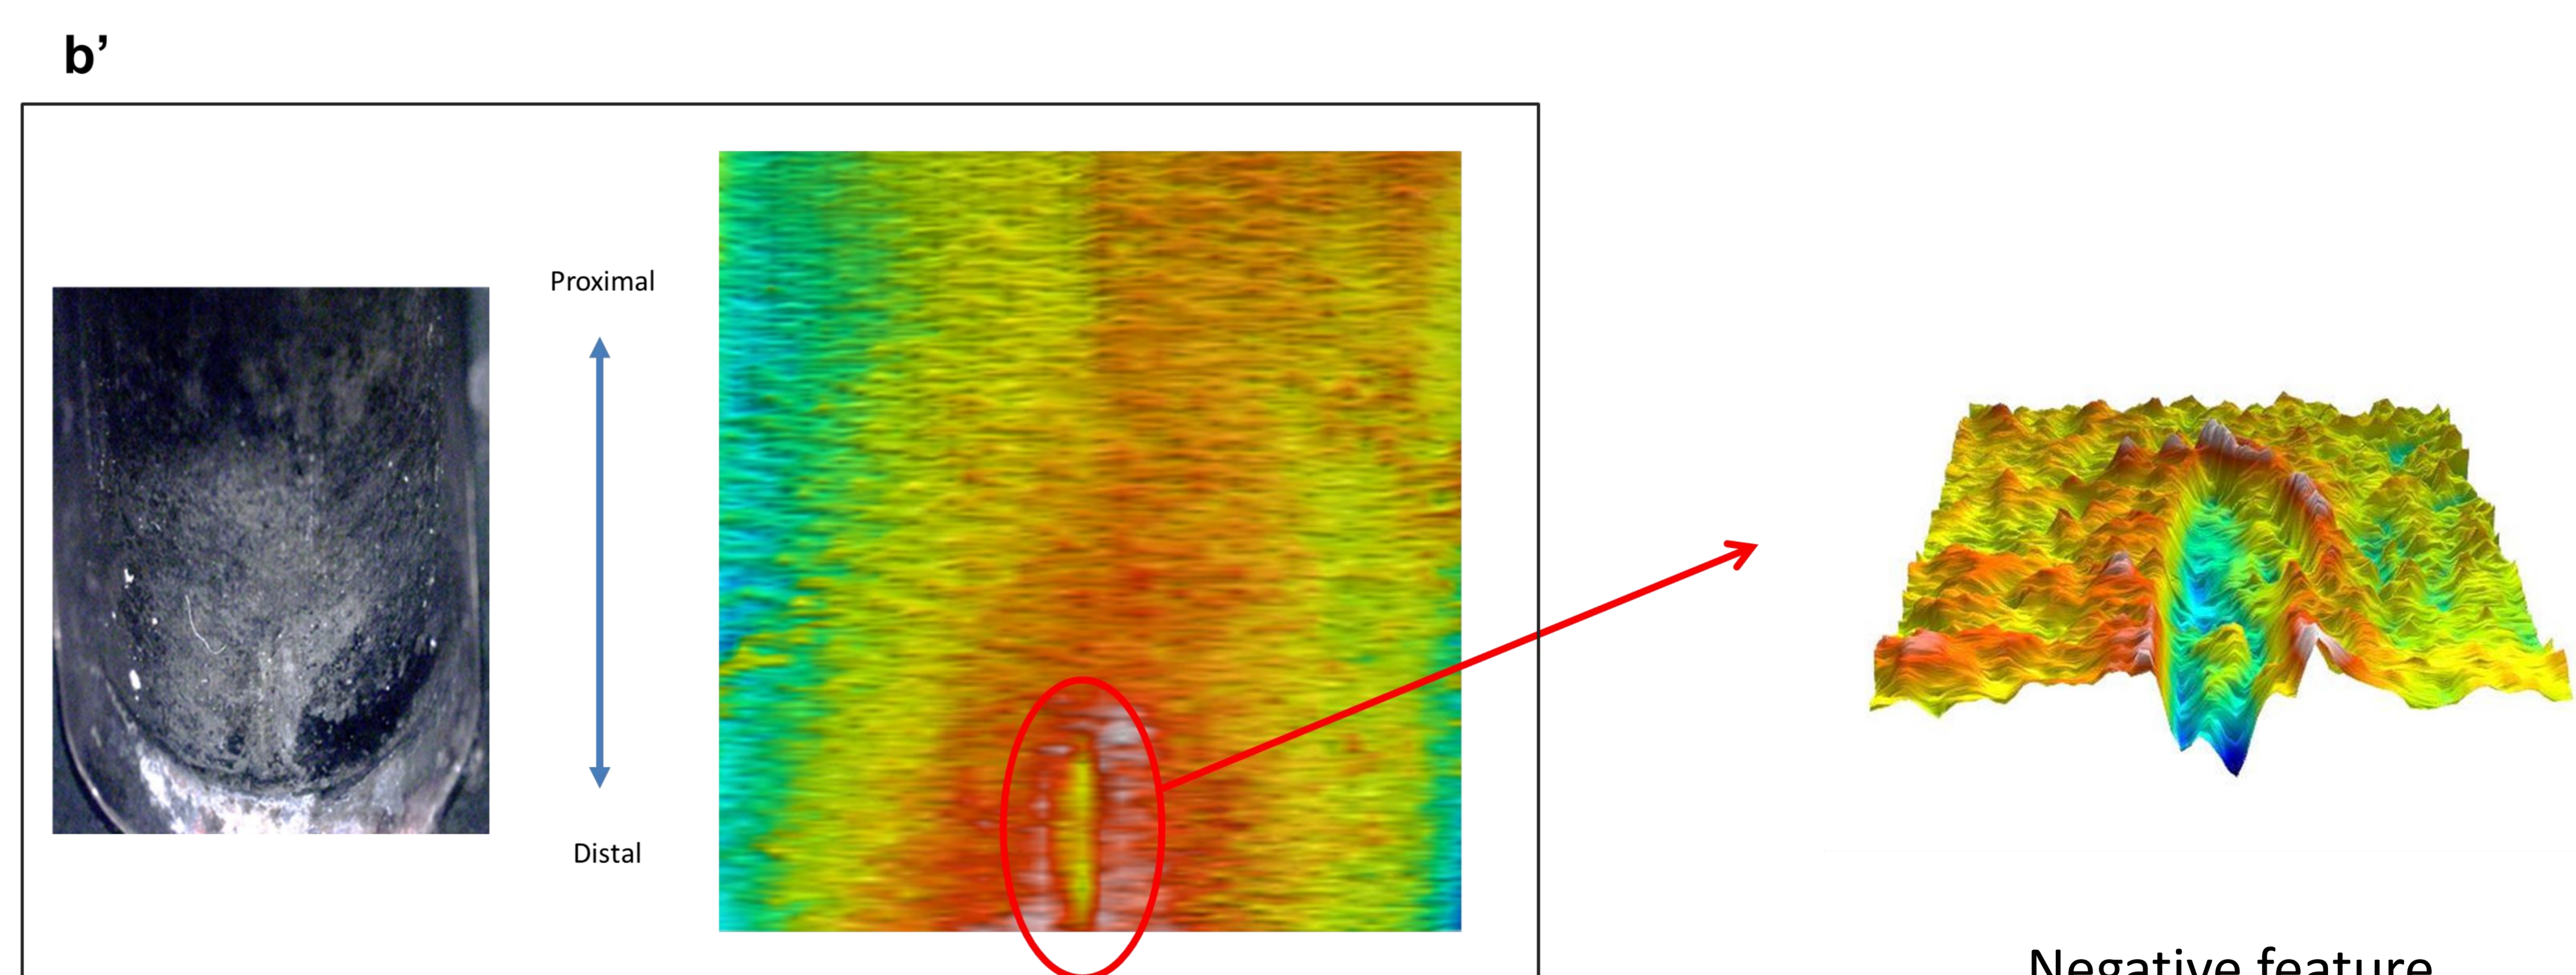
3-Dimensional map of the medial round surface of the of the stem bore taper. Deepest area of damage in blue.
