Understanding Why Dual-Taper Hips Fail

# Understanding Why Dual-Taper Hips Fail

## Dual-taper systems

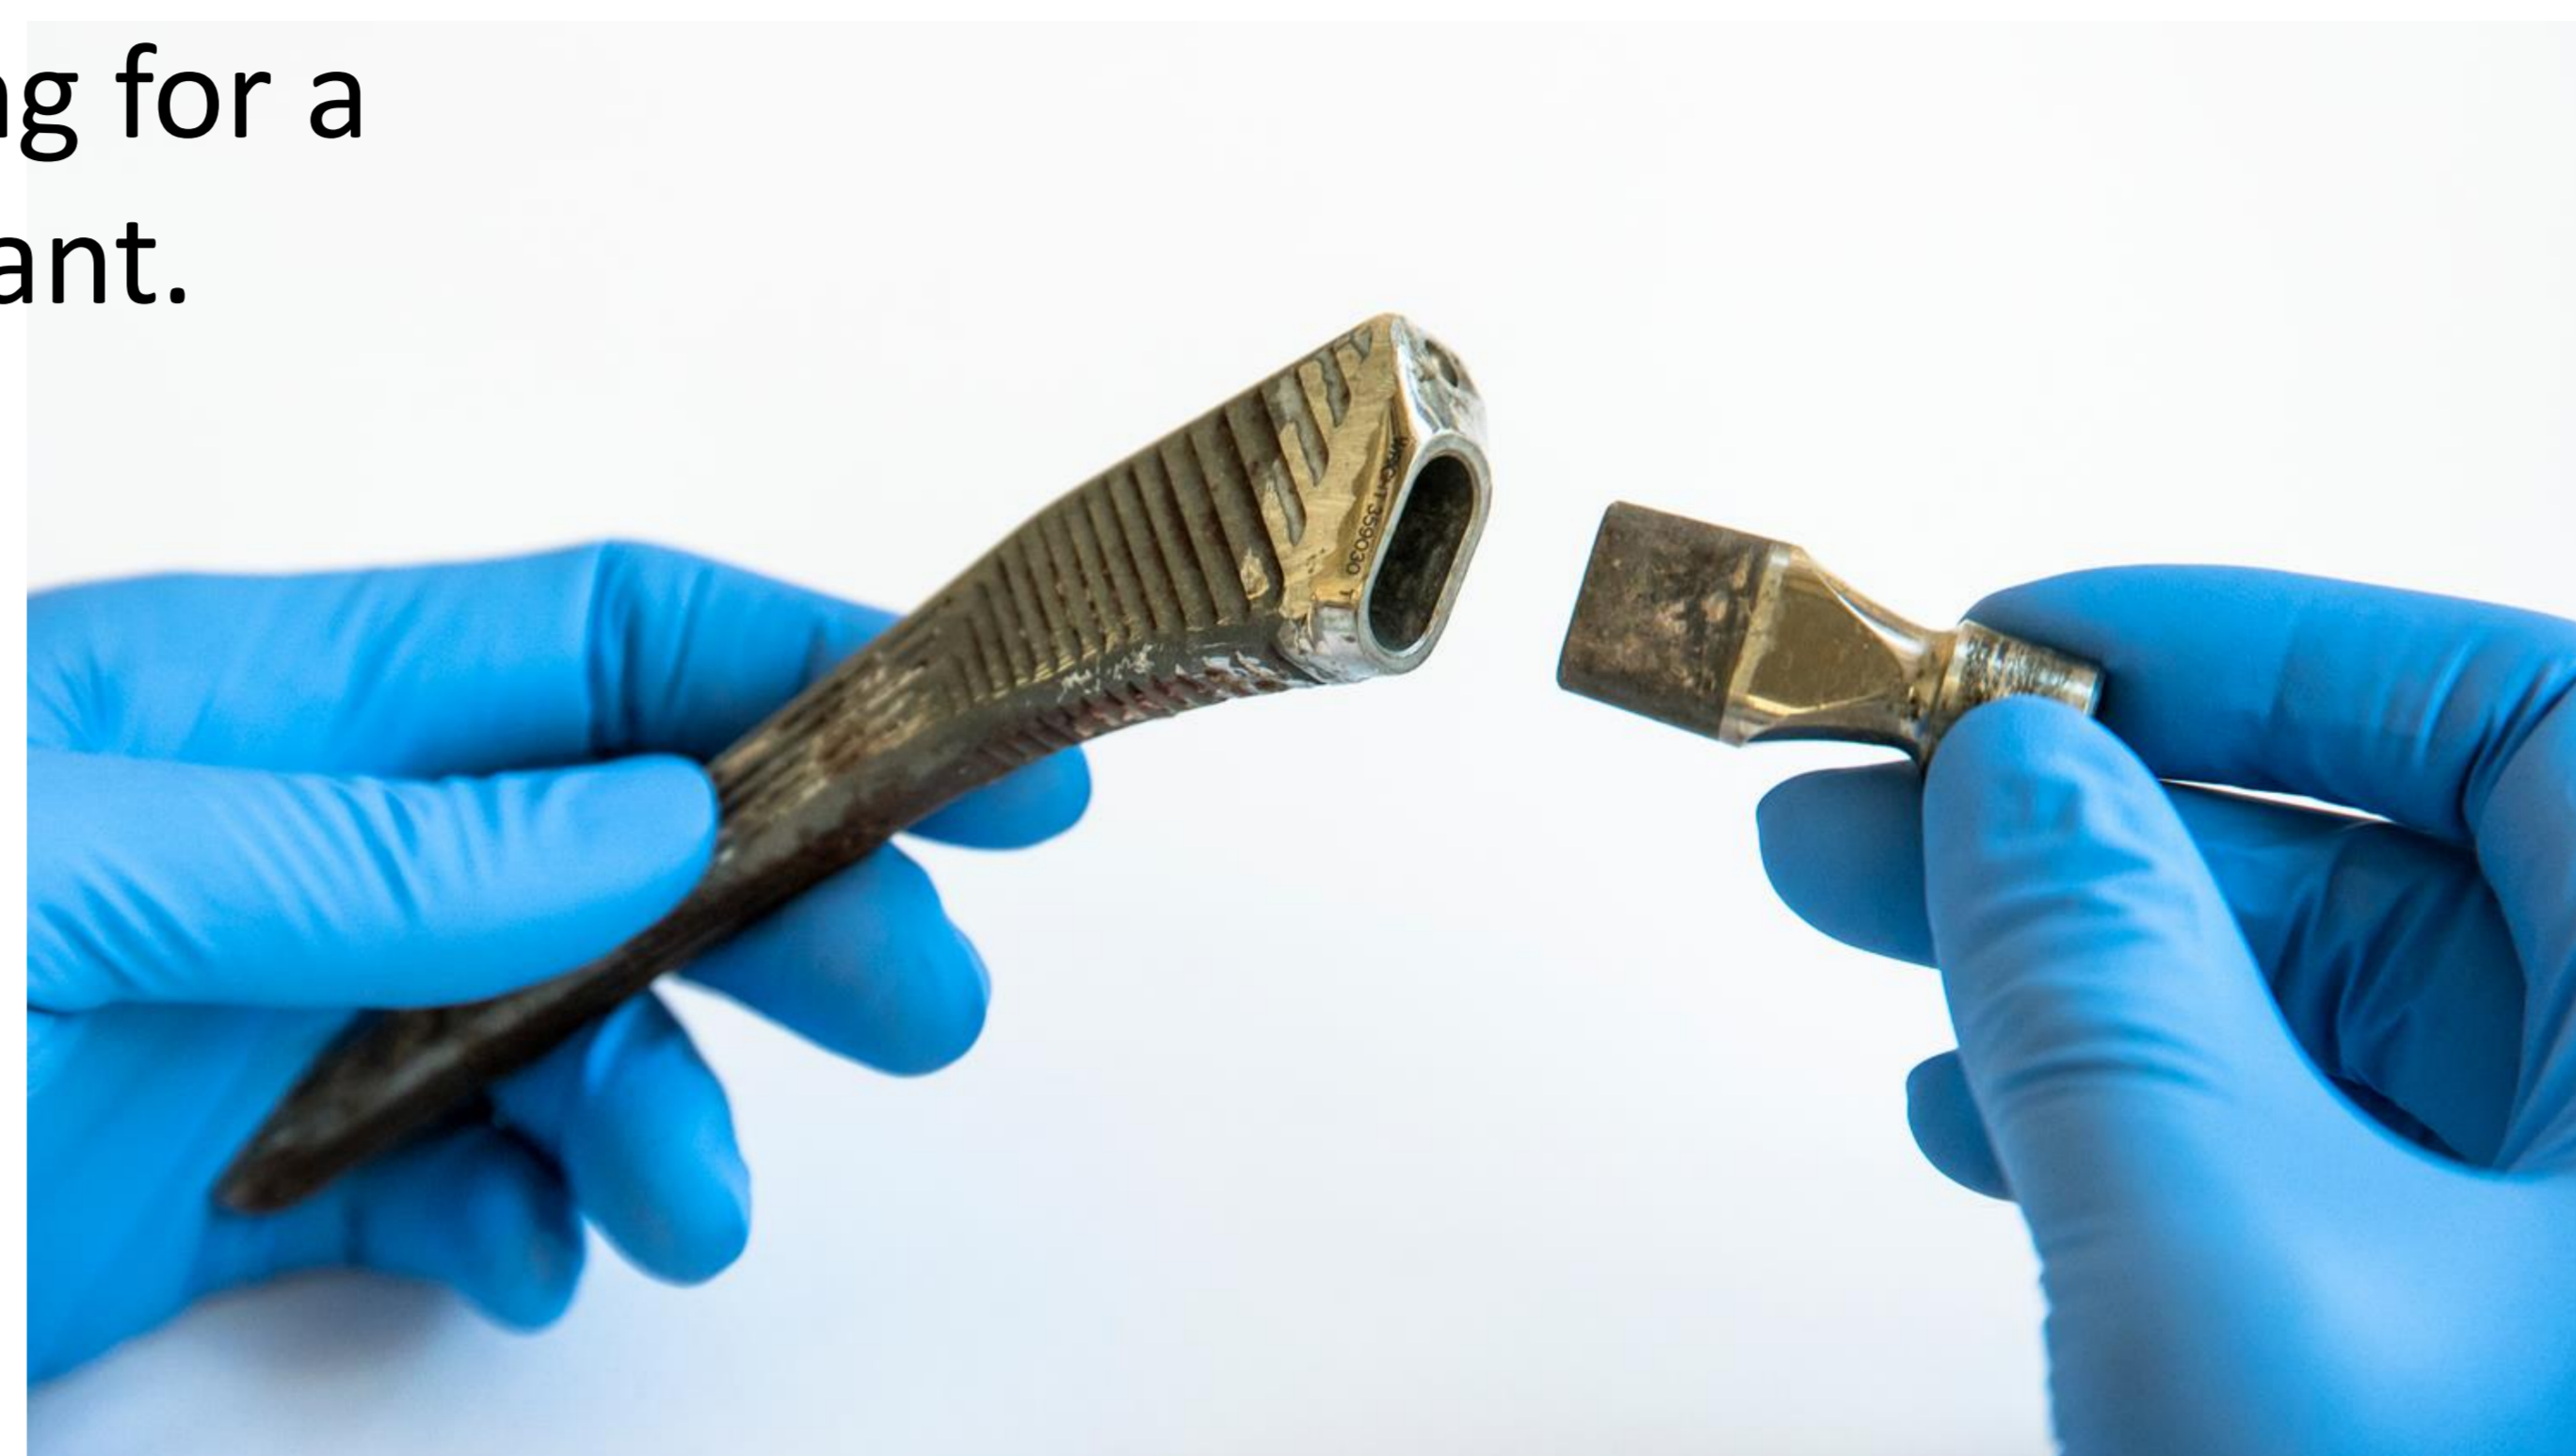
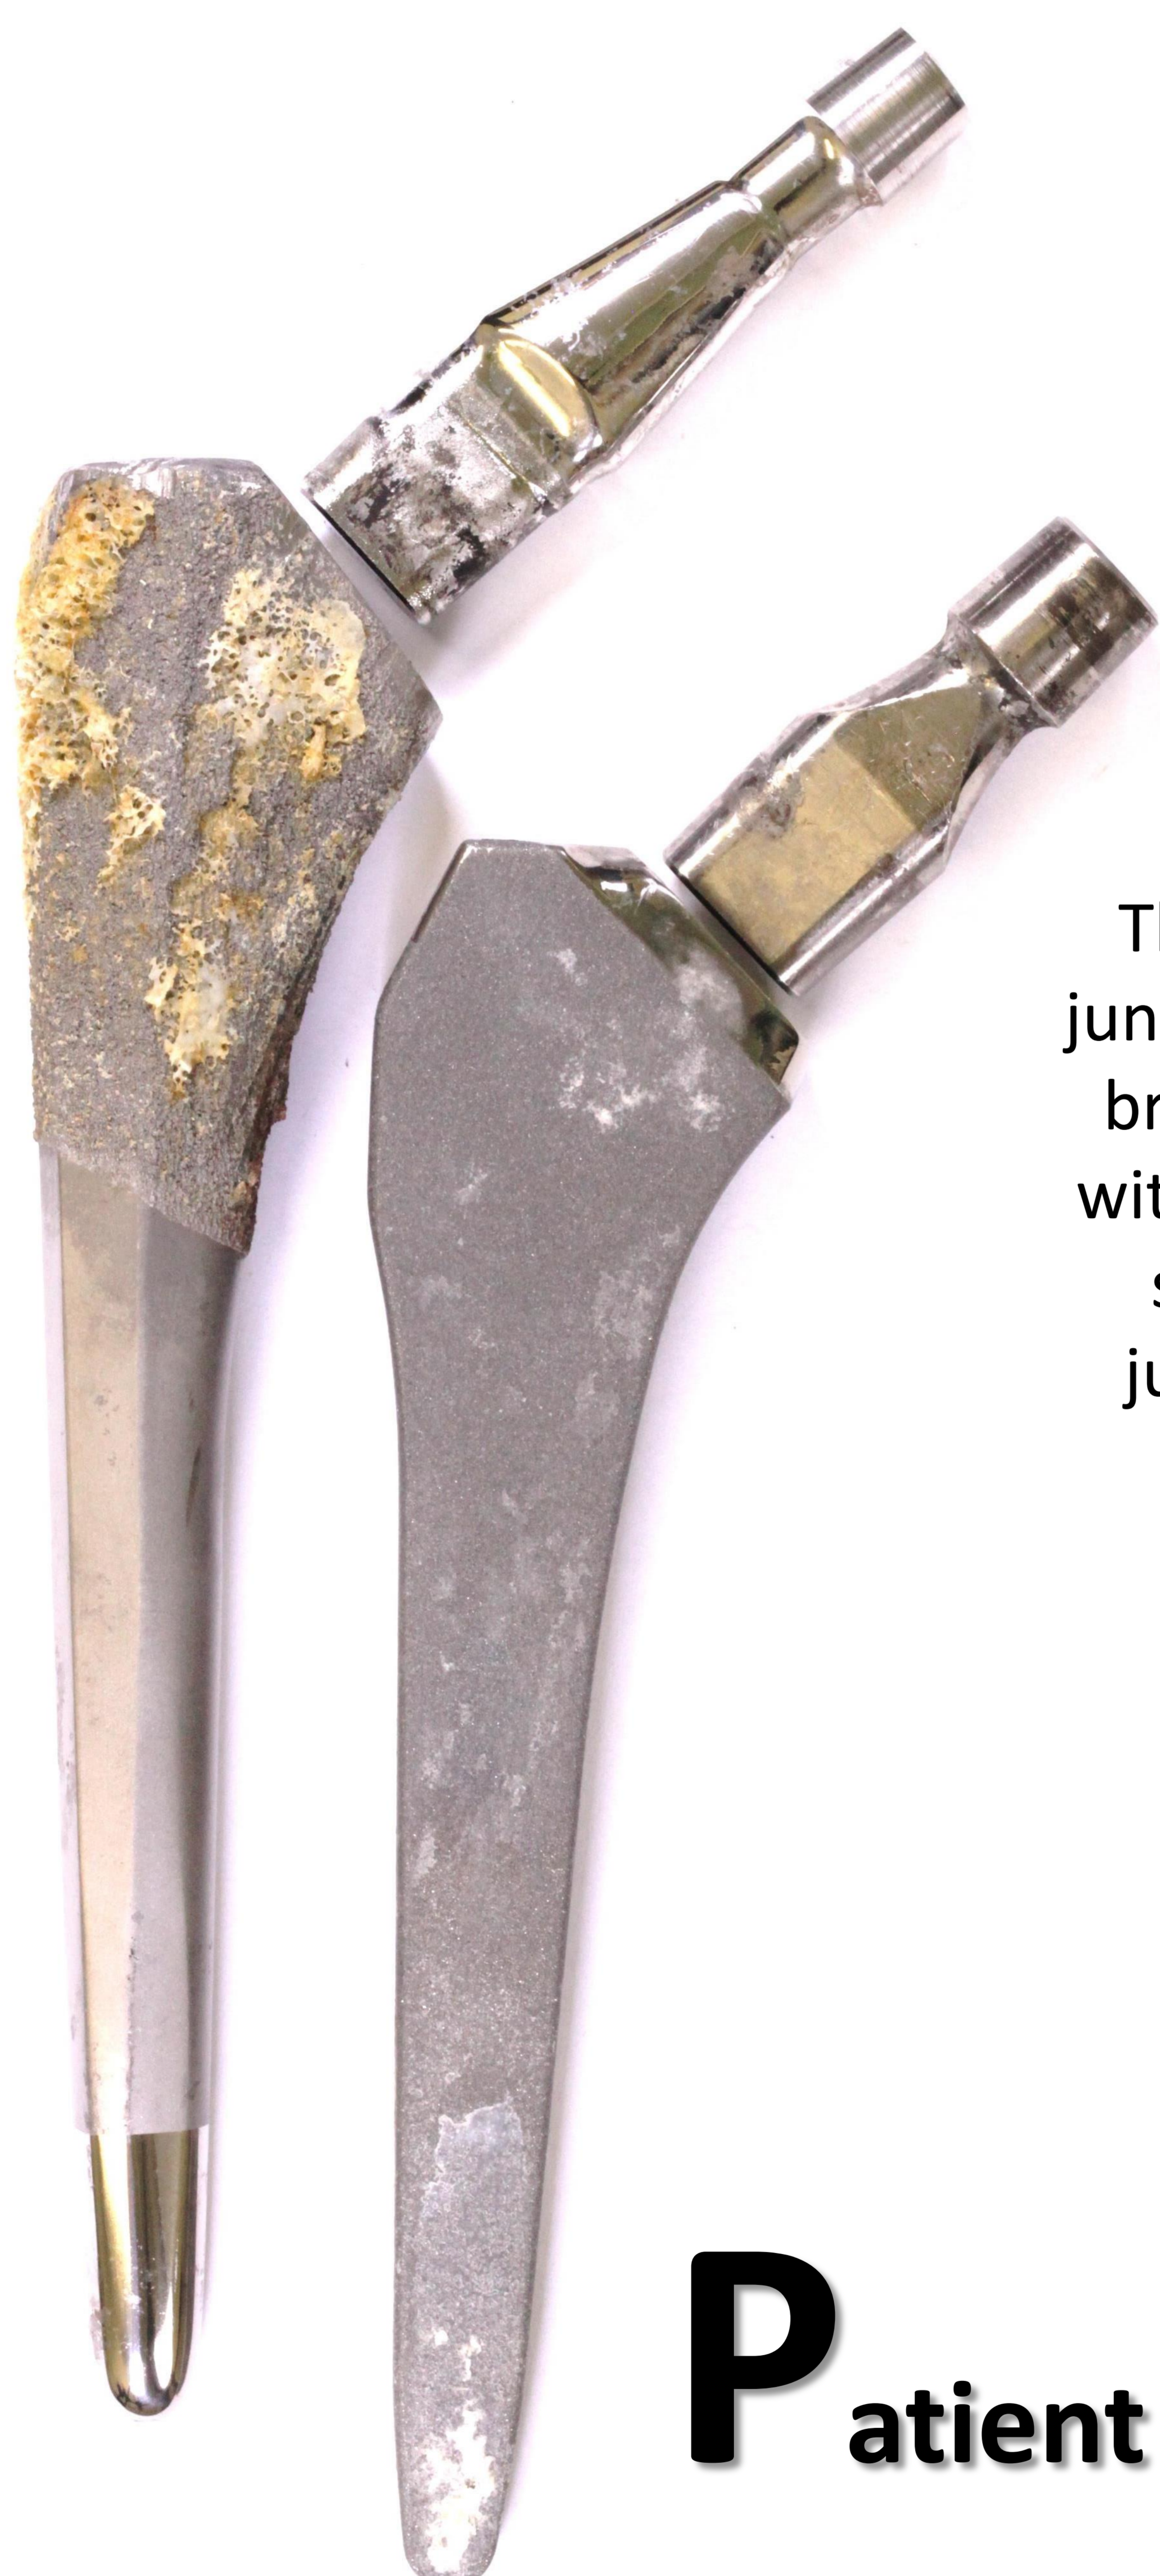
## Surgical

Surgeons should avoid long varus necks if opting for a dual-taper implant.

The mismatch of materials at the junction seems to avoid catastrophic breakage of the necks as reported with Ti-Ti junctions [7], however we see corrosion at the neck-stem junction in all the designs having CoCr necks and Ti stems.
