**THE USE OF 3D SURFACE ANALYSIS TECHNIQUES TO
INVESTIGATE THE WEAR OF MATT SURFACE FINISH
FEMORAL STEMS IN TOTAL HIP REPLACEMENT**

LEIGH TONI BROWN

A thesis submitted to The University of Huddersfield in partial fulfilment of the
requirements for the degree of Doctor of Philosophy

April 2006

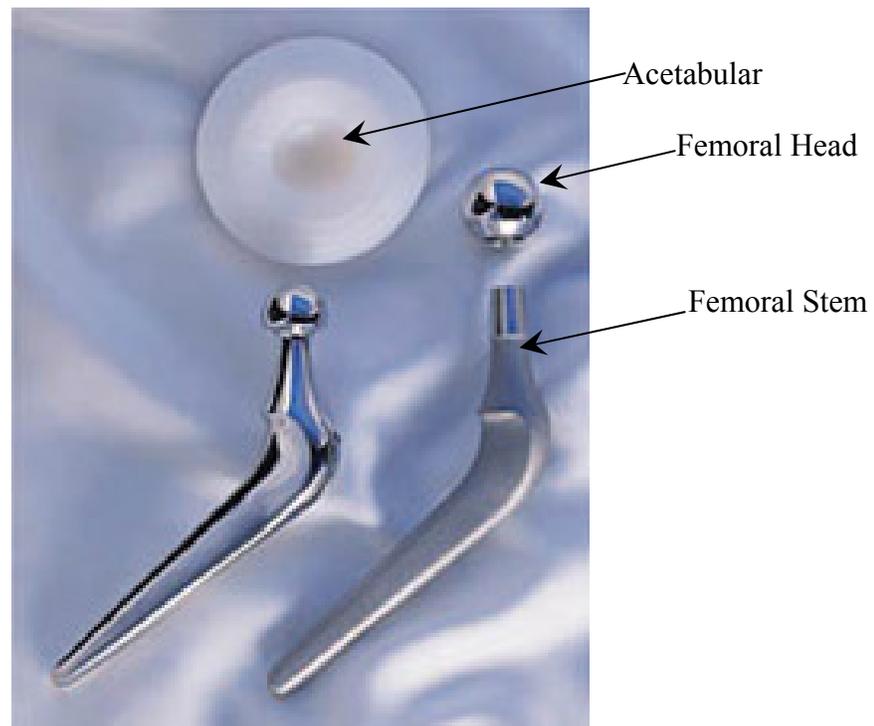
Figure 2.4 – Charnley hip replacement system

Figure 2.4 shows the "Charnley" Hip replacement system, the Charnley design still accounts for a large proportion of market share even today with in around 60% (D W Murray et al 1994) cemented type prostheses available for use.

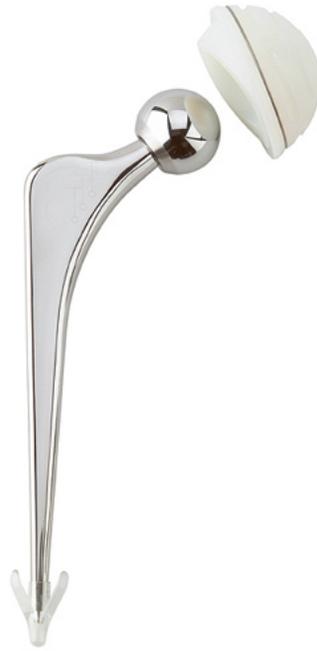
Figure 2.5 the Exeter hip replacement system (Stryker)

The other industry gold standard replacement hip prostheses the Exeter hip system pioneered by Prof R S M Ling, A J C Lee et al. The basic rationale of a cemented system is the same as the Charnley hip though the geometrical design differs; figure 2.5 shows the current Exeter stem design.

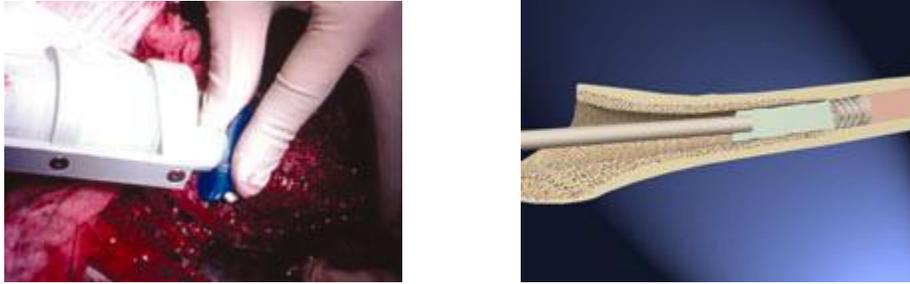
There is a large range of PMMA bone cements commercially available, most orthopaedic implant manufacturers also typically produce a range of bone cements. High viscosity cements upon preparation form dough like substances which are similar to putty in texture, these cements are the preferred type for applications such as insertion of the acetabular cup and also are useful in the fixation of components during total knee replacement. Low viscosity cements however mix to form a runny substance with initial consistency of paste. It is during this “paste” phase before the curing process begins and dough like substance is formed, that the cement is generally pressurised into the femoral canal by means of a “cement gun”.

Figure 2.8 Cement pressurisation using a “cement gun”

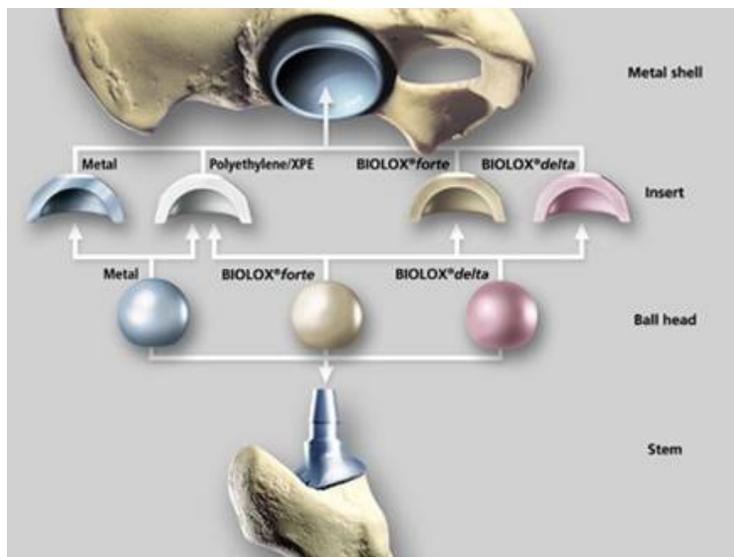
Femoral Components are more commonly made from one of three types of metal: Titanium alloys typically Ti-6Al-4V; CoCr alloys; and Orthinox® a high grade stainless steel. The standard material for the acetabular cup is UHMWPE (Ultra High molecular weight Polyethylene), with recent exploration into the use of ceramics, such as Alumina or Zirconia as well as metals, typically CoCr alloys. Possible combinations for materials used in modular designs can be seen in figure 2.9.

Figure 2.9 - Modular Designs and Material Combinations(www ceramtec.com)

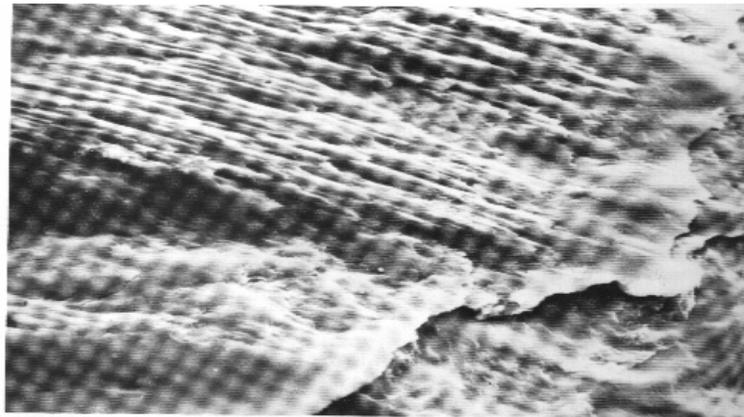
*Figure 2.10-A Surface displaying the change in topography due to fretting wear
(Engel & Klingele 1981)*

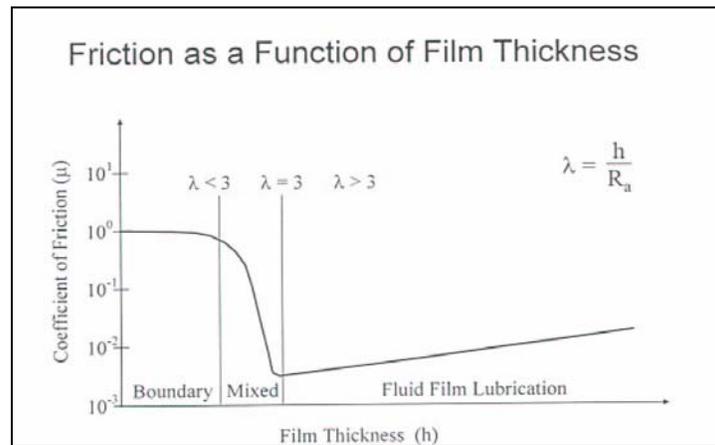
Figure 3.1 – The Stribeck Curve demonstrates the relationship of clearance and surface finish to friction of replacement joints(R M Hall 2003)

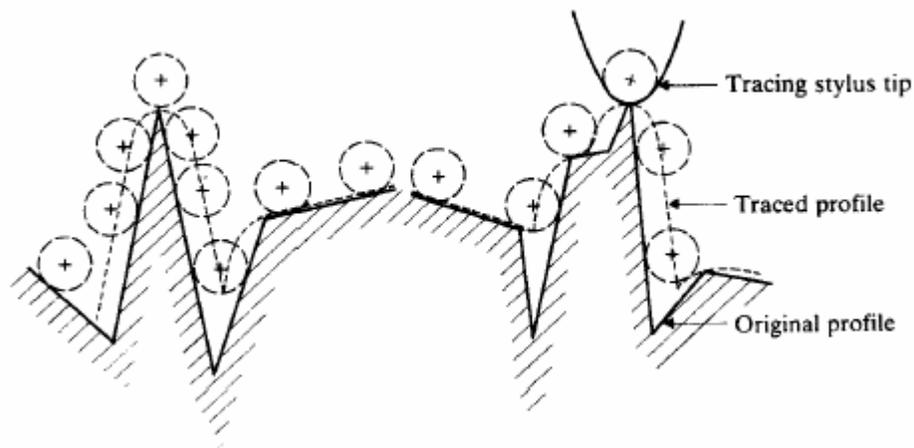
Figure 3.6 displays how the stylus tip radius determines the quality of measurement output. The stylus, due to its nature has physical limitations as to the size and depth of scratches and peaks that can be penetrated and fully resolved.

Figure 3.6 - Schematic showing the limitations of the stylus due to the tip size (K J Stout et al 1993)

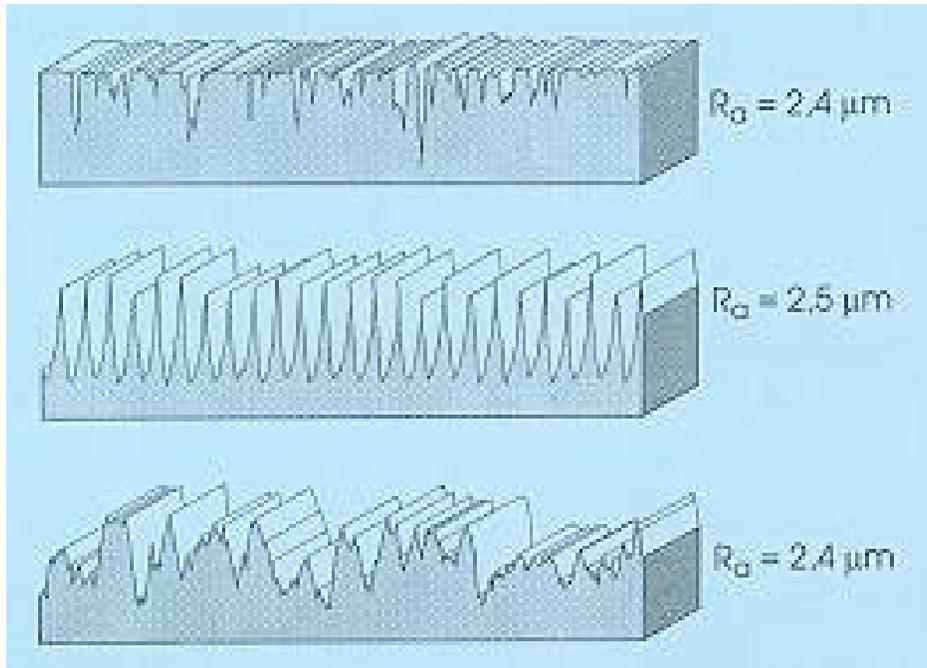
There are inherent problems with 2D surface measurement and characterisation, a fundamental problem is that a 2D profile does not necessarily indicate functional aspects of the surface. If Ra is taken as an example then, figure 3.8 shows the profiles of three surfaces, all return the same Ra value when filtered under the same conditions. It can be seen that the three surfaces have very different features and consequently very different functional properties.

*Figure 3.9 Profiles showing the same Ra with differing height distributions
(Surface Texture Analysis – The Handbook, L Mummery 1992)*

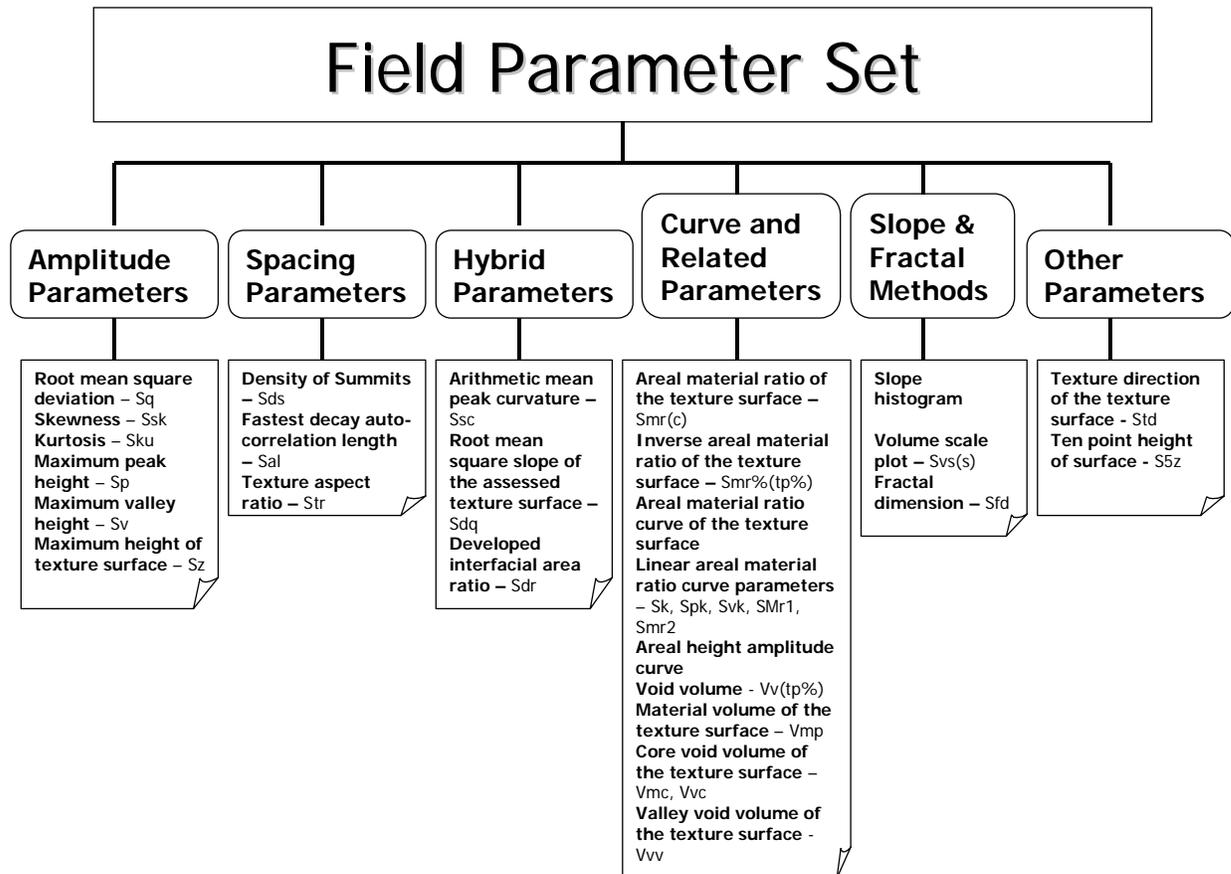
Figure 3.11 – 3D surface texture parameters shown in their family groups

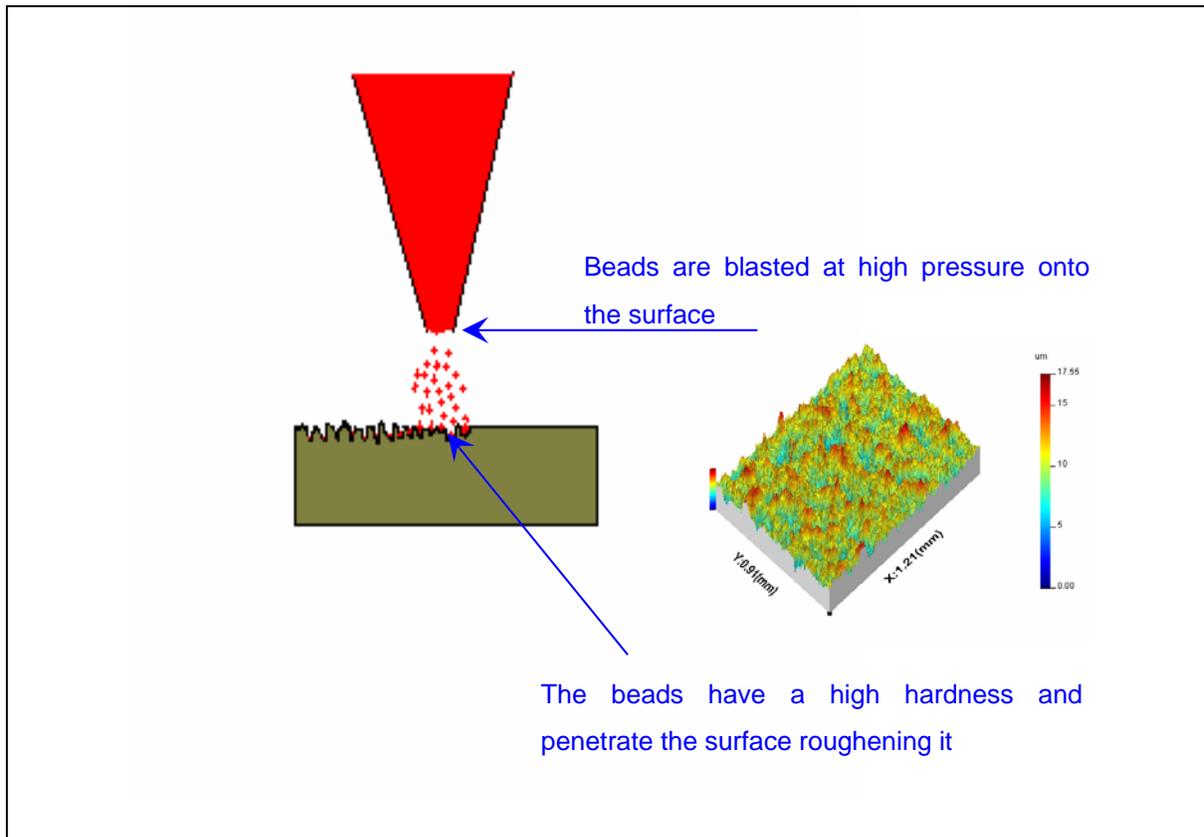
Figure 4.1 – The Bead Blasting Process and Resultant Surface Texture

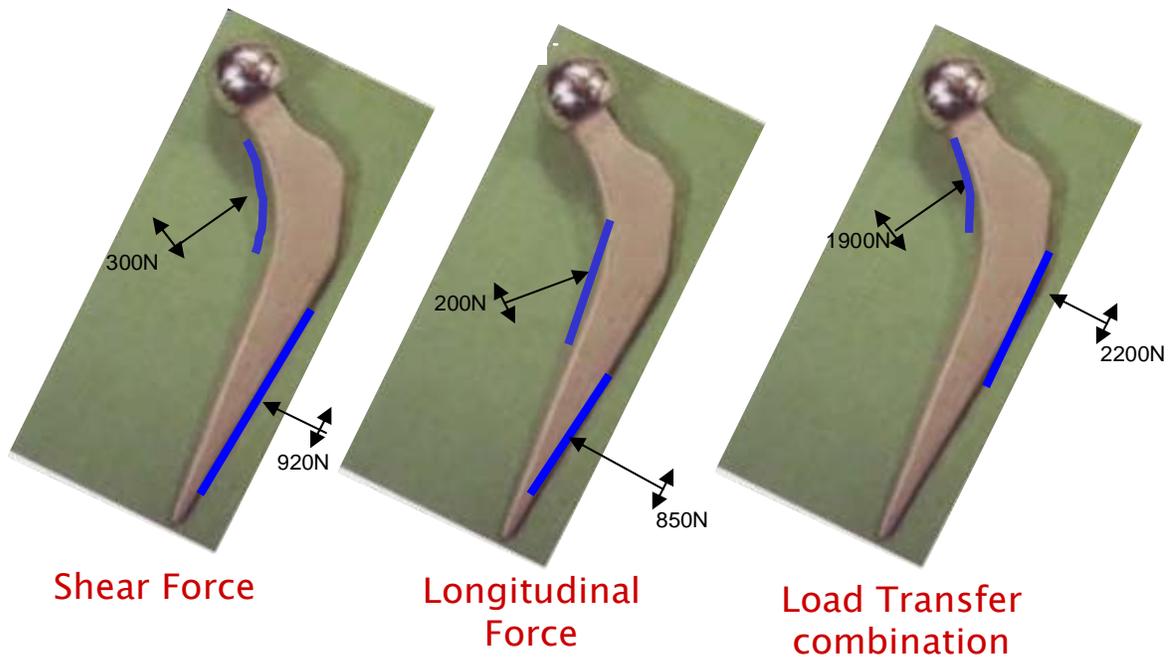
Figure 4.2. Typical loading regime of a stem at 50% of Gait cycle

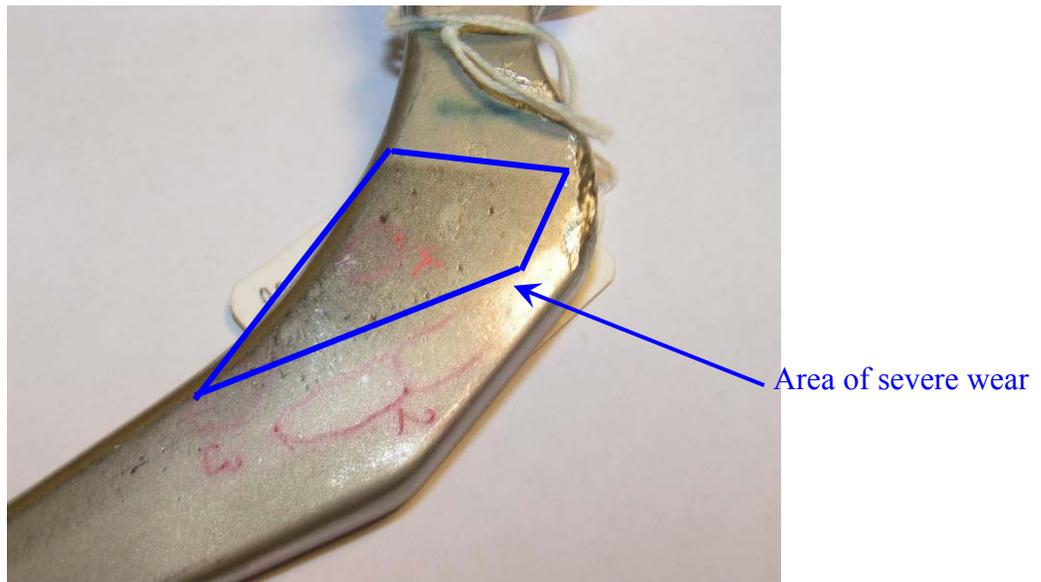
The wear of the retrieved stems was different to that observed on polished stems previously studied (J Cook 1998, J Howell et al 1998). Instead of the characteristic scarring and pitting seen on polished stems, smoothing of the surface was apparent. Figure 4.3 shows a picture showing an area of severe wear on one of the explanted stems, the area highlighted indicates where the stem is worn and appears to be polished compared to the rest of the stems topography.

Figure 4.3 – Matt Finish Exeter Femoral Stem showing an area of severe wear

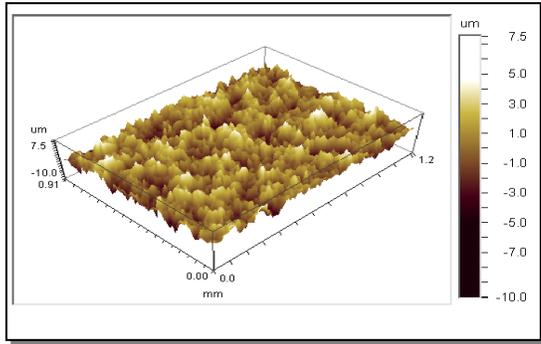
Figure 4.4a.

Figure 4.4 shows the 3D axonometric plots of measurements taken on one stem at each visual wear grade. This is a typical example of the other measurements which can be found in appendix II.

Pol0 – Measurement of Pol0 is taken from the upper most part of the neck where no contact with cement has been made. This wear grade denotes no wear. The plot shows there to be prominent asperities present.

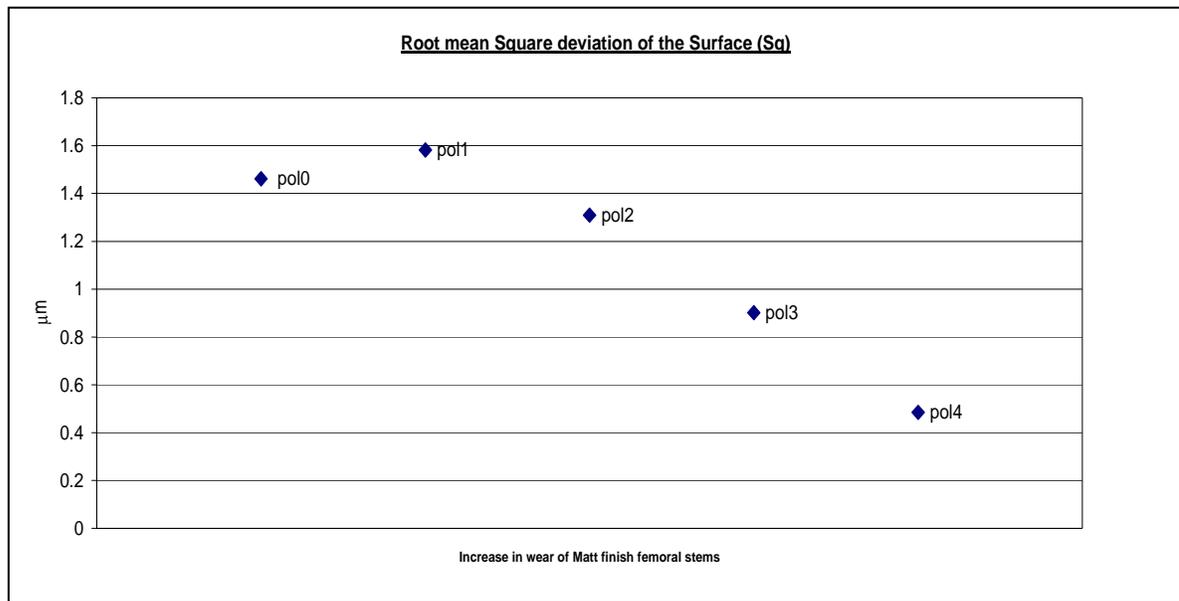
Figure 4.6 shows the results for average change in Sq with increase in wear grade, it can be seen from the results that following an initial increase in Sq there is a definite trend showing a decrease in Sq through wear grades Pol1 to Pol4. This indicates that following an initial very slight increase in roughness at Pol0 there is a definite reduction through wear grades Pol1 to Pol4 or that smoothing of the surface texture has occurred. This phenomenon was visually evident from the 3D axonometric plots. This would reinforce the notion that the asperities are worn away with an increase in wear.

Figure 4.6 – Average change in Sq with increase in visual wear grade for the range of stems measured

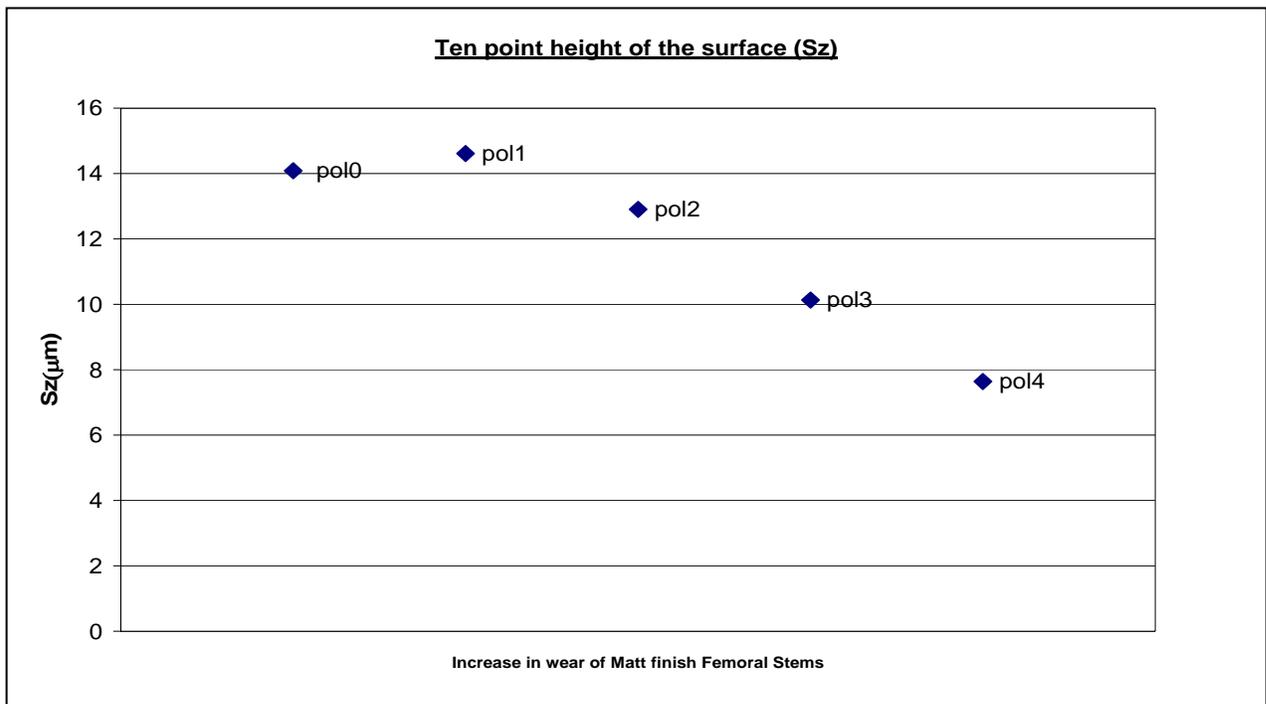
Figure 4.7 shows the average change in Sz with increase in visual wear grade. The trend matches that seen in figure 4.6, the results seen for Sq, there is an initial slight increase in Sz, followed by a steady decrease in the maximum height of the topographic surface. This decrease indicates that the maximum peak to valley height has on average decreased with increase in wear grade, it is not apparent from this parameter whether or not this is due to the valleys becoming shallower or the peaks becoming less pronounced. From analysing at this data along side the 3D axonometric plots, it would be sensible to assume, that this change at least in part is due to the removal of the asperities present at Pol0 and Pol1.

Figure 4.7 – Average change in maximum height of topographic surface with increase in visual wear grade

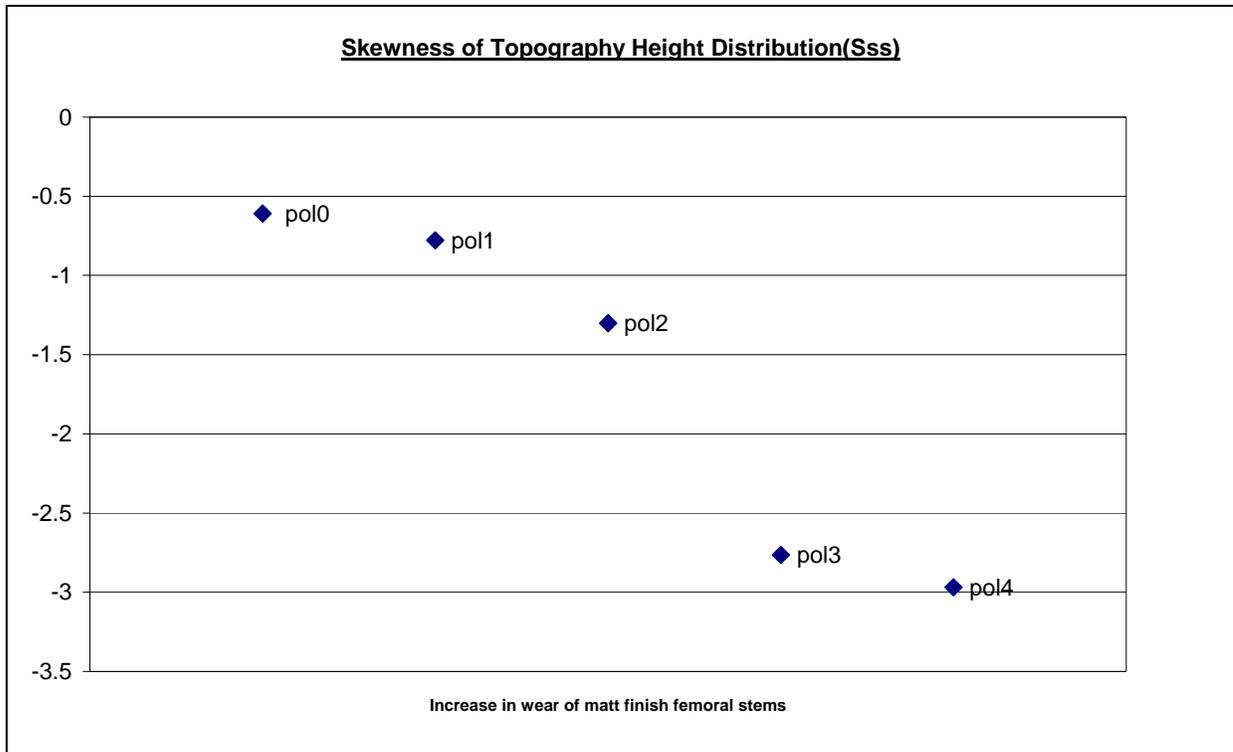
Figure 4.8 – Average change in skewness with increase in wear grade

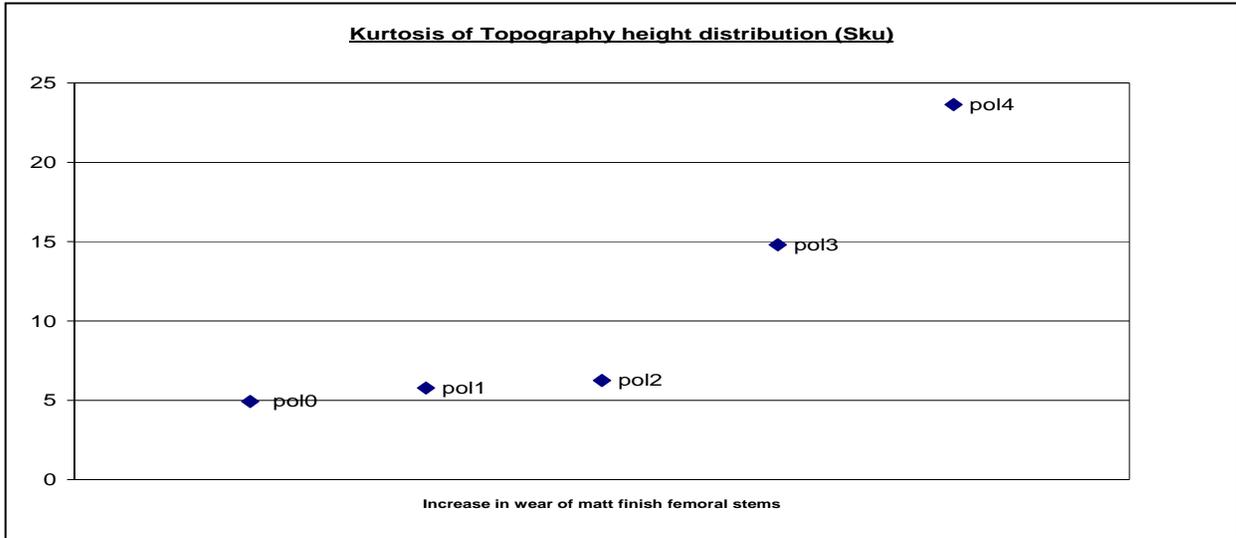
Figure 4.9 Average change in Kurtosis with increase in visual wear grade

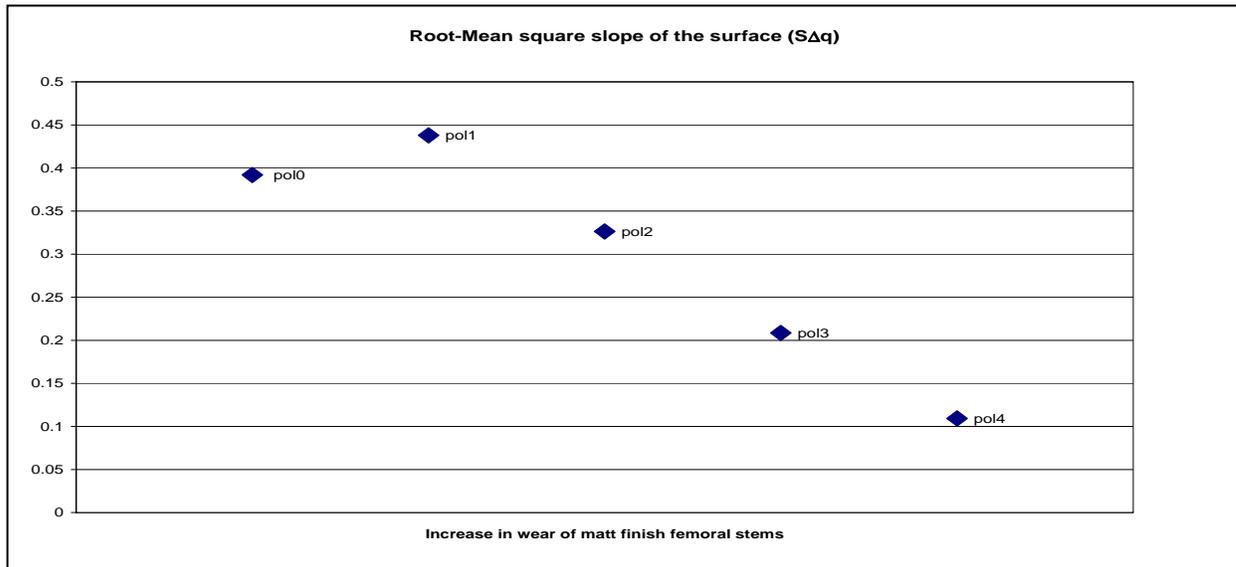
Figure 4.10 The average change in $S\Delta q$ with increase in visual wear grade

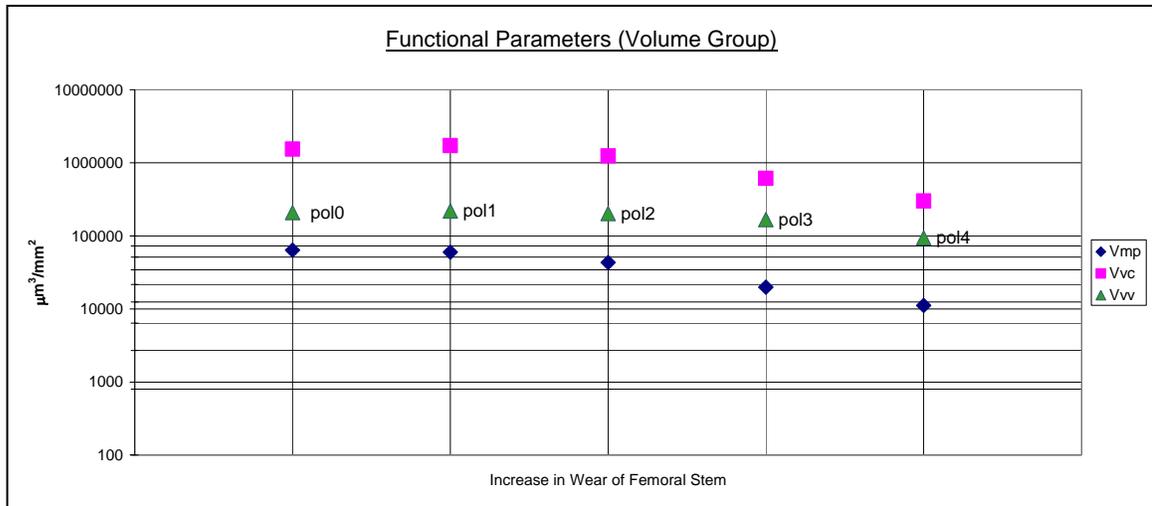
Figure 4.11 The average change volume family parameters with increase in visual wear grade

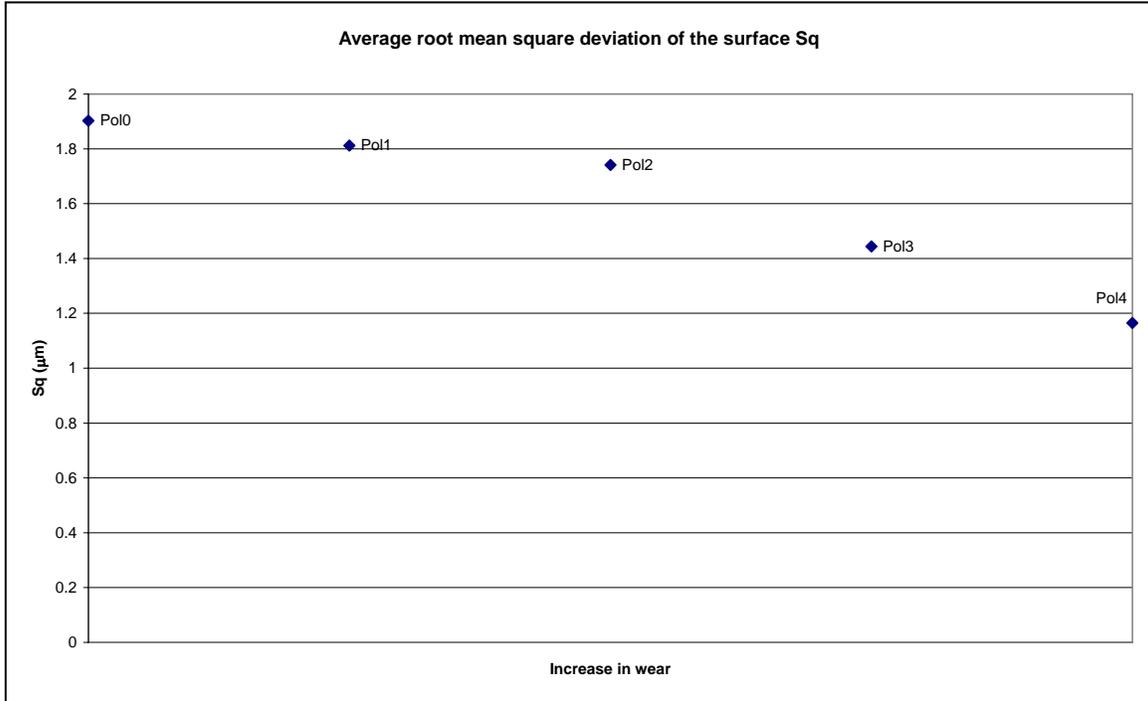
Figure 5.2 – Change in Sq with increase in visual grading system

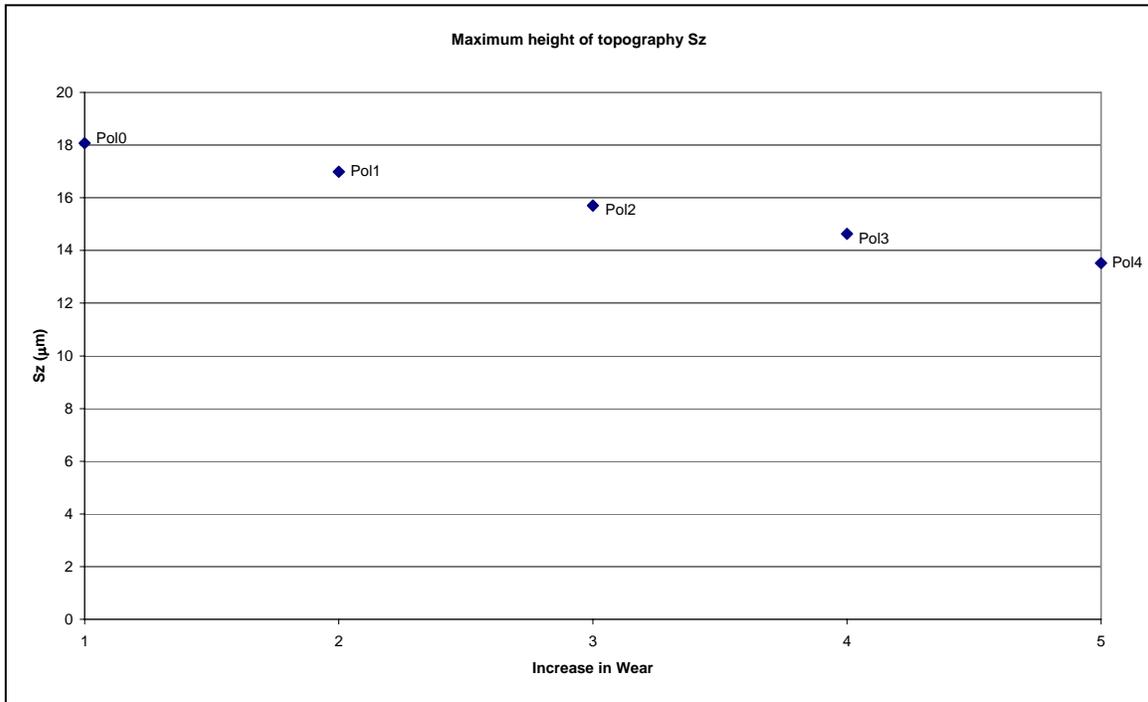
Figure 5.3 Change in Height of the topography of the surface with increase in wear

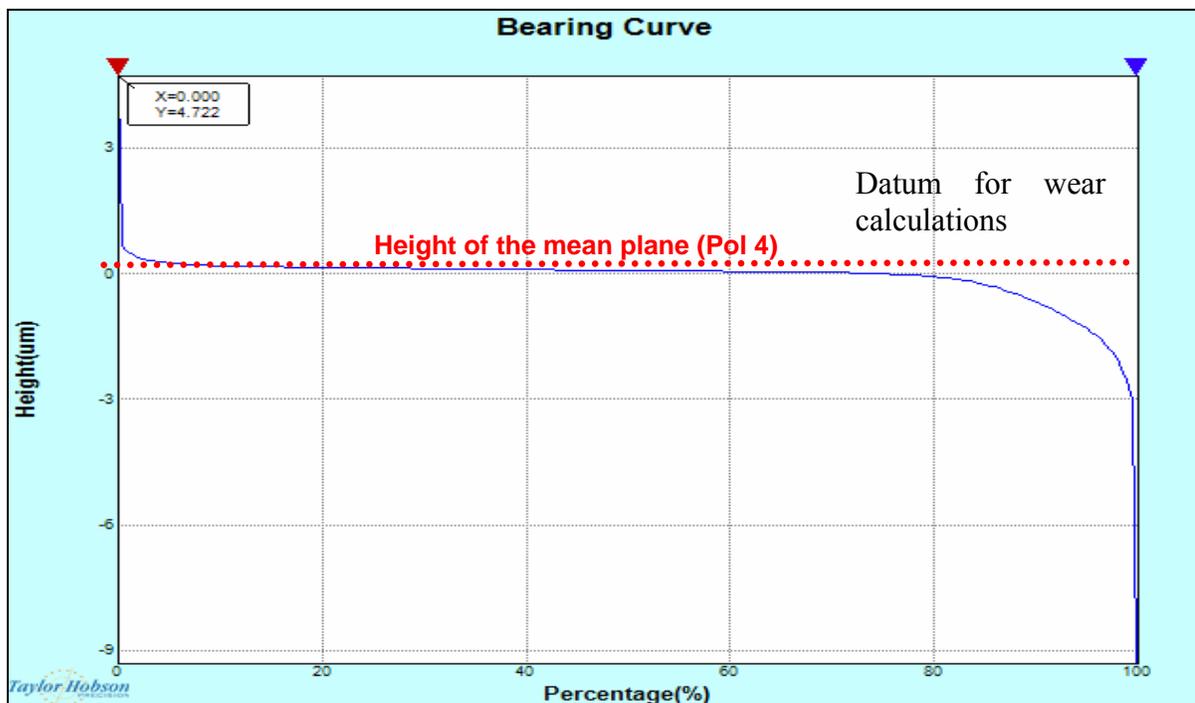
Figure 5.4 Use of the bearing area curve to determine the height of the mean plane

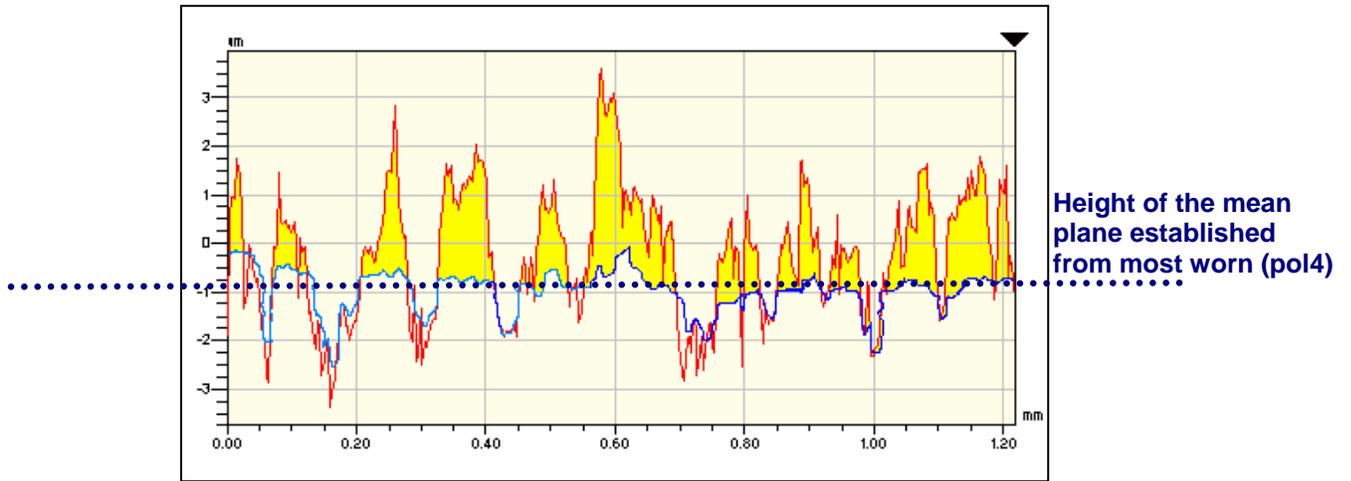
Figure 5.5 Representation of the difference between a pol4 and pol0 surface

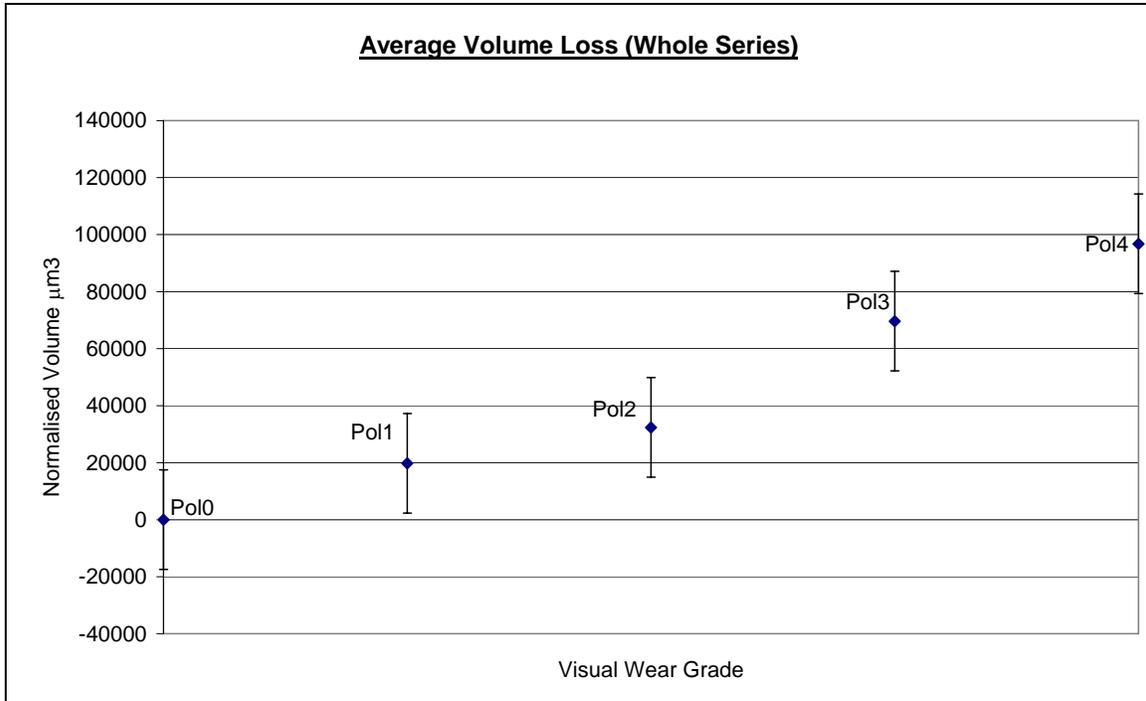
Figure 5.6 – Average volumetric wear loss as a function of visual wear grade

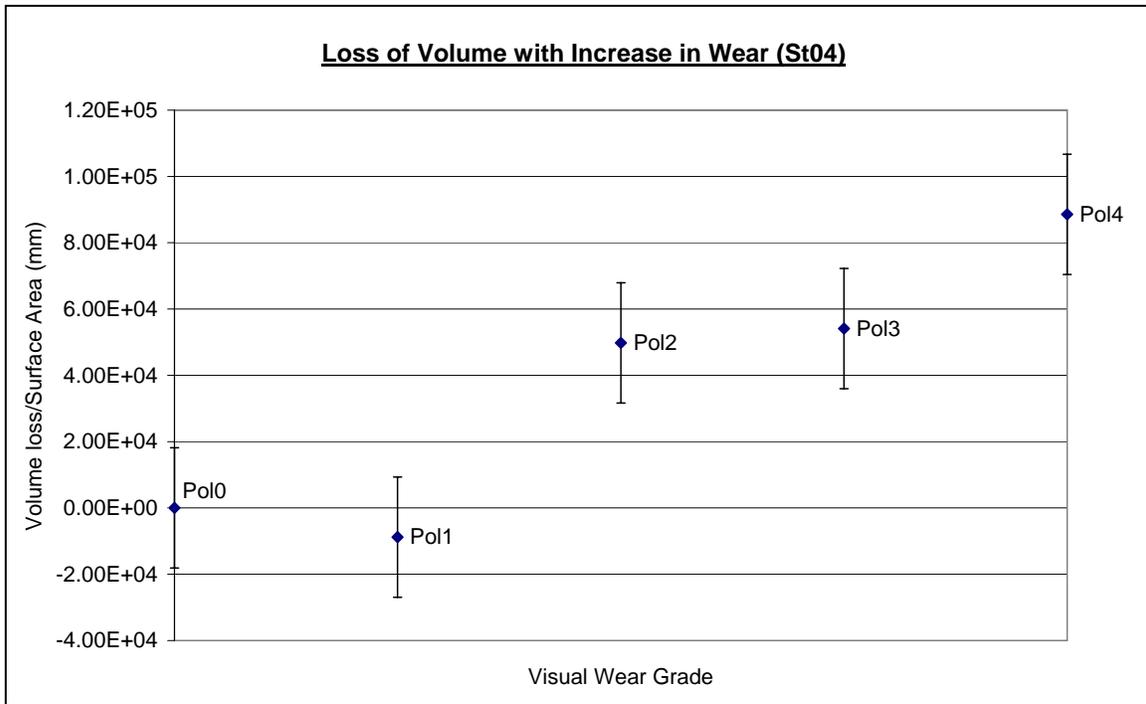
Figure 5.7 –Volumetric wear loss as a function of visual wear grade for a matt finish 316L stainless steel Exeter stem

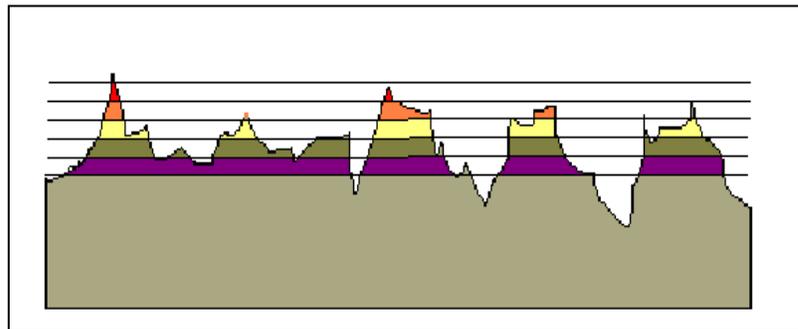
Figure 5.8 – Slices taken through the unworn topography representing “classic abrasive wear”

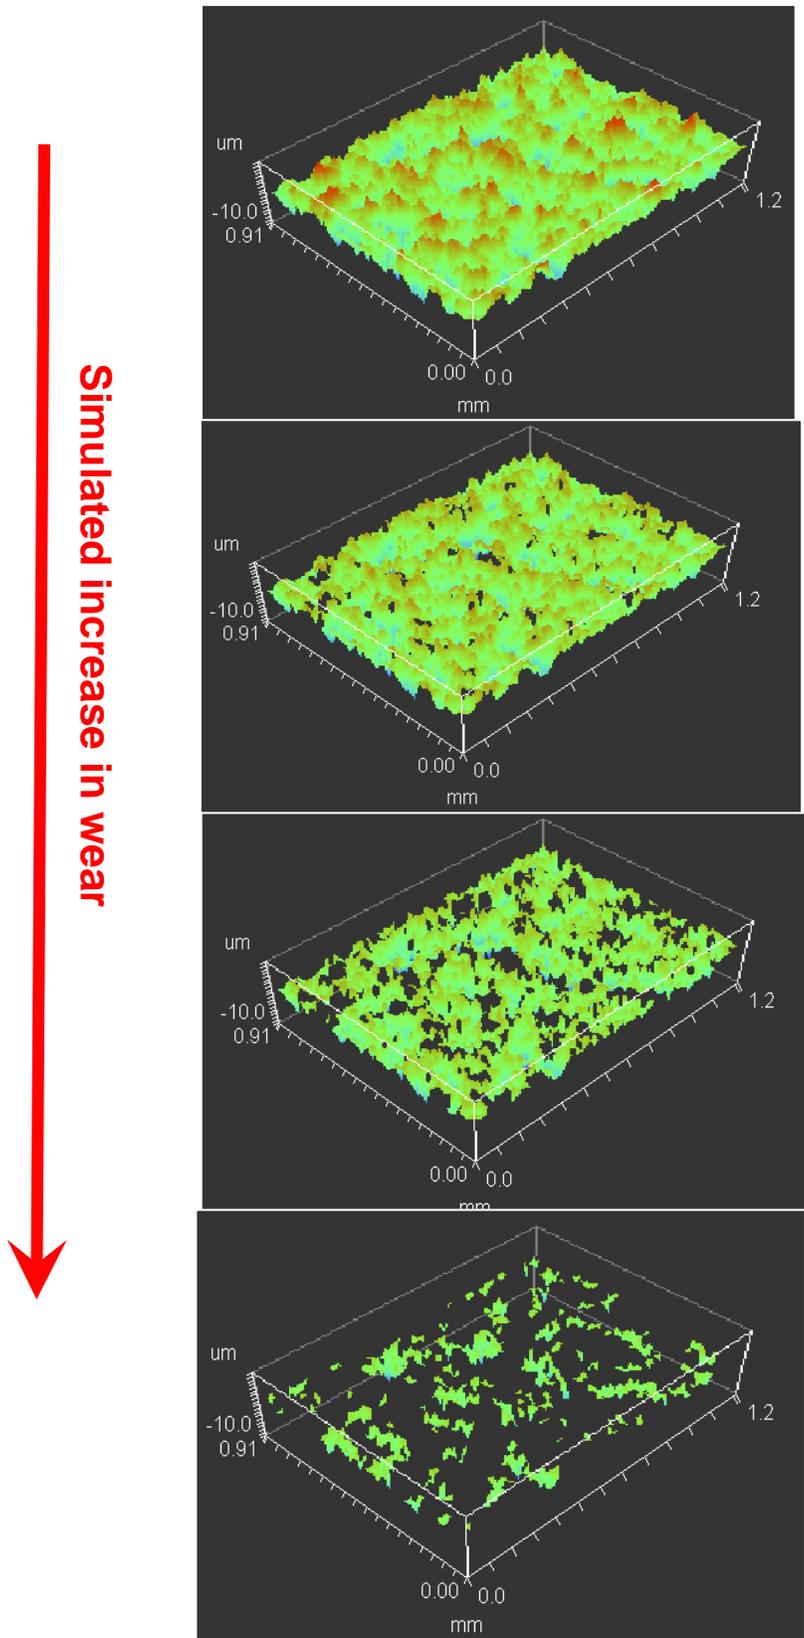
Figure 5.9 – Representation of the development of topography during truncation to simulate “classic abrasive” wear

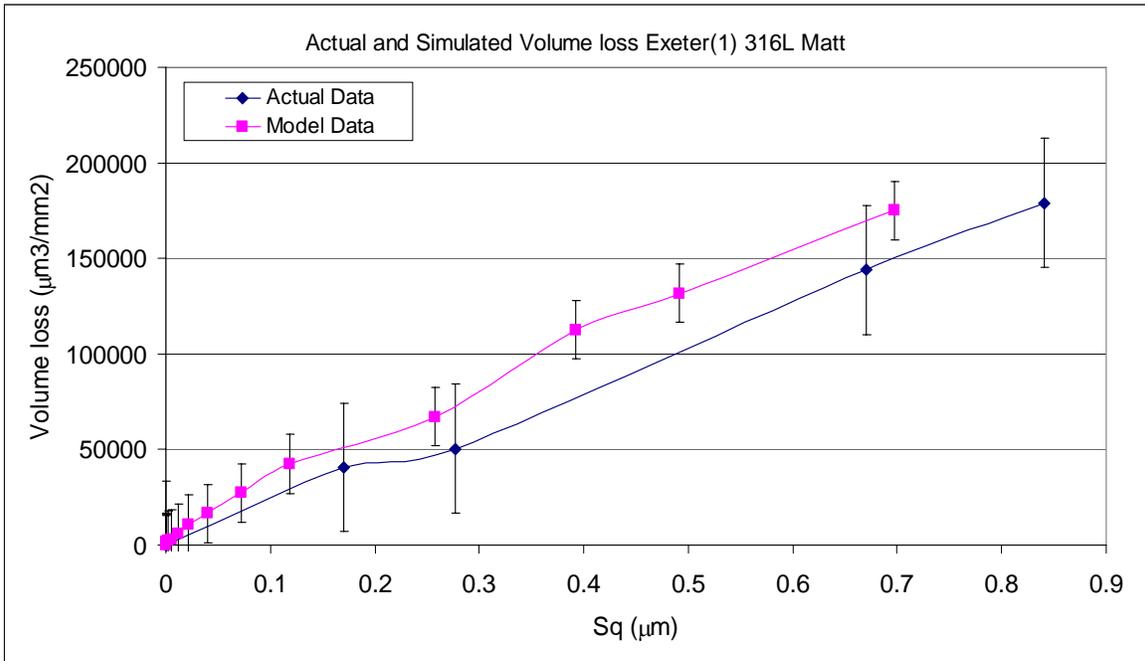
Figure 5.10 – Comparison of actual and simulated wear for St04 Exeter 316L stainless steel matt finish femoral stem

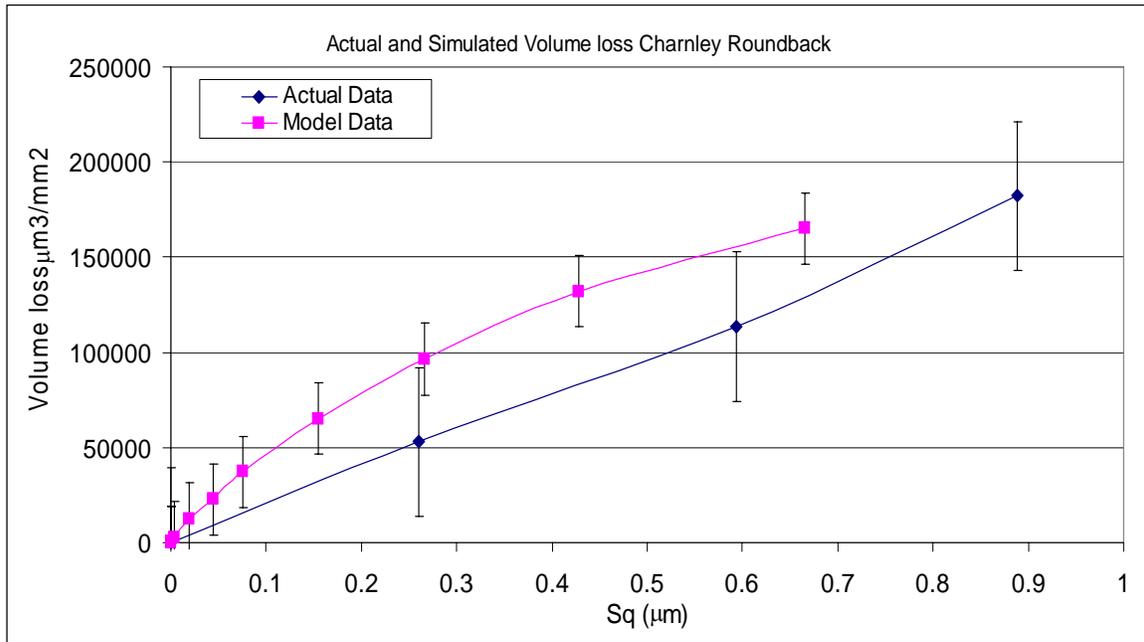
Figure 5.11 – Comparison of actual and simulated wear for a Charnley Roundback stainless steel matt finish femoral stem

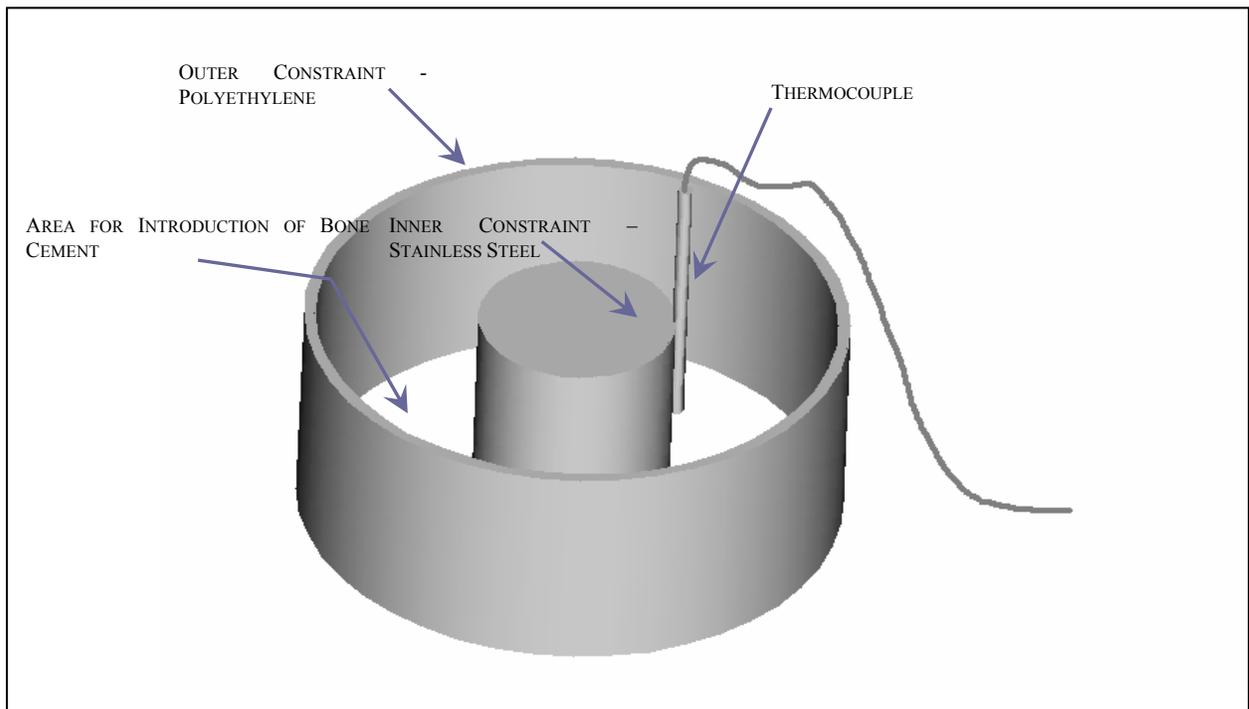
Figure 6.1 Set up of thermal change monitor

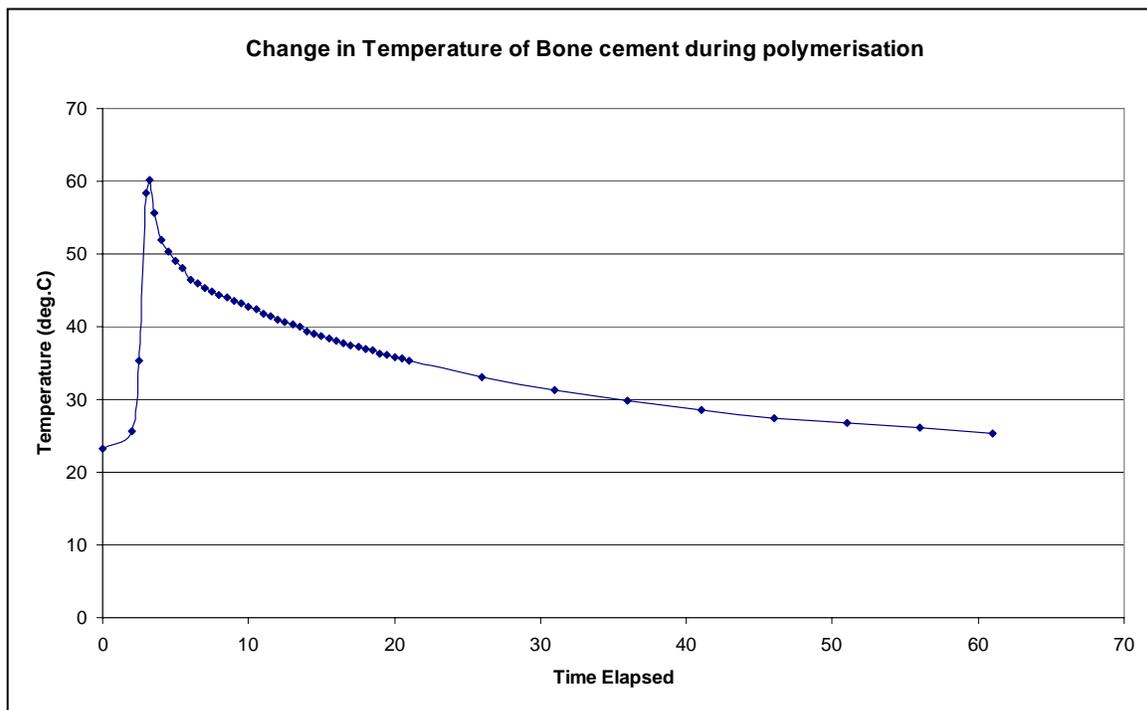
Figure 6.2 – Thermal change of bone cement during polymerisation (Simplex P)

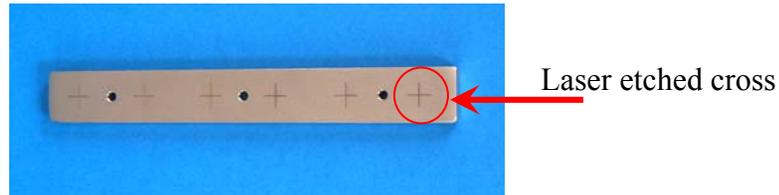
Figure 7.1 – 316L stainless steel billet showing laser etched relocation marks.
