**THE USE OF 3D SURFACE ANALYSIS TECHNIQUES TO
INVESTIGATE THE WEAR OF MATT SURFACE FINISH
FEMORAL STEMS IN TOTAL HIP REPLACEMENT**

LEIGH TONI BROWN

A thesis submitted to The University of Huddersfield in partial fulfilment of the
requirements for the degree of Doctor of Philosophy

April 2006

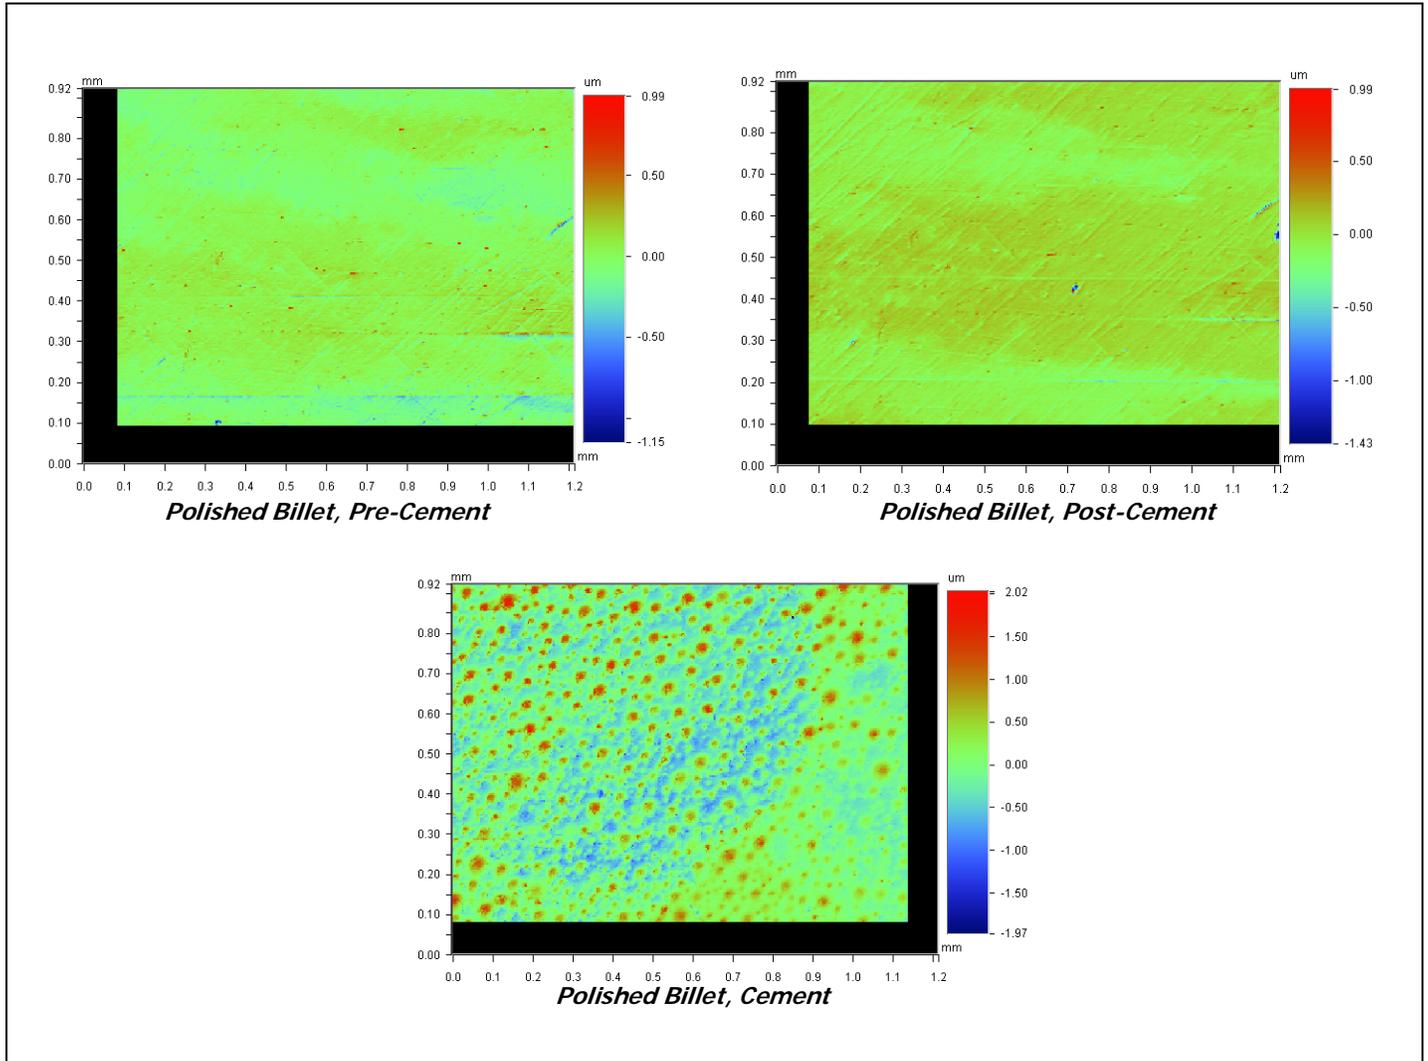
Figure 7.4. Contour Plots comparing topography differences pre and post cement

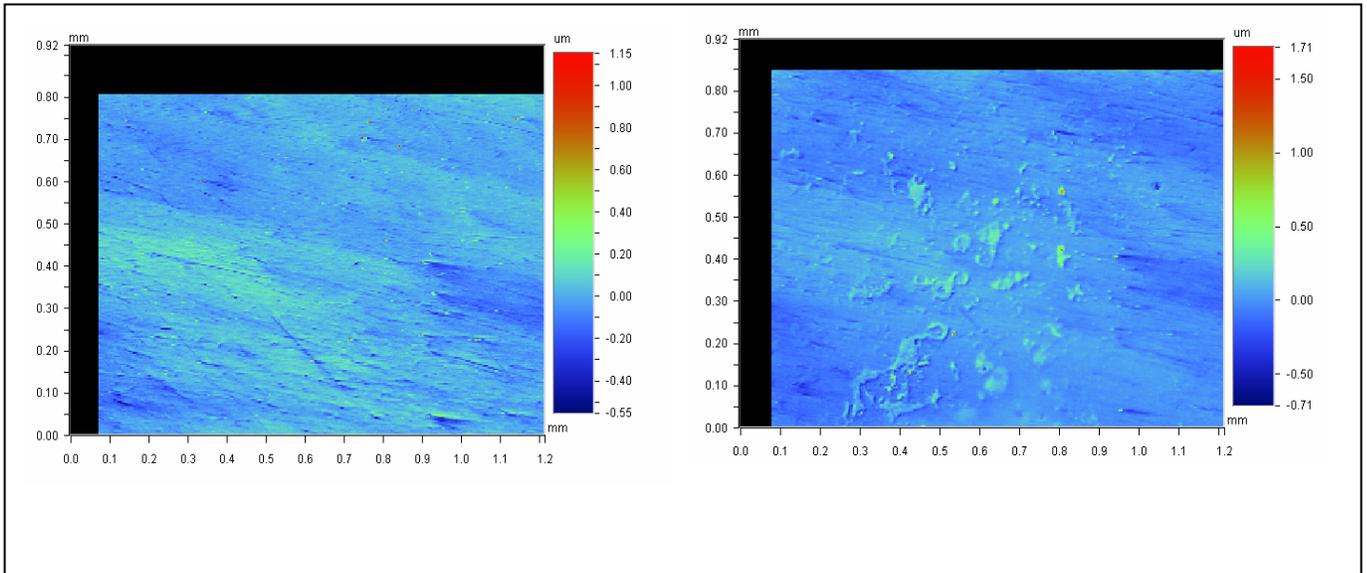
Figure 7.5. Pre and Post Cement Topography of area PB3-P5-5b

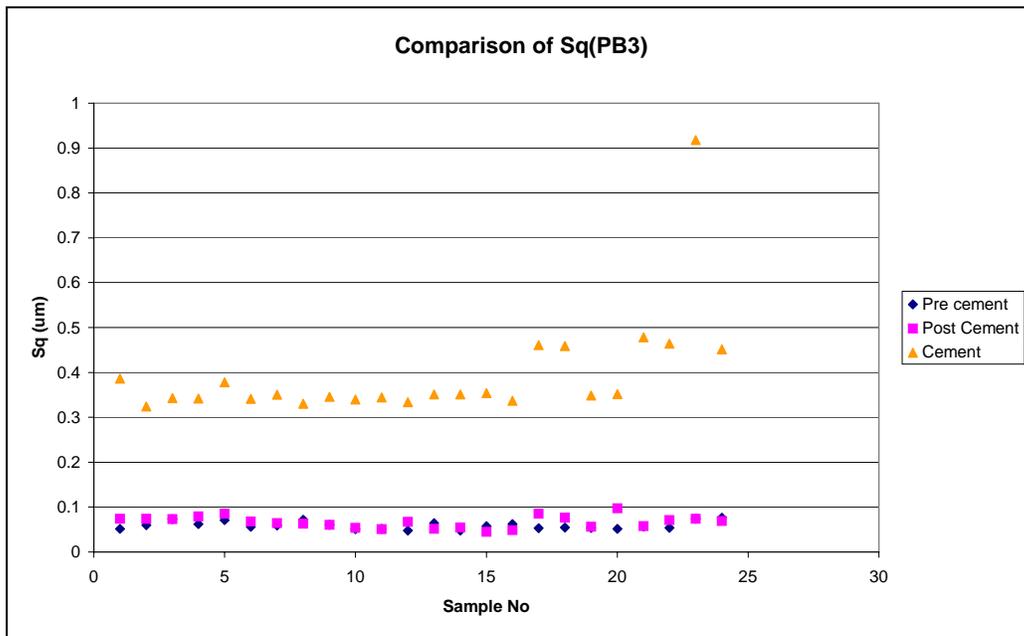
Figure 7.7 Comparison of Sq for polished billet 3

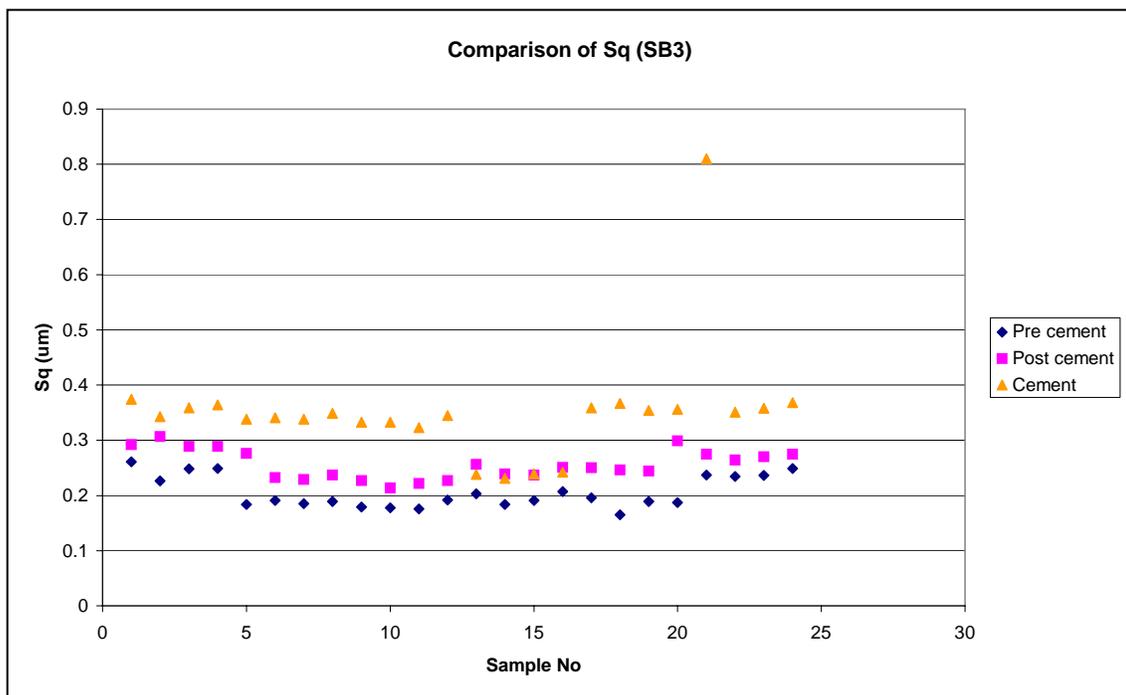
Figure 7.11 Comparison of Sq for satin billet 3

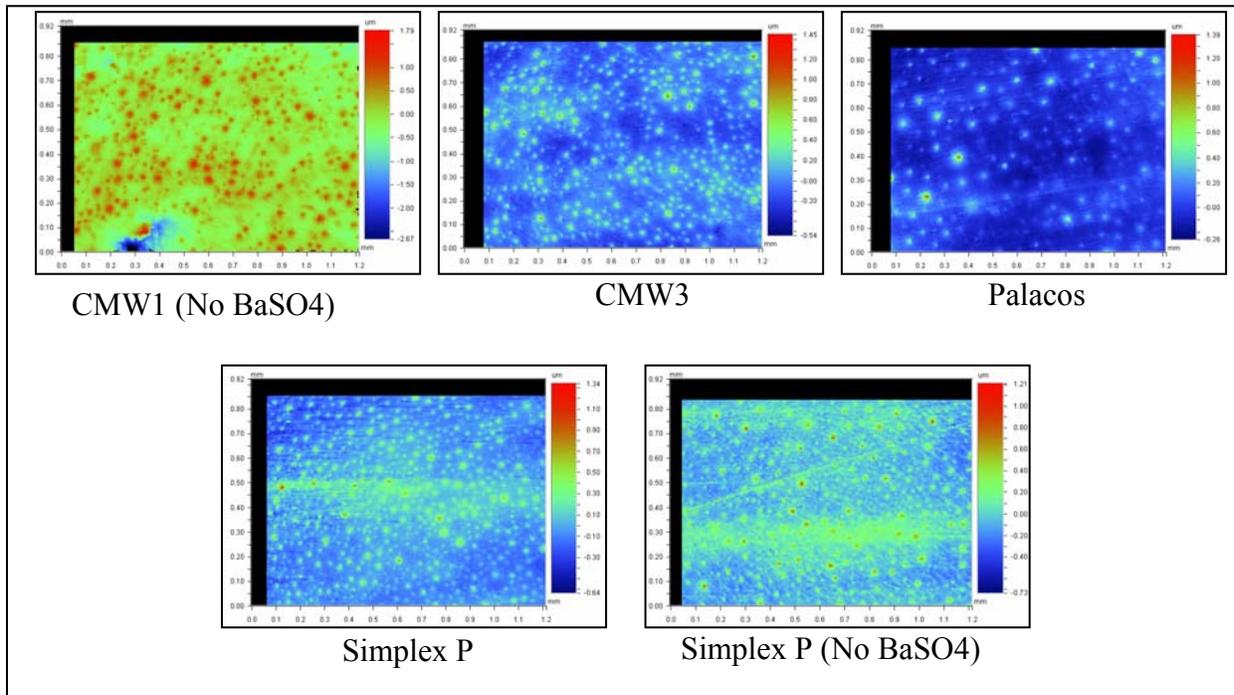
Figure 7.19 – Difference in cement topography with variation in brand

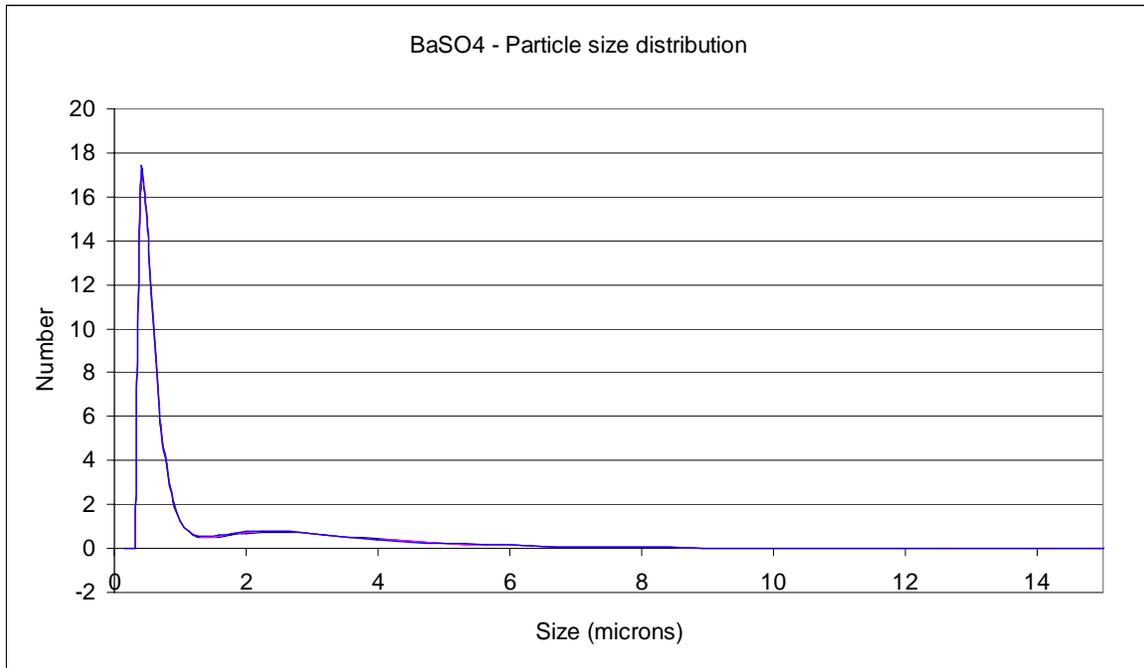
Figure 7.20 – Barium Sulphate Particle size distribution

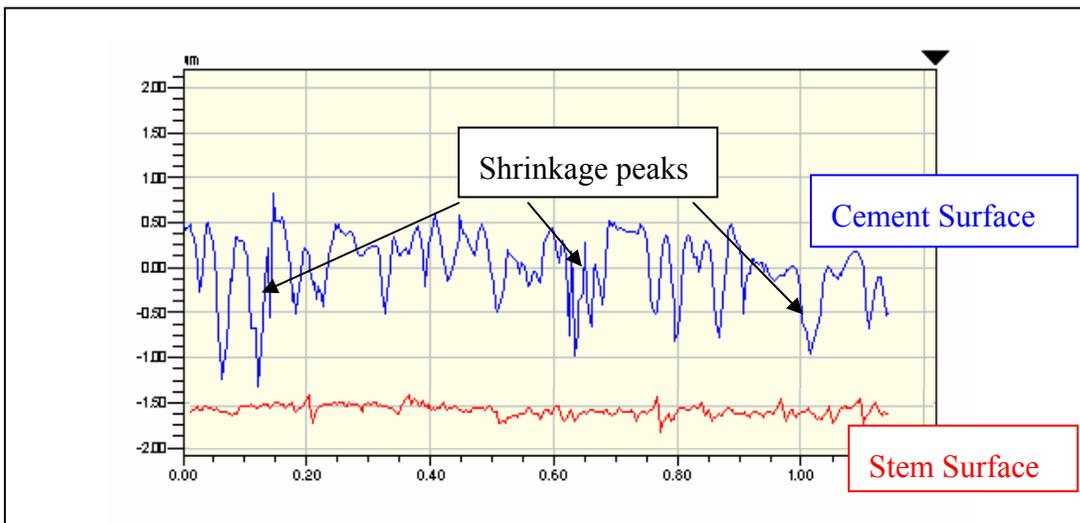
Figure 7.22, Cement topography following clinical insertion of an Exeter polished stem
 Figure 7.23 shows the magnitude of difference between the stem and cement following curing and polymerisation.

Figure 7.23, 2D plot showing the nature of interaction between stem and cement
 The 2D plot is an extraction from the 3D surface topography measurements of the stainless steel stem and the cement topography following curing and polymerisation, the implications of peak contact can clearly be envisaged in terms of peak supported channels allowing debris transportation, or alternatively should the peaks compress

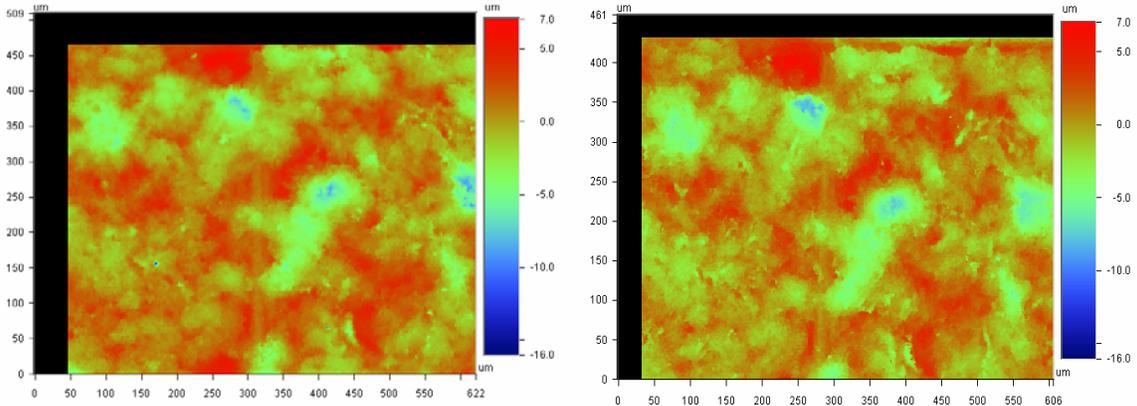
Figure 8.1 – Surface maps of (a) prior to wear and (b) post simulated wear of a matt finish Exeter femoral stem

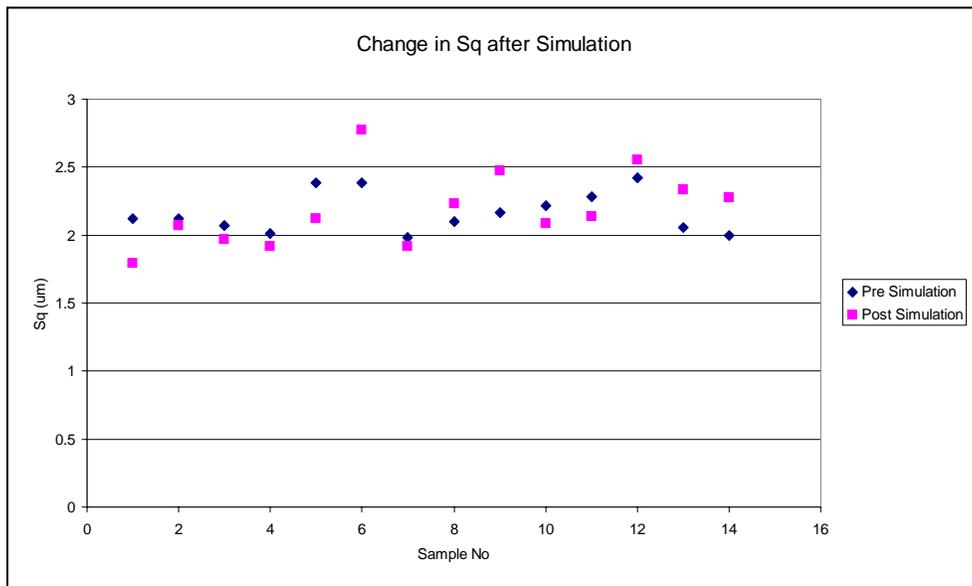
Figure 8.2 – Change in root mean square deviation of topography pre and post wear simulation

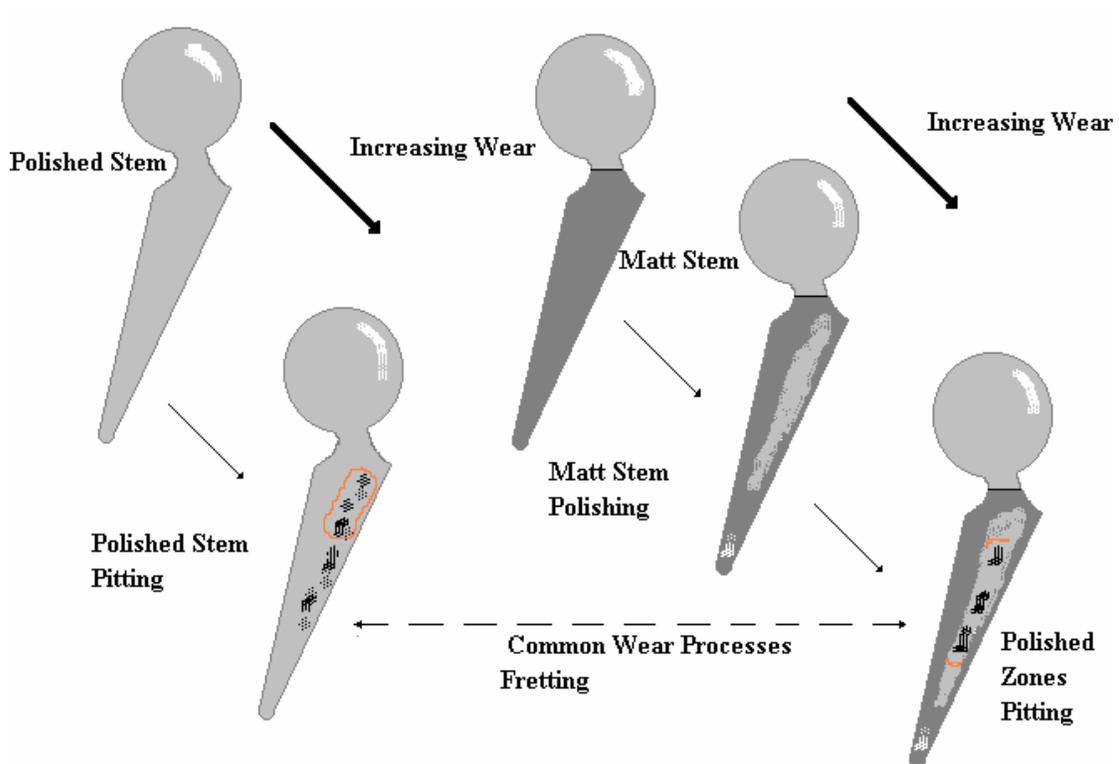
Figure 9.1 The proposed mechanism for wear of matt and polished femoral stems

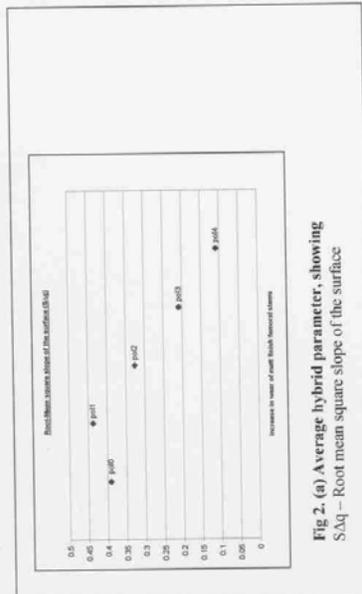
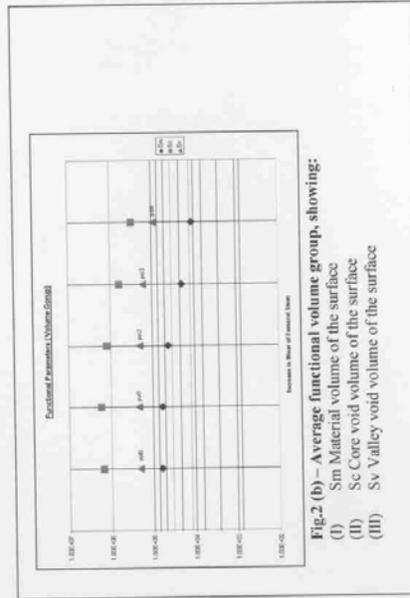
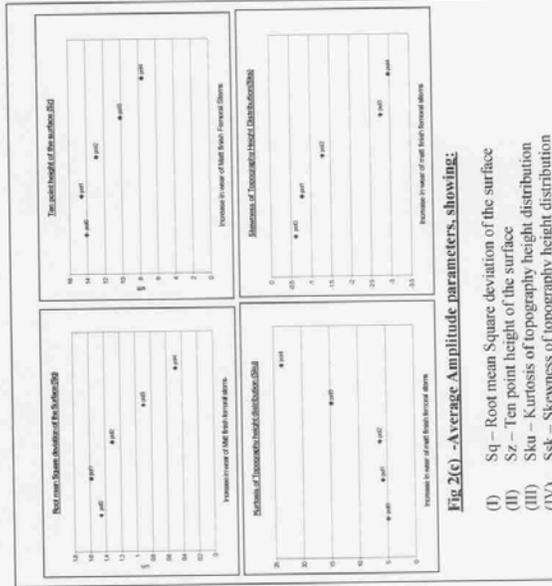
From these graphs (Fig.2 a-c) the relationship between increase in wear can be clearly seen. The parameters that are believed to be the most suitable for this application are those that show the change in surface amplitude and the change in surface volume with increase in wear: Fig.2a shows the data for the hybrid parameter rms slope of the surface SAQ, although the first data point Po10 does not follow the pattern, the other data points po11 - po14, decrease almost linearly.
