Defect Detection in Thin-film Photovoltaics; Towards Improved Efficiency and Longevity

Elrawemi, Mohamed, Blunt, Liam, Fleming, Leigh, Sweeney, Francis and Robbins, David (2014) Defect Detection in Thin-film Photovoltaics; Towards Improved Efficiency and Longevity. In: 5th International Renewable Energy Congress. IREC 2014 . IEEE, Hammamet, Tunisia, pp. 524-528. ISBN 978-1-4799-2196-6

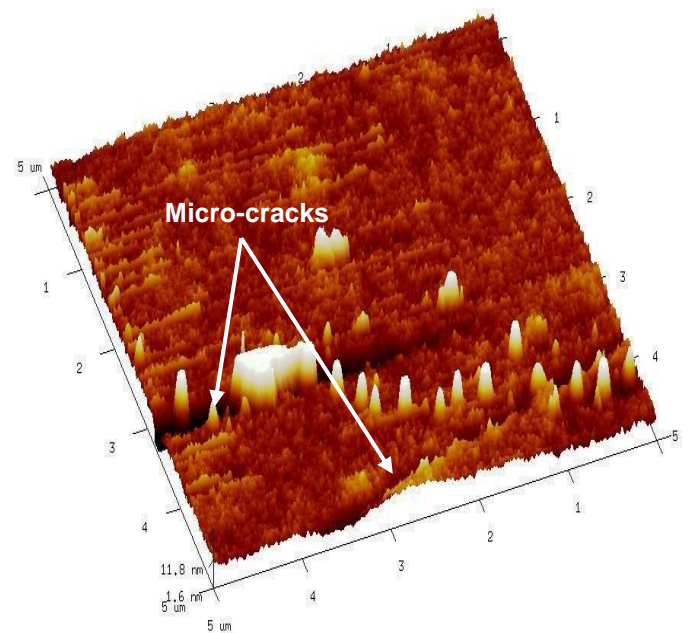
Although the object targeting and the image acquisition can be more rapid using the SEM, polymers are difficult to examine as they have a tendency to rapidly charge, even with a conductive coating, resulting in beam divergence and image degradation. In contrast, AFM can analyse the samples with minimal sample preparation, thus preserving surface textures and allowing repeat analyses without the risk of charging. The AFM can produce an equal or higher data resolution image of an equivalent area, but with the addition of absolute X, Y and Z for any features. In this study, a Bruker Dimension Icon AFM was used as an independent measure of the Al_2O_3 ALD film. It allows much smaller defect sizes to be examined than would be possible by the SEM. It can also be used to determine the size of the cracks over the films which were not detectable by the CCI or the optical microscopy techniques. Fig 5 shows crack type defect captured by this technique.

Fig. 5. AFM image-micro-crack type defect
