Defect Detection in Thin-film Photovoltaics; Towards Improved Efficiency and Longevity

Elrawemi, Mohamed, Blunt, Liam, Fleming, Leigh, Sweeney, Francis and Robbins, David (2014) Defect Detection in Thin-film Photovoltaics; Towards Improved Efficiency and Longevity. In: 5th International Renewable Energy Congress. IREC 2014 . IEEE, Hammamet, Tunisia, pp. 524-528. ISBN 978-1-4799-2196-6

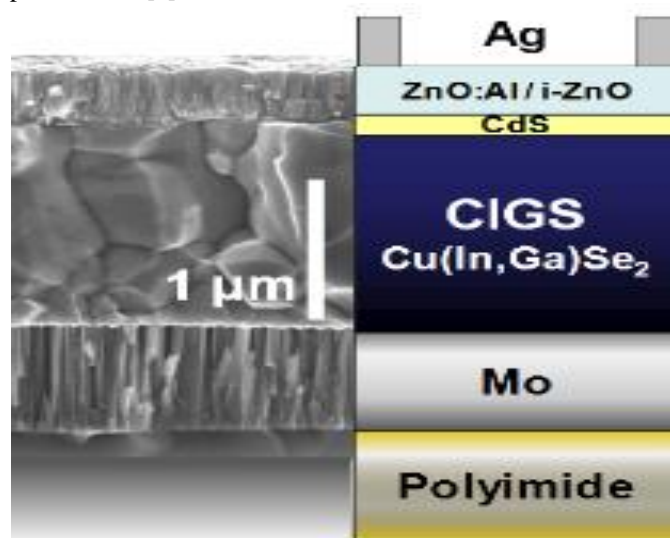
Fig. 1. Typical structure of flexible PV module (Courtesy of Flisom, Switzerland)

construction of Si solar cells hampers their economic integration into residential and commercial buildings; however, thin film solar cell technologies may prove to be most appropriate with respect to cost and ease of manufacture, and it is anticipated that the next generation of photovoltaic devices will be based entirely on thin film technologies. These cells are based on the material $\text{CuIn}_{1-x}\text{Ga}_x\text{Se}_2$ (CIGS) as the absorber layer (p-type) and they are the most efficient cells at the present time [2].

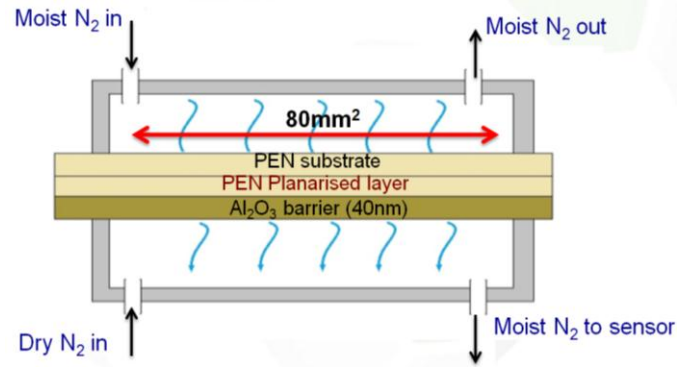
Prior to the surface measurements, the samples were measured for water vapour transmission rate (WVTR) using Isostatic standard test instrumentation (MOCON®) at specified conditions (38°C° and 90% RH respectively). This method involves the test specimen being held in a sealed chamber such that it separates two sides of the chamber as shown in the Fig 3.

Fig. 3. Schematic representation of WVTR test

On one side of the sample a highly saturated wet environment is maintained at a constant temperature, whilst on the other, a dry nitrogen carrier gas is passed to a coulometric phosphorous pentoxide sensor where water vapour which enters is converted to a measurable charge [5].

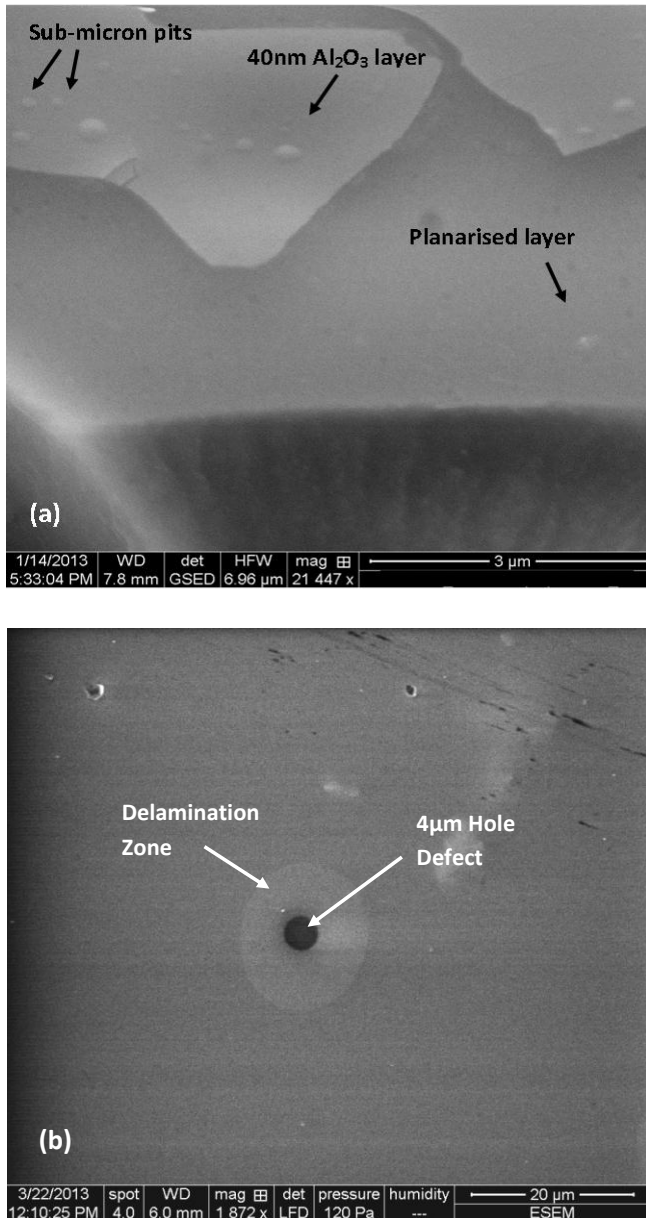
investigate the Al_2O_3 /polymer structure, the low vacuum mode was employed using water vapour at pressures between 120 and 400 Pa. An off-axis large field detector was used to collect the amplified secondary electron signal emitted from the specimen; this detector has the advantage of providing images with a relatively large field-of-view. A cross-sectional electron micrograph was obtained near the edge of the Al_2O_3 /polymer structure as shown in Fig (4a). The image shows the 40-nm Al_2O_3 barrier layer that exhibits pit-like defects between 100 nm and 500 nm in diameter on the surface. In Fig (4b) an image of a typical hole defect, approximately 4 μm in diameter, in the Al_2O_3 layer is shown. A region of differing contrast is observed in the area surrounding this hole; this is attributed to the delamination of the Al_2O_3 layer from the underlying polymer structure due to water penetration.

Fig. 4. ESEM of defects in Al_2O_3 barrier layer (a) Al_2O_3 /polymer cross-section, (b) typical hole type defect

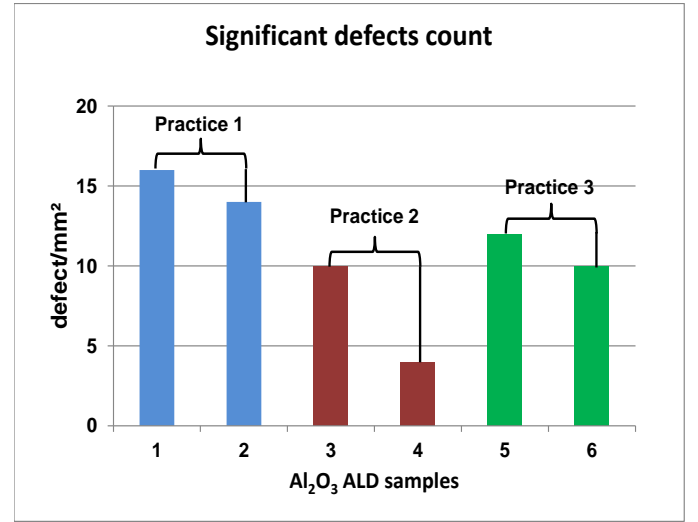
The results in Fig 7. Showing significant defects count as analysed by the 'wolf pruning' method. Comparing each two sets of the samples results, feature segmentation analysis and the pruning condition of (6σ where $S_q = 0.6\text{nm}$ height and $15\mu\text{m}$ width) have provided a clear evidence for the correlation of surface defects size, defect density, and the transmission of water vapour through the barrier coating layers. The investigation concludes that large defects are the dominant factor for determining the WVTR.

Fig. 7. Shows the significant defects count
