Walton, Karl, Blunt, Liam, Fleming, Leigh, Goodhand, Martin and Lung, Hang (2014) A real parametric characterisation of ex-service compressor blade leading edges. *Wear*, 321. pp. 79-86. ISSN 00431648

Areal parametric characterisation of ex-service compressor blade leading edges

Karl Walton^{a,*}, Liam Blunt^a, Leigh Fleming^a, Martin Goodhand^b, Hang Lung^c

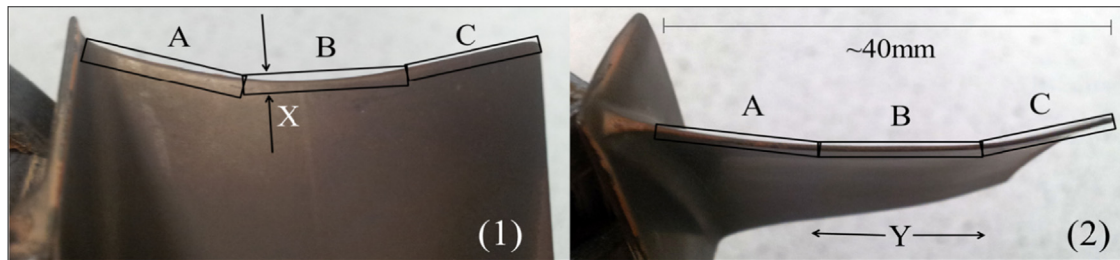
Fig. 5. Typical leading edge measurement traverses (spanwise), (1) leading edge profile from pressure side (2) leading edge viewed edge on from pressure side, showing 3 typical measurement fields A, B and C, field B having traverse length Y and scan height X. (see Fig. 1 for blade nomenclature).

with a single instrument field employed at close to zero angle of attack the central 60° to 90° arc of the edge (corresponding to central 1/2 to 2/3 of the projected frontal leading edge area) was captured, see Fig. 2. Surface regions at flank angles extending beyond this range offer increasingly poor data quality, and increased residual form to remove. Suitably fixed and aligned by goniometer for; pitch, yaw and angle of attack, a minimum vertical scan height and maximum traverse length were achieved for a given measurement traverse (see Fig. 5).

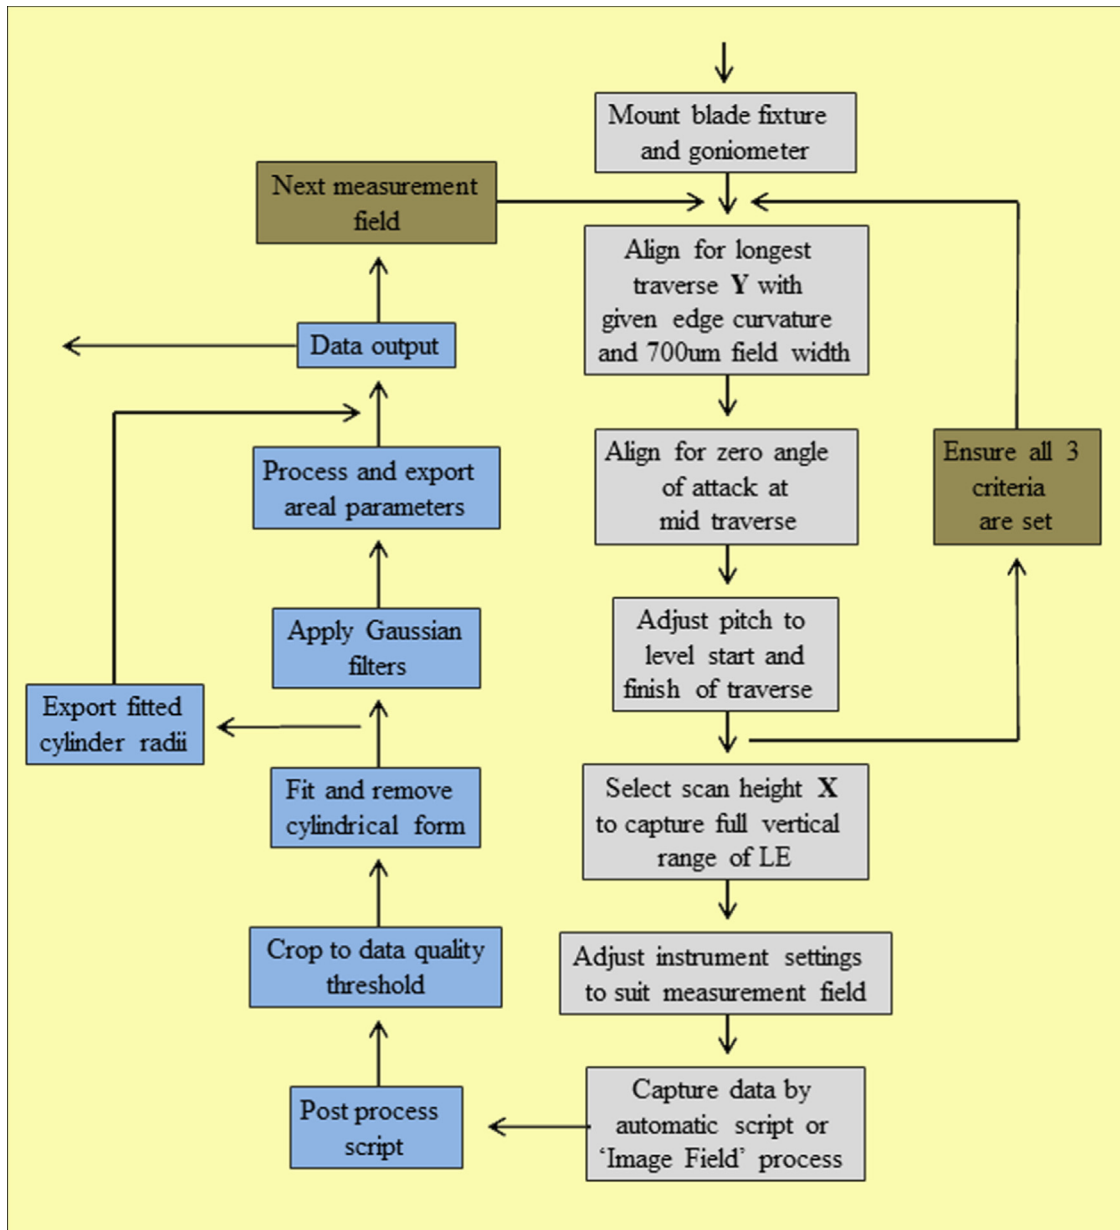
Fig. 6. Measurement and post processing flow chart (detailed with respect to Fig. 5).

Dependent on specific curvature and geometry, one or more automated (spanwise) traverses were required to acquire data for the length of the leading edge in individual 500 μm fields, leading edges being ~180–30 mm long (IPC1–HPC6). Using this approach the desired leading edge region occupied varying areas and positions within a measurement field, consequently extraction of the required central data region proved subjective. Automation of this task was therefore necessary to allow for the scale of measurement envisaged and ensure repeatability. Alicona captured data has associated with each data point an uncertainty value (data quality) expressed in terms of the vertical distance over which the measurement is estimated to be repeatable within a two standard deviation confidence interval. It can be seen in Fig. 7 that as the leading edge flank angle increases, holes in the image begin to appear, representing data falling below the instrument default minimum quality value. It was seen that using data quality as a metric and assigning a suitable value the data field could be thresholded at any desired level, leaving only the high quality data from the central region of interest. It was then possible, employing script written for this purpose and implemented with respect to [17] [4],[18], to systematically; threshold for data quality, fit to and remove nominal cylindrical form, capture fitted cylinder radius, filter and compute areal parameters from the captured data sets. The 300 μm Gaussian L filtration in the script (see Fig. 7) was applied to attenuate the effects of longer surface wavelengths not removed by cylindrical form removal. Given the wide variation in surface character of individual leading edges or sections thereof it proved necessary to tailor the quality threshold values to suit, consequently extracted field sizes varied somewhat from those intended, in the approximate range 100–700 μm. Fig. 6 shows a measurement process flow chart.
