Areal parametric characterisation of ex-service compressor blade leading edges

Walton, Karl, Blunt, Liam, Fleming, Leigh, Goodhand, Martin and Lung, Hang (2014) Areal parametric characterisation of ex-service compressor blade leading edges. *Wear*, 321. pp. 79-86. ISSN 0043-1648

# Areal parametric characterisation of ex-service compressor blade leading edges

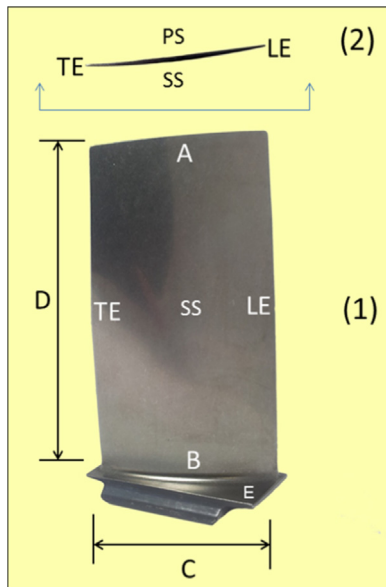
**Fig. 1.** Generic compressor blade nomenclature; (1)-side view and (2)-tip view(x section) showing; LE-leading edge, A-tip, B-root, C-chord (chordwise direction), TE-trailing edge, D-Span (spanwise direction), SS-suction side (convex), PS-pressure side (concave), E-end wall.

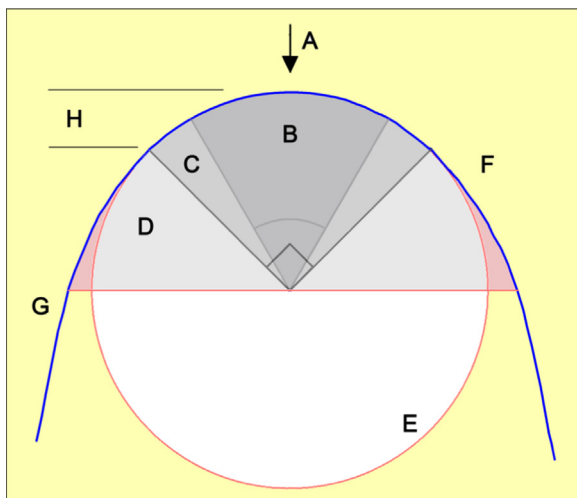
**Fig. 2.** Leading edge region cross-section schematic; (A) instrument optical axis (zero angle of attack) (B) central 60° frontal field of leading edge, (C) central 90° frontal field of leading edge, (D) nominal frontal field of whole leading edge, (E) circle fitted to nominal leading edge circular profile, (F) approximate blend point of leading edge into blade suction or pressure side (see Fig. 1), (G) leading edge flank, (H) approximate depth of measurement field.

Fig. 2 details the approximate frontal (zero angle of attack) projected region of a typical leading edge that it is possible to capture both practically and with robust surface roughness data. Additionally the flanks of the edge can be captured, but this must be done with a minimum of two extra measurement fields perhaps 60° either side of zero. Due to the complex geometry of leading edges see Fig. 5 it is not practical to combine or spatially register the resulting fields, thus limiting their usefulness. Additionally, section 3.1 indicates these flank regions exhibit a transitional (non-uniform) surface roughness character and thus are not homogeneous; homogeneity being a prerequisite for areal parametric characterisation [16]. Hence

with a single instrument field employed at close to zero angle of attack the central 60° to 90° arc of the edge (corresponding to central 1/2 to 2/3 of the projected frontal leading edge area) was captured, see Fig. 2. Surface regions at flank angles extending beyond this range offer increasingly poor data quality, and increased residual form to remove. Suitably fixed and aligned by goniometer for; pitch, yaw and angle of attack, a minimum vertical scan height and maximum traverse length were achieved for a given measurement traverse (see Fig. 5).

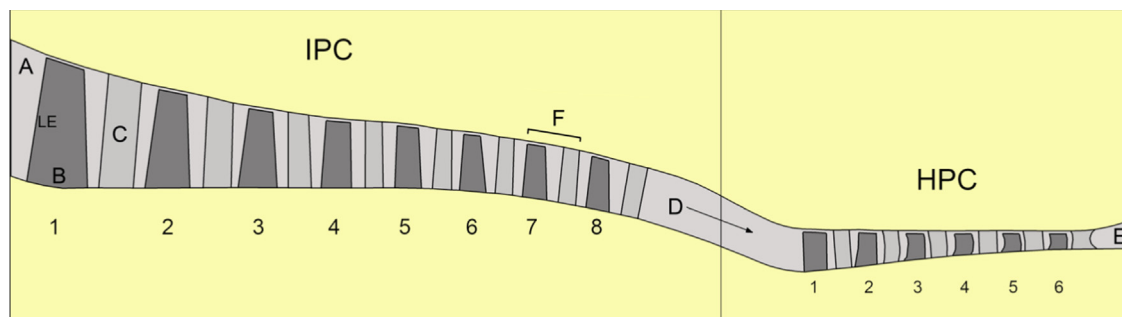
**Fig. 3.** Compressor jet core schematic; High pressure compressor HPC and intermediate compressor IPC (A) Inlet, (B) rotor blade root, (C) stator blade (vane), (D) compressor core flow, (E) combustion chamber, (F) single compressor stage, (LE) leading edge. Inset numbers indicate blade number.

To date the large majority of investigations into compressor degradation have focussed on military or power generation applications. In civil aero engines the levels of degradation are more modest, and unlikely to be safety critical, but can have a significant effect on fuel burn. The fact that they are not safety critical means that there is little published data of leading edge metrology. The compressor blades investigated have circular leading edges; typically with nominal leading edge radii less than 1 mm and high flank angles (see Fig. 2 (G)). A flank angle of 90° means the surface is parallel to the optical axis and not measurable; measurements become optimal as this angle approaches 0°. In practice imperfections arising during manufacture as well as the deterioration in-service, means that the leading edges are rarely circular in practice and as such, their dimension is typically described as 'half thickness'. This study focuses on the leading edges of the rotor blades from a single engine see Fig. 3; one blade

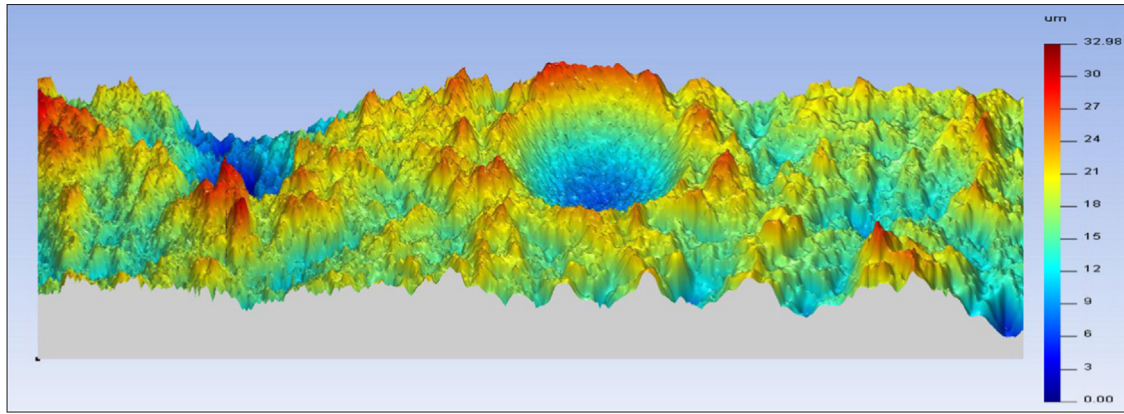
**Fig. 4.** 250 × 1000 μm leading edge false colour height map, acquired from a recovered HPC 1 blade employing a Taylor Hobson 'Coherence Correlation Interferometer' (CCI) and SurfStand™ software.

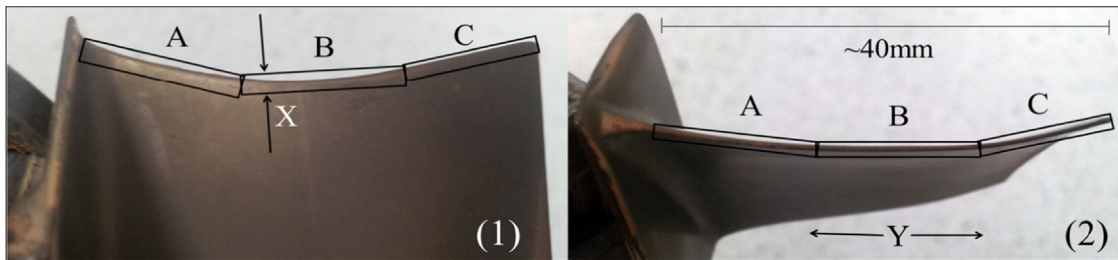
**Fig. 5.** Typical leading edge measurement traverses (spanwise), (1) leading edge profile from pressure side (2) leading edge viewed edge on from pressure side, showing 3 typical measurement fields A, B and C, field B having traverse length Y and scan height X. (see Fig. 1 for blade nomenclature).

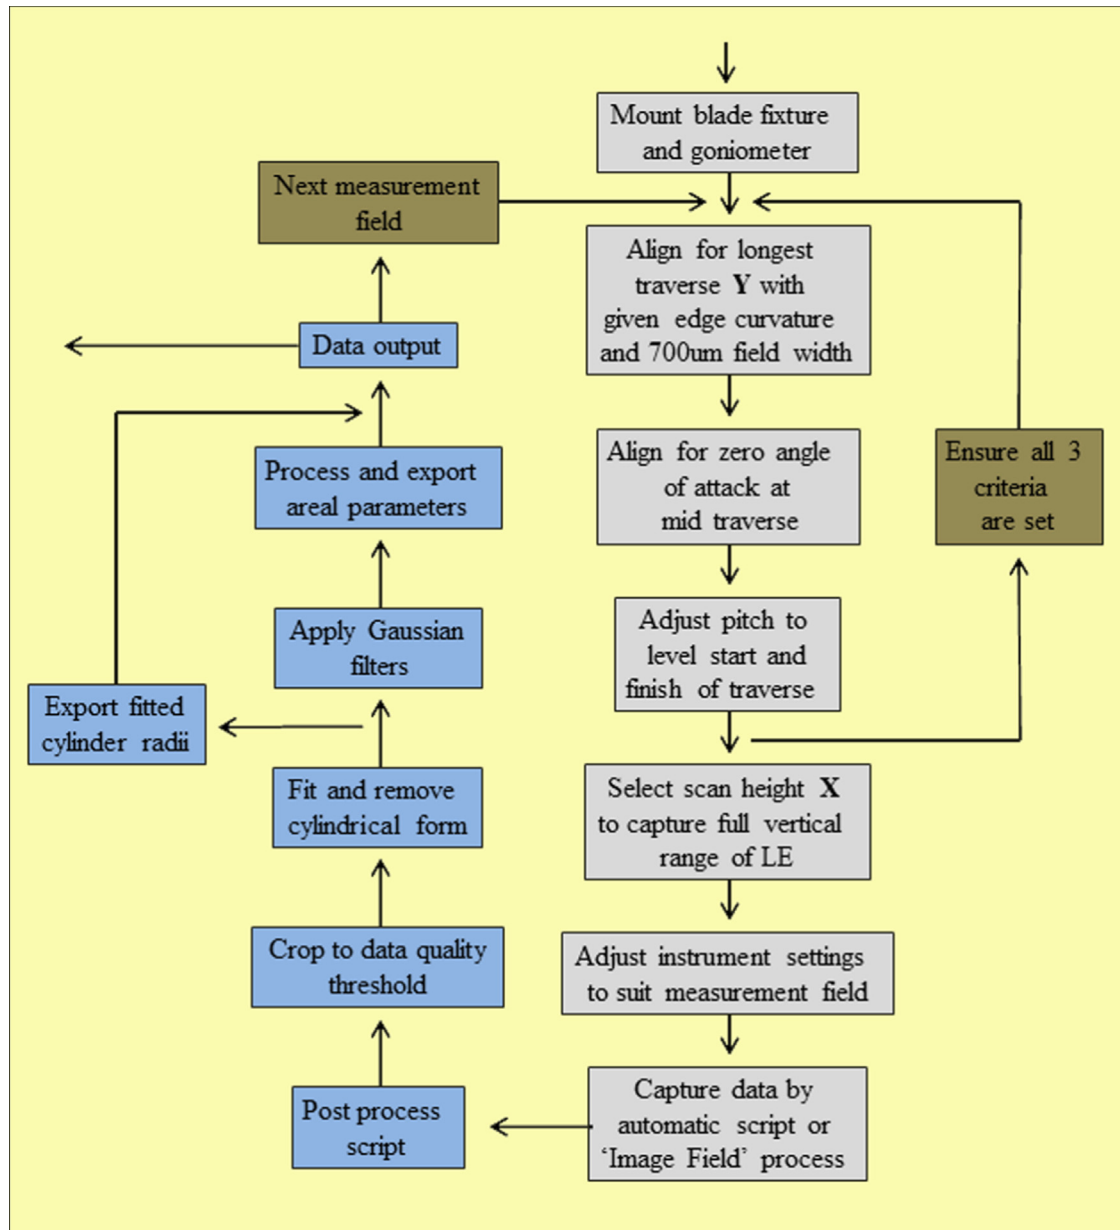
**Fig. 6.** Measurement and post processing flow chart (detailed with respect to Fig. 5).

Dependent on specific curvature and geometry, one or more automated (spanwise) traverses were required to acquire data for the length of the leading edge in individual 500 μm fields, leading edges being ~180–30 mm long (IPC1–HPC6). Using this approach the desired leading edge region occupied varying areas and positions within a measurement field, consequently extraction of the required central data region proved subjective. Automation of this task was therefore necessary to allow for the scale of measurement envisaged and ensure repeatability. Alicona captured data has associated with each data point an uncertainty value (data quality) expressed in terms of the vertical distance over which the measurement is estimated to be repeatable within a two standard deviation confidence interval. It can be seen in Fig. 7 that as the leading edge flank angle increases, holes in the image begin to appear, representing data falling below the instrument default minimum quality value. It was seen that using data quality as a metric and assigning a suitable value the data field could be thresholded at any desired level, leaving only the high quality data from the central region of interest. It was then possible, employing script written for this purpose and implemented with respect to [17] [4],[18], to systematically; threshold for data quality, fit to and remove nominal cylindrical form, capture fitted cylinder radius, filter and compute areal parameters from the captured data sets. The 300 μm Gaussian L filtration in the script (see Fig. 7) was applied to attenuate the effects of longer surface wavelengths not removed by cylindrical form removal. Given the wide variation in surface character of individual leading edges or sections thereof it proved necessary to tailor the quality threshold values to suit, consequently extracted field sizes varied somewhat from those intended, in the approximate range 100–700 μm. Fig. 6 shows a measurement process flow chart.

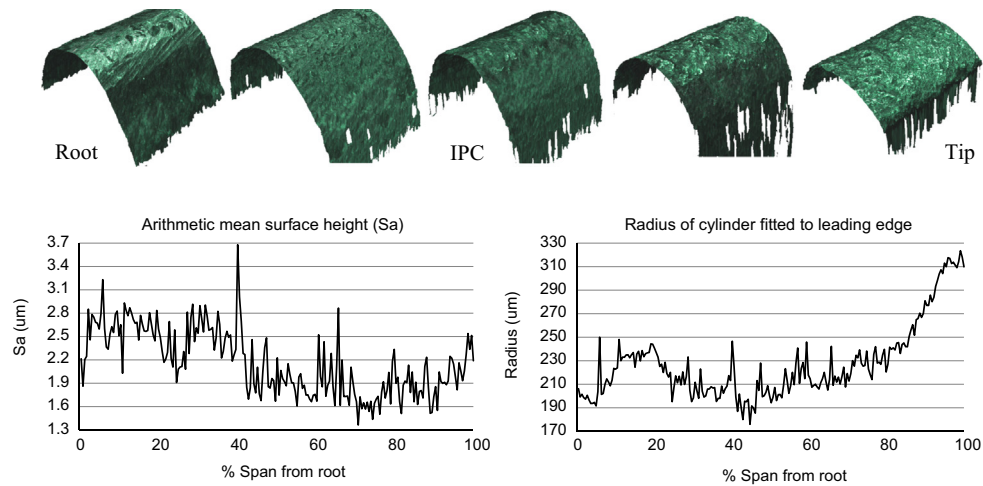
**Fig. 7.** Excerpted microscopic photographic images of a typical IPC blade, with charts detailing  $S_a$  (arithmetic mean surface height) [22] and fitted cylinder leading edge radius for each measurement field. Acquired with Alicona G4 IFM; X20 objective, lateral resolution  $2.9\ \mu\text{m}$  (sample spacing  $1\ \mu\text{m}$ ), vertical resolution (quantisation)  $100\ \text{nm}$ , Gaussian L filter nesting index 300  $\mu\text{m}$  (high pass surface filter) [23].

Fig. 7 shows microscopic images of individual measurement fields for an example IPC blade spaced equally along the leading edge, and plots of  $S_a$  and fitted radius with % span from route. For proprietary reasons no comparative as manufactured edge half thickness values are quoted, though as a general trend these values decrease from root to tip. The data is plotted for individual captured fields  $\sim 450\ \mu\text{m}$  of leading edge; this has the effect of showing the local variations due to the scale of impact features and deposits. This may or may not be desirable, and the data could be filtered or averaged to give a more general trend to suit another application. Fig. 7 illustrates the usefulness of fitted radius as a basic metric of leading edge profile change and hence the extent of wear; the tip region of this typical IPC blade is seen to have a significantly flattened profile and correspondingly elevated values of fitted radius in this region. Visual assessment confirms a positive correlation between deviation from the expected plot of a progressive reduction in fitted radius from root to tip and gross leading edge geometry change due to erosion. It was anticipated that a positive correlation would exist between peak leading edge wear and surface roughness. Fig. 7 clearly shows this not to be the case. Low wear (erosion) of the root half of the leading edge is seen to be associated with higher  $S_a$  values than the tip region which exhibits high wear. As a general rule abrasive particulates in the core flow tend to be centrifuged towards the blade tips [19] hence the characteristic tip biased wear pattern. It is noted that where erosion is the dominant in the IPC that a general positive correlation exists between peak regions 'Autocorrelation length' ( $S_{al}$ )<sup>1</sup> [20] [21] and  $S_a$ , meaning, as might be expected, that larger particulate impacts produce surface features of larger amplitude and lateral length scale (wavelength). This is to some extent borne out by visual inspection of Fig. 7. When deposition becomes apparent and erosion less dominant from the late IPC onwards

this correlation is less notable. Thus it appears that the overall quantity and specific combination of particulate scales acting at a given leading edge location dictate the level of erosion and roughness character generated though the relationship between these effects is not straightforward.

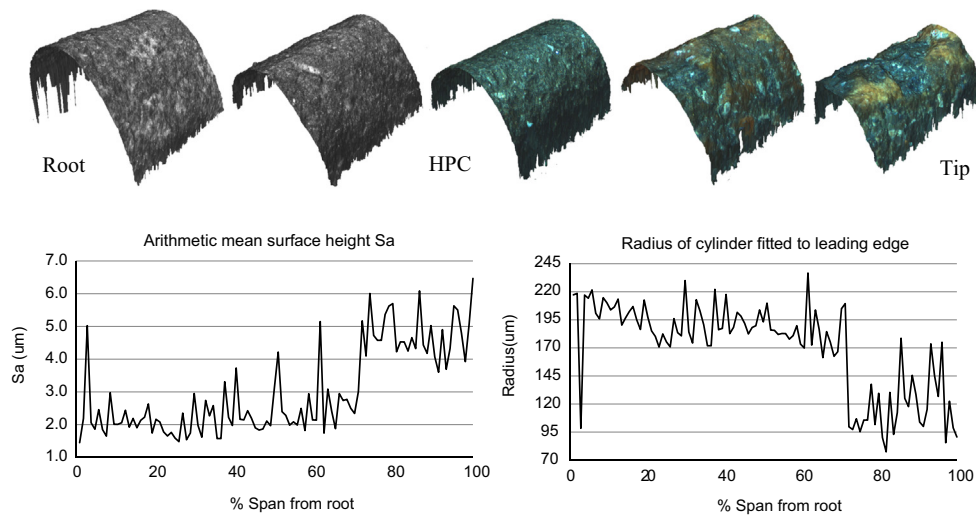
**Fig. 8.** Excerpted microscopic photographic images of a typical HPC blade, with charts detailing  $S_a$  (arithmetic mean surface height) [22] and fitted cylinder leading edge radius for each measurement field. Acquired with Alicona G4 IFM; X20 objective lateral resolution  $2.9 \mu\text{m}$  (sample spacing  $1 \mu\text{m}$ ), vertical resolution (quantisation)  $100 \text{ nm}$  Gaussian L filter nesting index  $300 \mu\text{m}$  (high pass surface filter) [23].

Fig. 8 shows the same elements as Fig. 7 but shows an example HPC blade. The appearance of deposits at the leading edge tip is most notable and visible here. Fitted radius and surface roughness are strongly negatively correlated, and both are erratic, demonstrating large variations over short spanwise lengths of the leading edge. Deposits in this tip region are seen to be highly variable and often asymmetric, causing the resulting changes in fitted leading edge cylinder radius. It is suggested that surface impact features may, by way of flow disturbance at abrupt changes of profile (such as that seen in the lee of a road vehicle) result in this deposition, or conversely deposits may be partially spalled by surface impacts.

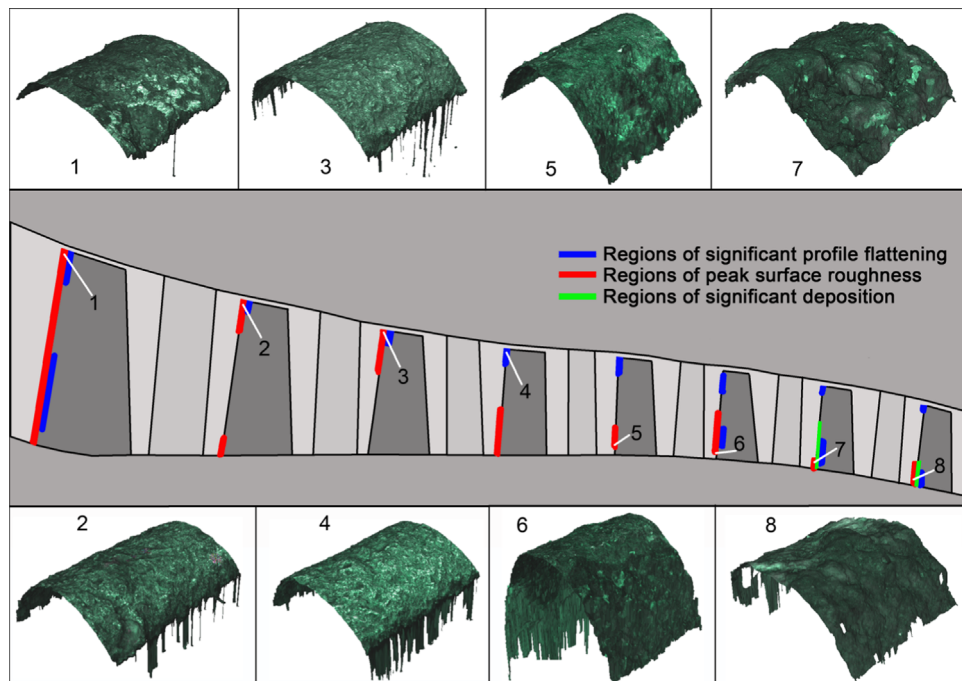
**Fig. 9.** Schematic annulus diagram of the IPC showing blade number. In red are regions of peak surface roughness. In blue are regions of (relative) pronounced increase of fitted radius due to erosion of profile. Above and below are leading edge fields from the numbered blades in the LE positions indicated by the white lines.

Fig. 9 shows colour coded details for the IPC of the spatial arrangement of leading edge peak roughness and regions of profile flattening (fitted radius increase) due to erosion of the leading edge. A single field image is included for each blade to illustrate typical features of the surface character and geometry. IPC1 shows essentially uniform roughness with the highest mean value in the IPC only exceeded in the compressor as a whole by that of HPC2. This pattern was attributed to the particulates entering the compressor not having yet been subjected to any significant fragmentary or centrifugal action, and hence being relatively large and uniformly distributed. Prior to the onset of deposition at IPC7 (see Fig. 9) it is only the effects of erosion that are characterised in the results.

All IPC blades exhibit some profile flattening erosion at the tip, IPC1–3 exhibit peak roughness at the tip, whereas IPC4–6 show peak roughness nearer the root. IPC7+8 begins to show deposition at the root where peak roughness is seen, it being highest on IPC7. Hence there is no clear correlation between peak erosion and peak roughness, and where deposition occurs it is associated with the highest roughness values.
