Damage patterns at the head-stem taper junction helps understand the mechanisms of material loss

Hothi, Harry, Panagiotopoulos, Andreas, Whittaker, Robert, Bills, Paul J., McMillan, Rebecca, Skinner, John and Hart, A. J. (2017) Damage patterns at the head-stem taper junction helps understand the mechanisms of material loss. *Journal of Arthroplasty*, 32 (1). pp. 291-295. ISSN 0883-5403

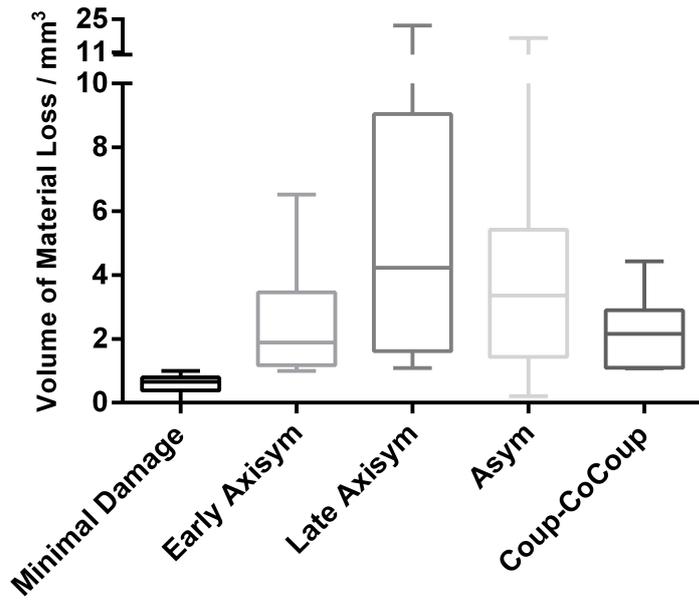
Figure 2: Volumetric material loss measured for the five categories

169 The median volume of material loss of all taper surfaces was 1.20mm^3 (0-22.35). We
170 found that 63 implants had material loss measurements of less than 1mm^3 , with a
171 median of 0.65mm^3 (0-0.99); these were therefore categorised in the 'minimal
172 damage' group. The material loss of the minimal damage group was significantly less
173 than the early axisymmetric, late axisymmetric, asymmetric and coup-countercoup
174 groups which had median material loss volumes of 1.89mm^3 (1-6.52), 4.23mm^3 (1.09-

175 22.35), 3.43mm³ (1.04-17.03) and 2.16mm³ (1.07-4.43) respectively, Figure 2. There
176 were no other significant differences for taper material loss measurements.
