**The Influence of Stem Design and Fixation Methods  
on the Lifetime of Total Hip Replacement**

**A thesis submitted to the University of Huddersfield in accordance with  
the requirements for the degree of Doctor of Philosophy**

The main purpose of this thesis is to study fretting wear mechanisms at the polished femoral stem–bone cement interface.

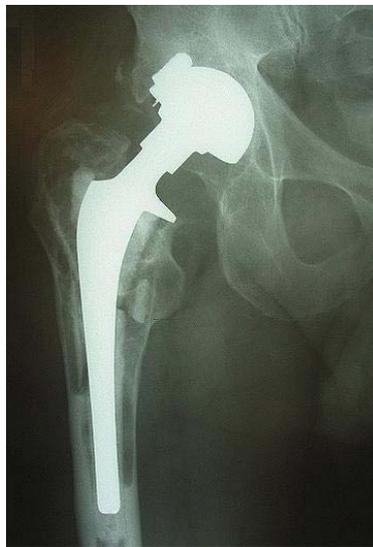
**Figure 1.3: Typical periprosthetic bone resorption**

Notwithstanding, it has been shown from autopsy retrieved hip prosthesis that, with regard to cemented THR, periprosthetic bone resorption acts as the primary reason for aseptic loosening, associated with debonding at the femoral stem–bone cement interface (Jasty *et al.* 1991, Mjoberg 1997, Maloney *et al.* 2002). Bone resorption can be mainly attributed to an immune system response to particulate debris generated by wear of the hip prosthesis, and also to stress shielding because of changed loading conditions at the bone stock after implantation of the hip prosthesis. As the particles are liberated from the implant, stimulated macrophages attempt to clear them, resulting in an inflammatory reaction. This leads to the production of foreign body giant cells that release chemical mediators, such as prostaglandin E<sub>2</sub>, cytokines interleukin–1 and interleukin–6. These chemical mediators activate osteoblasts which will absorb bone from around the prosthesis, figure 1.3.

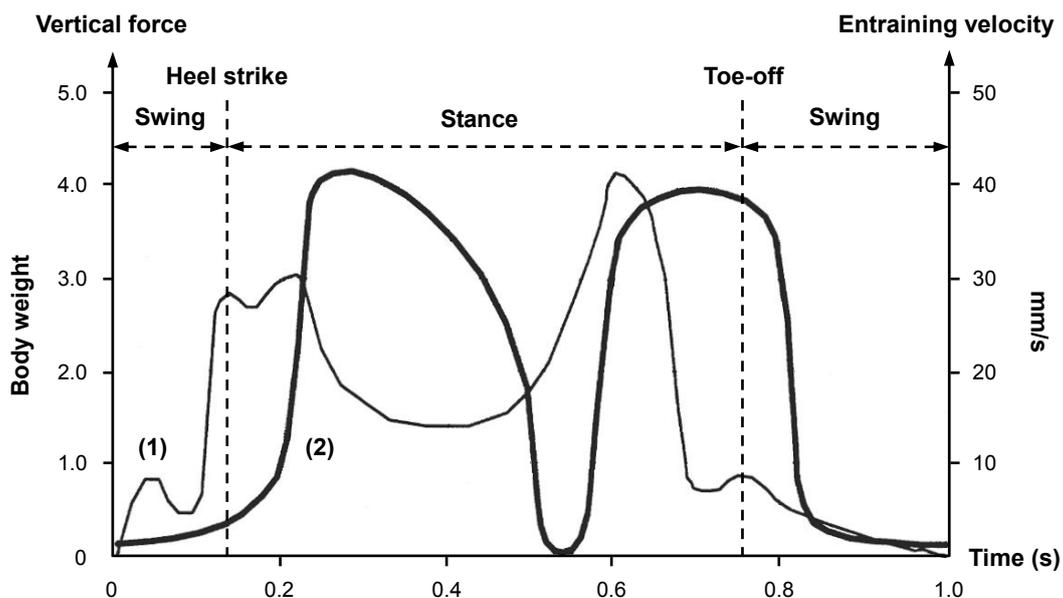
Figure 2.3: Hip joint reaction force in terms of body weight through one walking cycle (1) Vertical force (2) Entraining velocity (Paul 1967)

To date there have been a great deal of investigations performed concerning hip joint force. The first study of *in vivo* measurement of the force is considered to be the one carried out by Rydell in 1966. In that study he employed a metal prosthesis instrumented with strain gauges and collected data through subcutaneous leads. The peak force value was found to be about 3.3BW during walking for dynamic measurements. Another area of early research on the forces transmitted by hip joint in the human body completed by Paul in 1967 resulted in a curve that is still regarded as one of the standard loading configurations for modern hip simulators. He obtained a peak hip force value of around 3.9BW at a relatively low velocity in one walking cycle, figure 2.3. English and Kilvington in 1979 recorded similar values employing a telemetry system implanted in a hip prosthesis. More recently, Bergmann *et al.* (1993) measured *in vivo* hip forces in two patients, using a telemetering total hip prosthesis. They recorded that the peak force value during walking ranged between 2.8BW and 4.8BW, and it was as high as 5.5BW when jogging and 8.7BW when stumbling. This data is summarised in table 2.2.

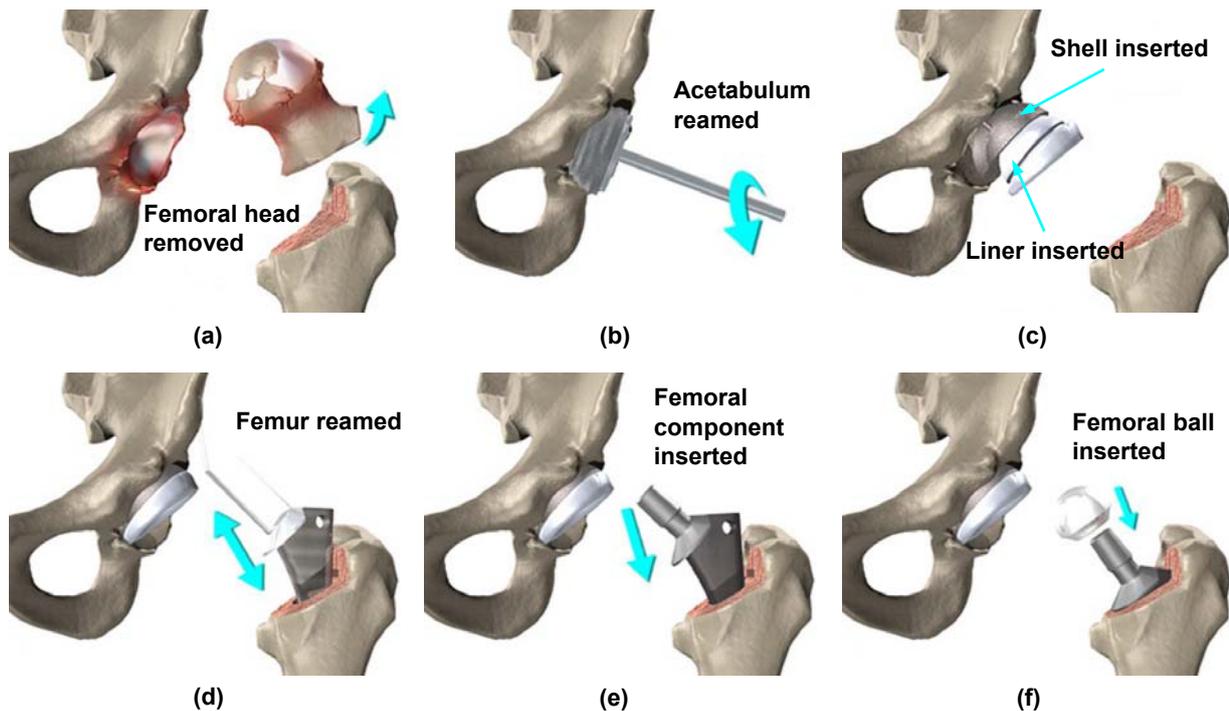
**Figure 2.4: Typical procedures of total hip replacement**

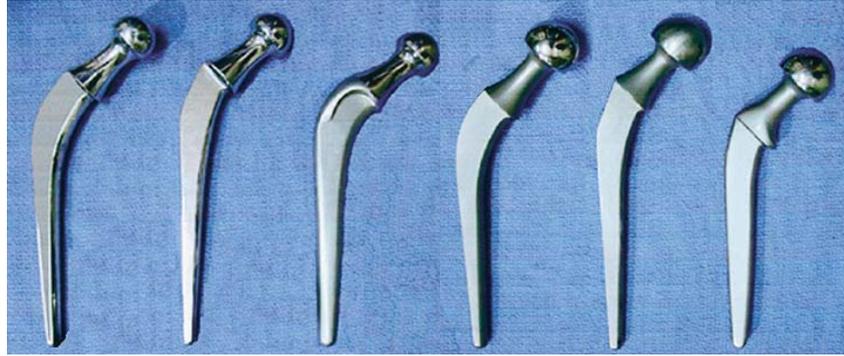
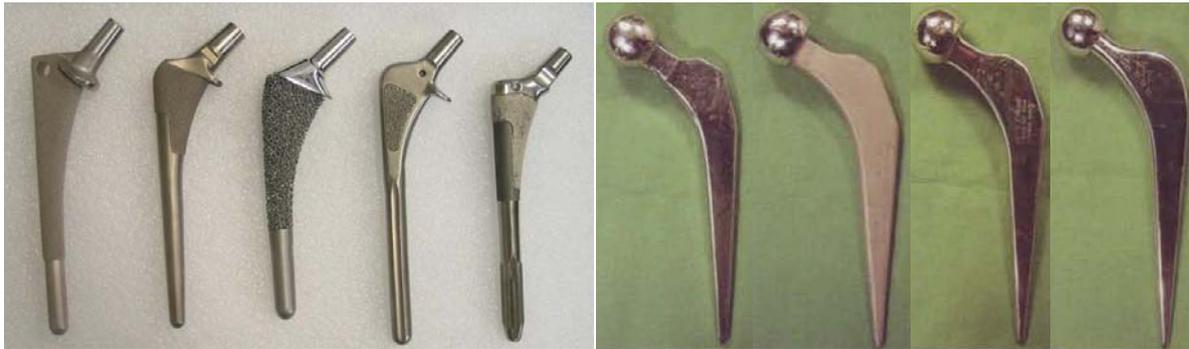
**Figure 2.5: Different designs of femoral implants**

Since the introduction of cemented THR in the 1960s by Charnley using an original Charnley femoral stem, great changes have occurred to this design, with Elite Plus (DePuy International Ltd., Leeds, UK) being the fifth generation. Evolvments happen not only to one single stem design, but also with the emergence of more and more diverse types of femoral stems, figure 2.5. Hip prosthesis technology has been continuously changing, with new designs and methodologies being introduced. For example, in 1995 there were more than 62 hip prostheses available on the market for the surgeons to choose from, which were provided by 19 different companies (Murray *et al.* 1995).

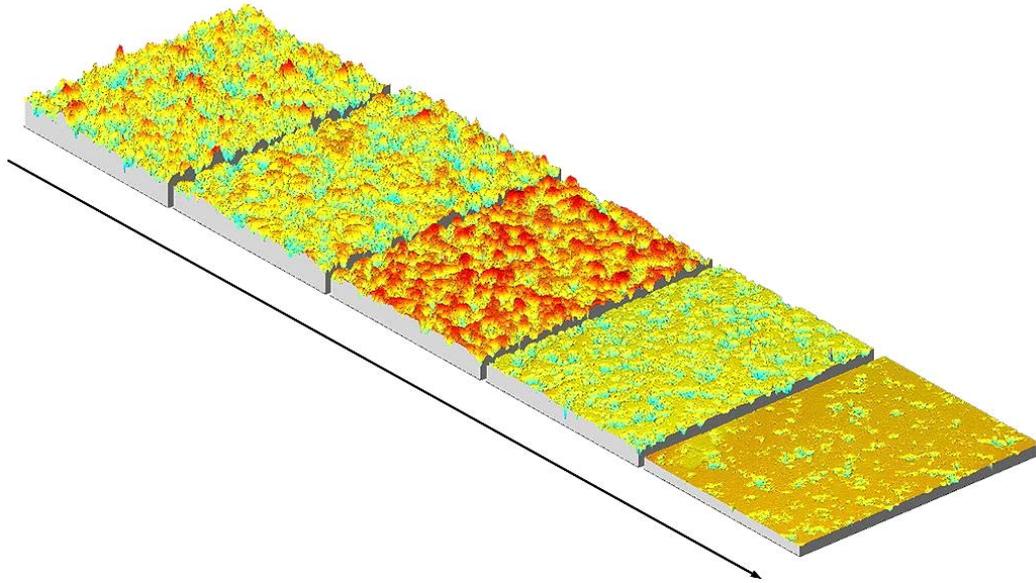
**Figure 2.16: The axonometric plots showing progressive stages of abrasive wear on an Exeter matt-surfaced stem, the asperities present on the unworn surface are removed during the wear process (Brown 2006)**

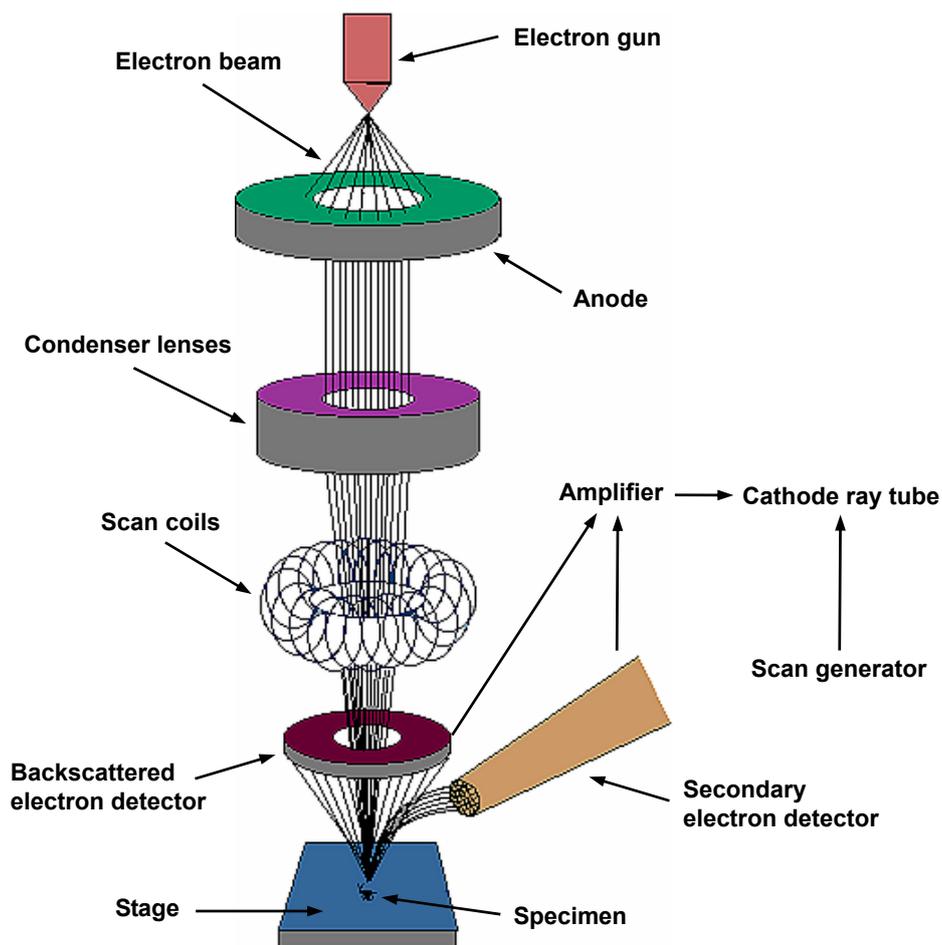
Figure 3.6: The schematic diagram showing the main components of a scanning electron microscope

Due to its unparalleled resolution, SEM is a premiere instrument to study the surface, near surface, and the microstructure of bulk specimens. Since it was invented in the early 1950s, SEM has developed extensive areas of application in both the medical sciences and the physical sciences. It utilises a fine beam of electrons passing through a vacuum to scan the surface of a sample and to build a topographical image, figure 3.6. Basically, the electron beam produced by an electron gun is accelerated to an energy of between 1keV and 30keV. It is then demagnified by a combination of condenser lenses and apertures until, as it hits the sample, it may have a diameter of around 2–10nm. When the energetically-focused electron beam bombard the sample, the interaction between them generates a variety of signals, including secondary electrons, backscattered electrons, X-rays, and transmitted electrons that are given off from each point of the surface, figure 3.7. The position of the electron beam is controlled by scan coils which allow the beam to be rastered over the surface of the sample. This enables information about a defined area on the sample to be collected, whilst certain detectors will view the electron signals. At the same time, the spot of a cathode ray tube (CRT) is scanned across the screen in a rectangular set of straight lines known as a raster, and the brightness of the spot is modulated by the amplified current which is translated through a photomultiplier tube. Gradually the image of the sample is created on the CRT screen.

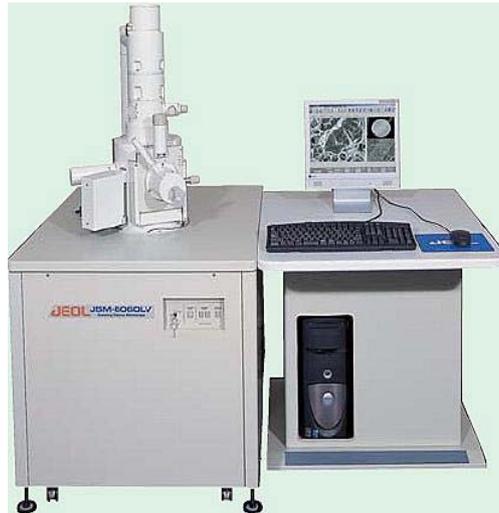
**Figure 3.8: The scanning electron microscope—JEOL JSM–6060**

JEOL JSM-6060 (Oxford Instruments, Abingdon, UK) has been employed in this present research, figure 3.8. It is a conventional SEM with high performance and a low cost. The intuitive computer interface and standard automated features, such as auto-focus, auto-gun alignment, and automatic contrast and brightness, allow the instrument to be very easily operated. In addition, the specimen chamber can accommodate a sample of up to 32mm in diameter. Its typical specifications are summarised in table 3.3.

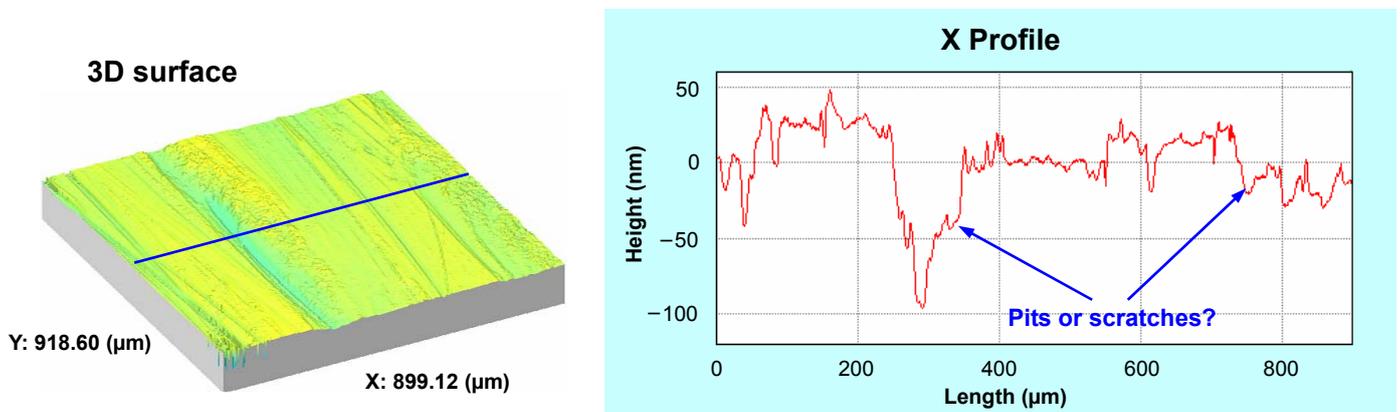
Figure 3.10: A 2D trace taken from an areal surface measurement shows the ambiguity of 2D surface characterisation

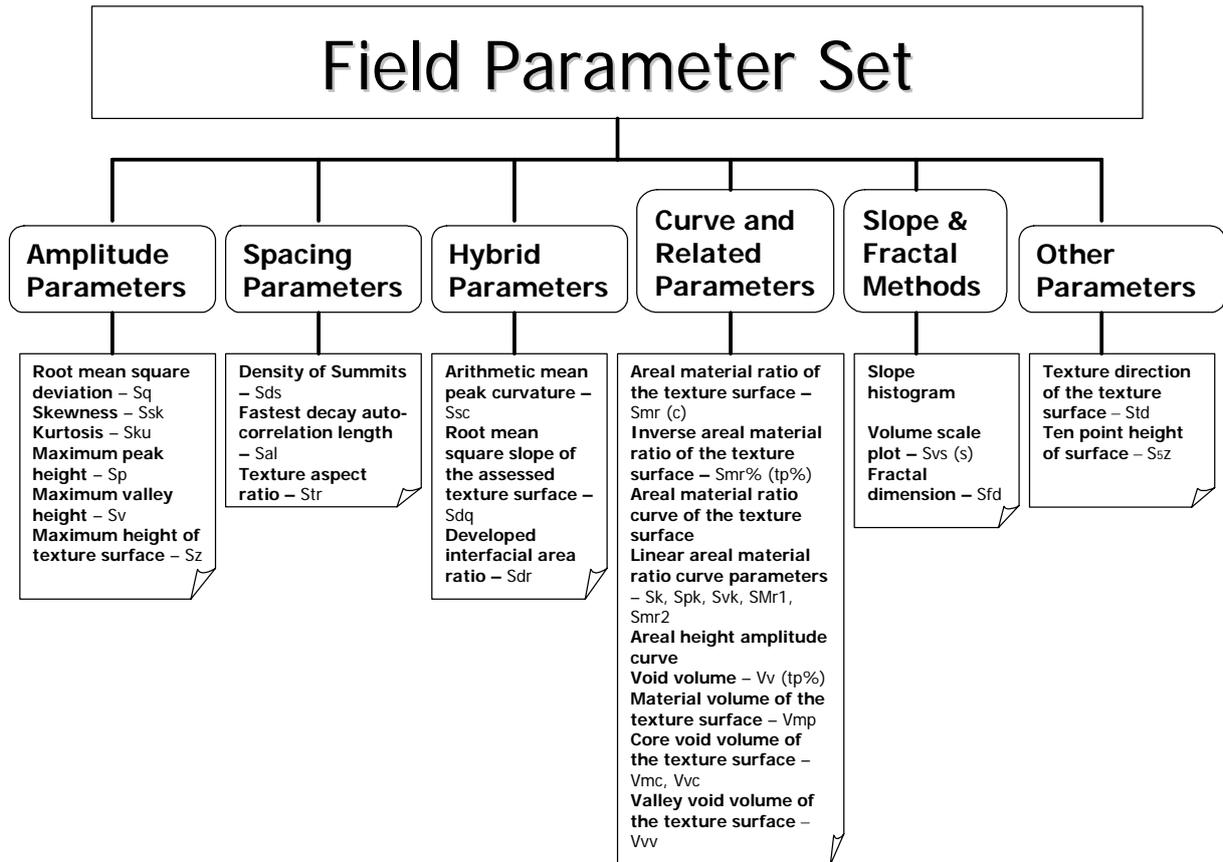
**Figure 3.11: The 3D field parameter set to describe functional performance of a surface**

The emergence of the 3D surface characterisation is largely due to the limitations of 2D surface analysis, and also as a result of the development of modern powerful computers. Comprehensive research has been initiated with the aim of developing a new fundamental, international standard for 3D surface measurement. A European Union (EU) funded project named “Surfstand” based at the University of Huddersfield sought to develop a suite of parameters that could more effectively characterise a surface. Through standardising filtering and characterisation techniques, a 3D field parameter set was devised, covering the majority of functional aspects of a surface and allowing a holistic picture of the surface to be numerically determined for comparison, figure 3.11. A detailed description of the parameters will be given for those that are utilised in further research.

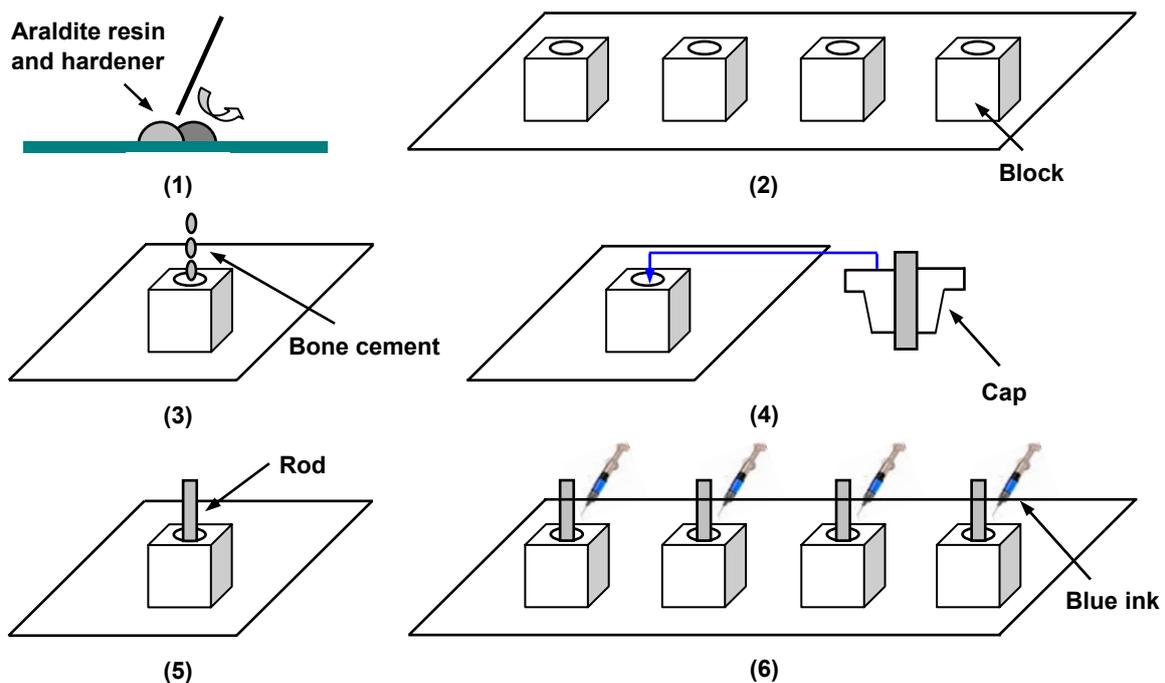
Figure 4.1: The schematic diagram to describe the steps to prepare the experimental specimen

Four stainless steel rods with polished, glass bead-blasted, shot-blasted, and grit-blasted surface finishes were manufactured. The polishing and blasting media will be discussed in detail later in section 4.3.2 and 4.4.2 respectively. Additionally, four steel blocks with a through hole in the middle and four steel caps to ensure centralisation of the rods in the steel blocks were fabricated. The procedure to prepare the experimental specimens was explained below: (1) An adhesive was obtained by thoroughly mixing Araldite resin and Araldite hardener into a compound. (2) The four steel blocks were stabilised by this adhesive upon curing on a clean glass plate. (3) Simplex P bone cement was mixed by hand and injected into the steel blocks to a predetermined height. (4) The cylindrical rods with the custom-made steel caps around were implanted to the steel blocks and the bone cement cured *in situ*. (5) The caps were gently removed from the rods and a cement cavity was produced. (6) Blue ink was injected into the cavity and the specimens were fixated on the glass plate again by the adhesive. A schematic diagram is given to clearly describe these steps, figure 4.1, and the experimental specimen is shown in figure 4.2.

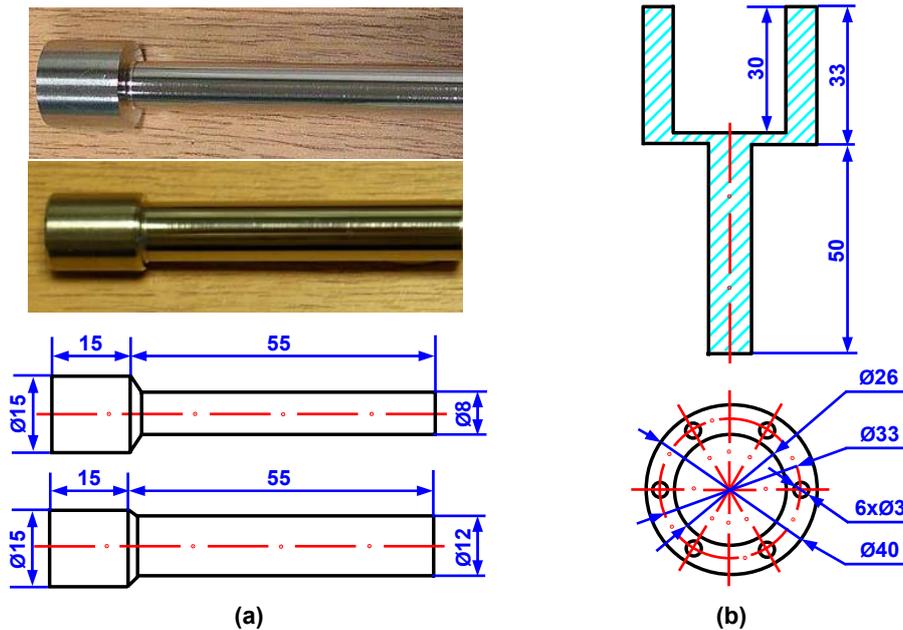
Figure 4.4: (a) Dimension of the stainless steel rods (b) Design of the steel holder

corresponding to the two kinds of stainless steel rods (diameters 12mm and 8mm respectively), figure 4.4 (b). Before cementing, the stainless steel rod was cleaned with alcohol and then fixated using a milling machine chuck, which could ensure accurate axial alignment of the rod within the cement mantle. All the bone cements were hand mixed at room temperature, according to the manufactures' instructions. A metallic ring was connected to the cylindrical holder by screws in order to apply pressure on the cement during the polymerisation process and to make sure that the interfacial failure will not occur between the bone cement and the cylindrical holder. Following polymerisation, the stainless steel rod was held into position vertically in a blind hole in the cement mantle, figure 4.5.

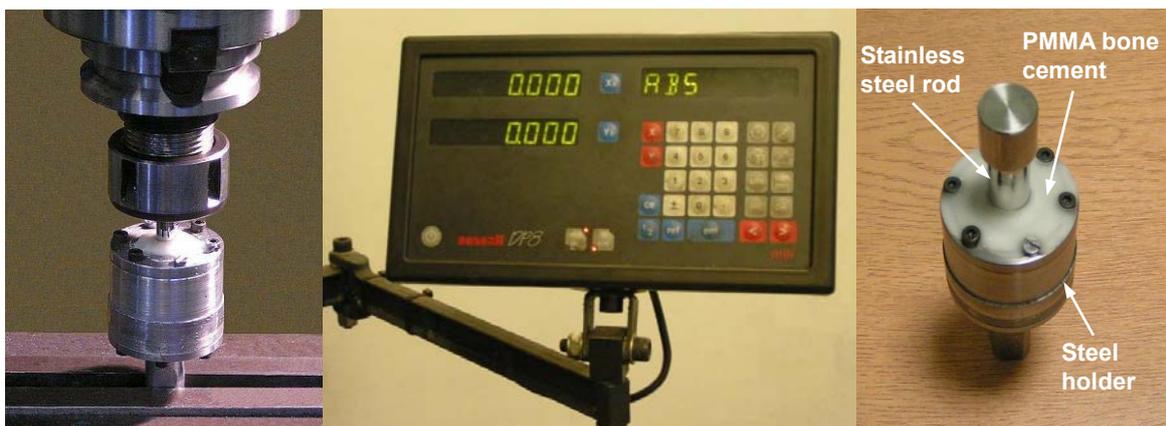
Figure 4.5: Preparation of specimen using a milling machine chuck to ensure axial positioning

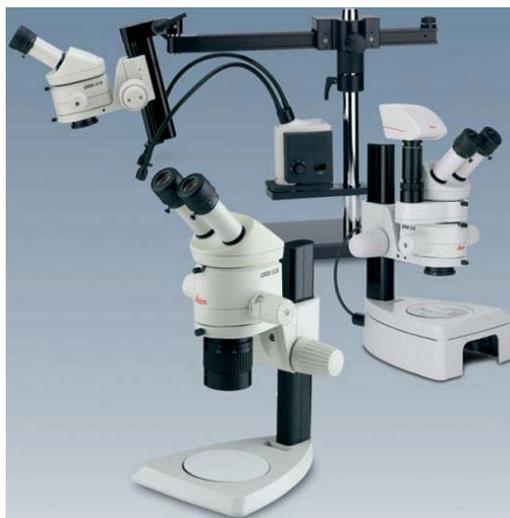
**Figure 4.7: The Leica optical stereomicroscope**

Following each pull out test, the stainless steel rod was re-polished to ensure identical surface roughness grade, and the cement was cautiously extracted from the mild steel holder and cut longitudinally into two equal parts. The inner surface of the cement was cleaned by alcohol and stained using red dye to facilitate observation of porosity with a Leica optical stereomicroscope (MZ6, Leica Microsystems Ltd., Wetzlar, Germany), figure 4.7. Totally 10 images were taken arbitrarily on the cement surface at x10 magnification, with each image area being  $4\text{mm}^2$ . All the images were processed using Matlab software 6.5 and the micropores were recognised based on grey scale threshold, figure 4.8. For each image, the porosity was determined by the ratio of the area of micropores to the area of whole cement surface. The number of micropores on the image was counted and the mean area of one micropore was determined. Subsequently, the micropore size was calculated as the diameter of one micropore, assuming it to be a perfect circle. Finally, the mean value of porosity and micropore size were obtained on the basis of the 10 images for each test.

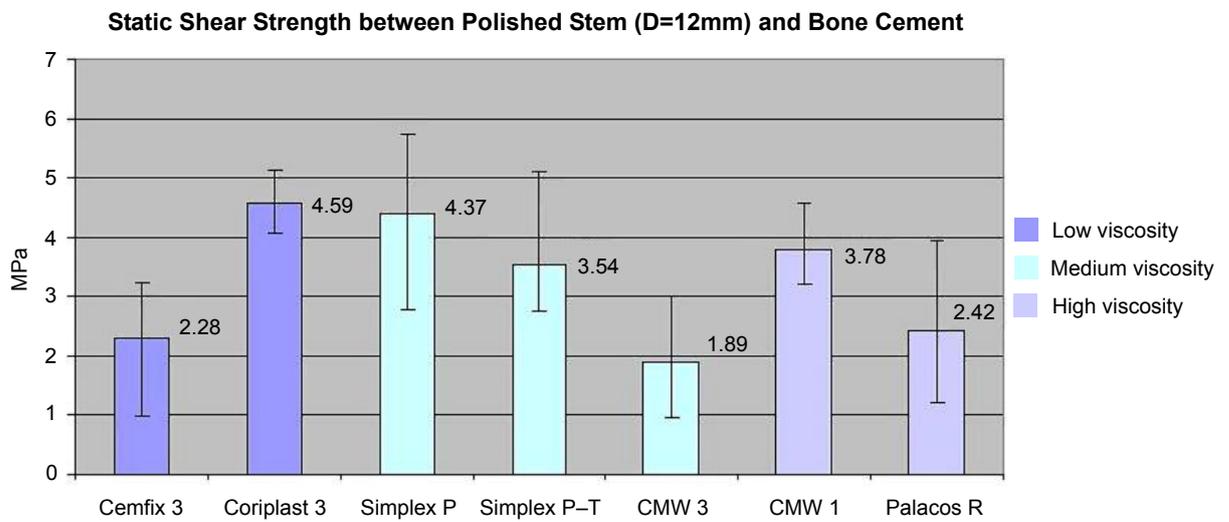
**Figure 4.10: Static shear strength for the 12mm diameter stainless steel rod**

The static shear strength, interfacial porosity, and micropore size (mean value and range) for each cement brand and each cement mantle thickness are shown in figures 4.10–4.15. It is evident to see from these figures that there is no direct relationship between the static shear strength and cement viscosity. It is, however, more dependent on cement brand, i.e. cement composition. In addition, the interfacial porosity shows much lower values for the cements with low viscosity possibly because of greater facilitation for the air bubbles to escape from the bulk matrix, but there seems to be no significant difference in terms of interfacial porosity for the cements with medium and high viscosity. The micropores size also appears to be determined by cement brand.

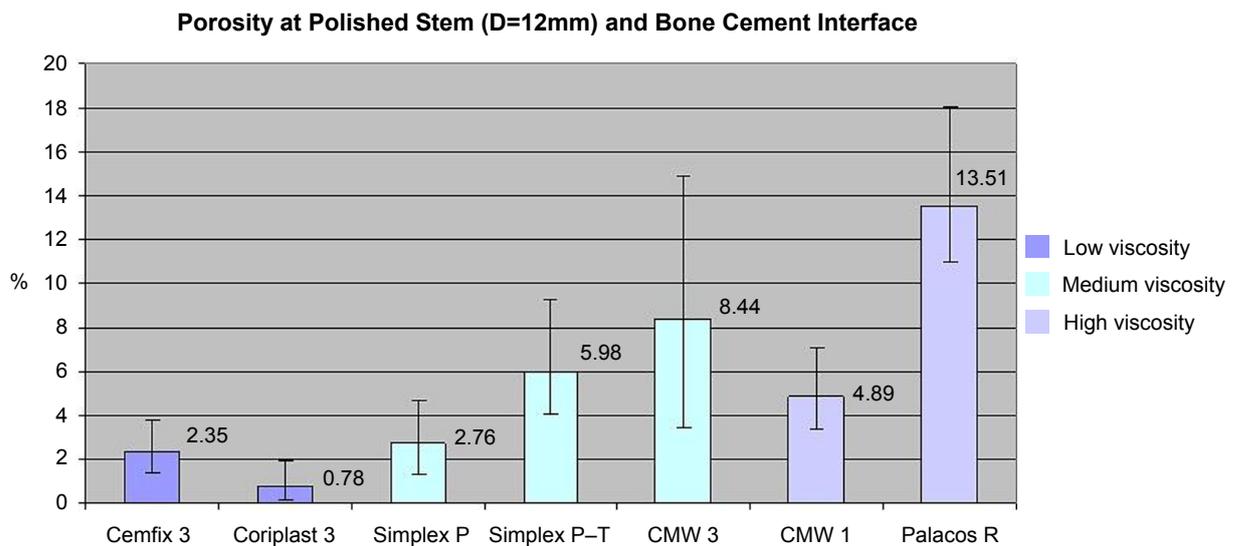
**Figure 4.11: Interfacial porosity for the 12mm diameter stainless steel rod**

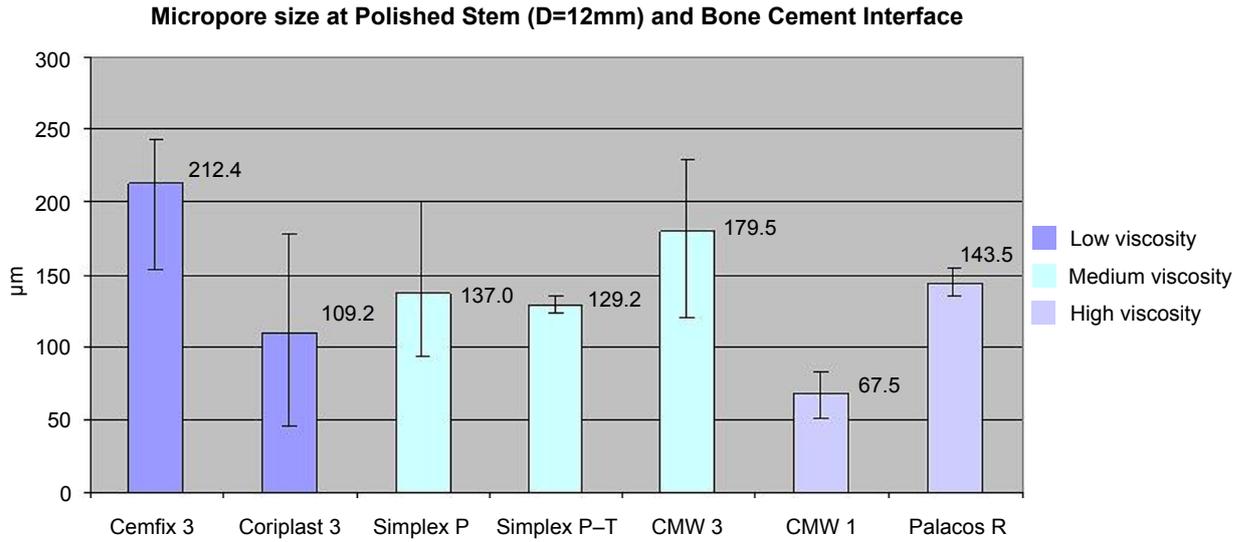
**Figure 4.12: Micropore size at the interface for the 12mm diameter stainless steel rod**

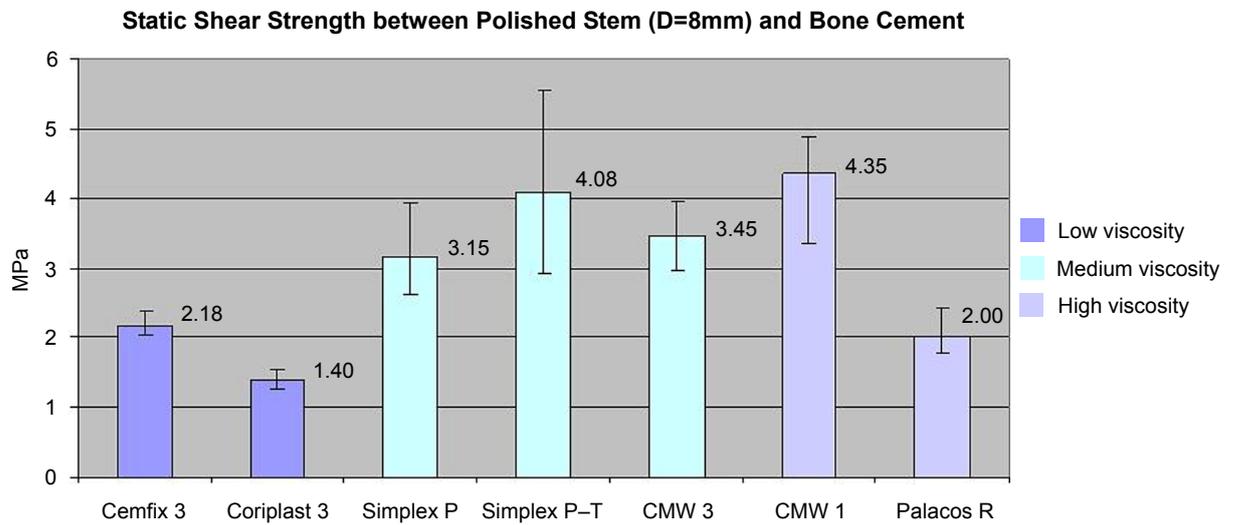
**Figure 4.13: Static shear strength for the 8mm diameter stainless steel rod**

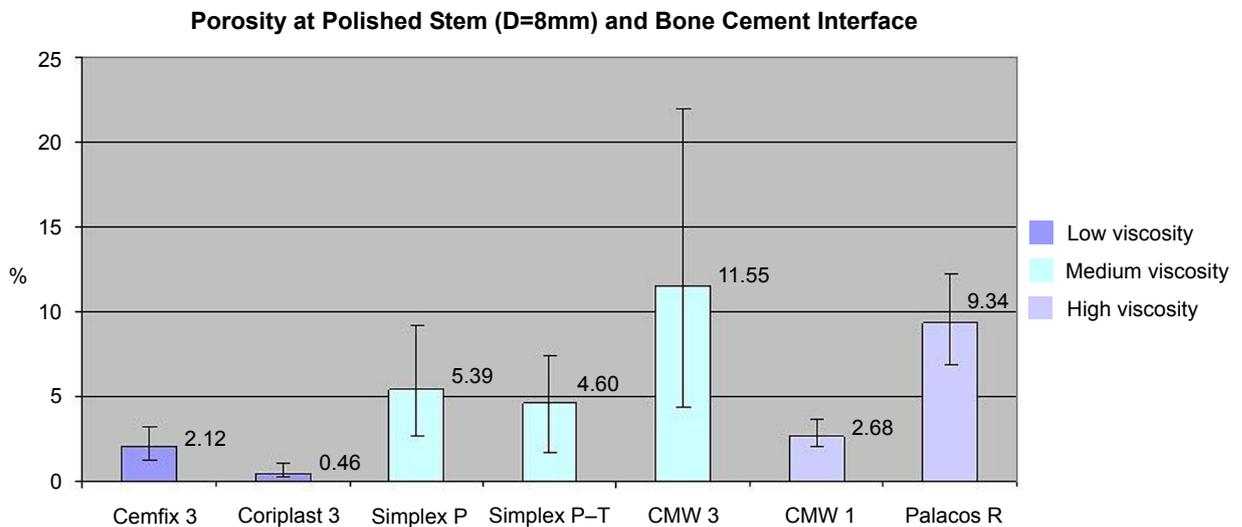
**Figure 4.14: Interfacial porosity for the 8mm diameter stainless steel rod**

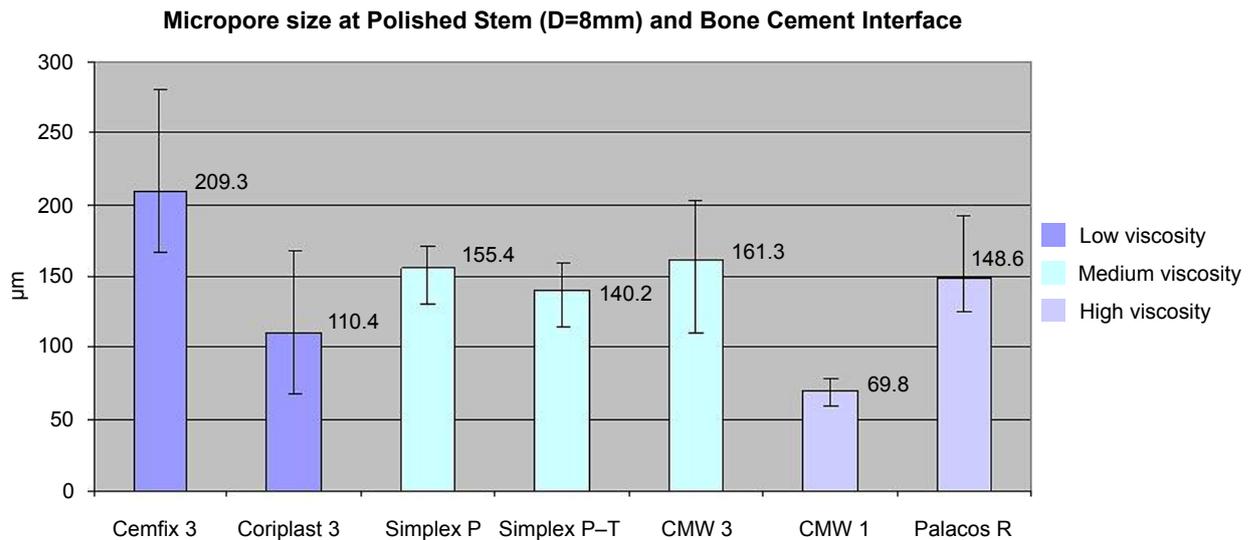
**Figure 4.15: Micropore size at the interface for the 8mm diameter stainless steel rod**

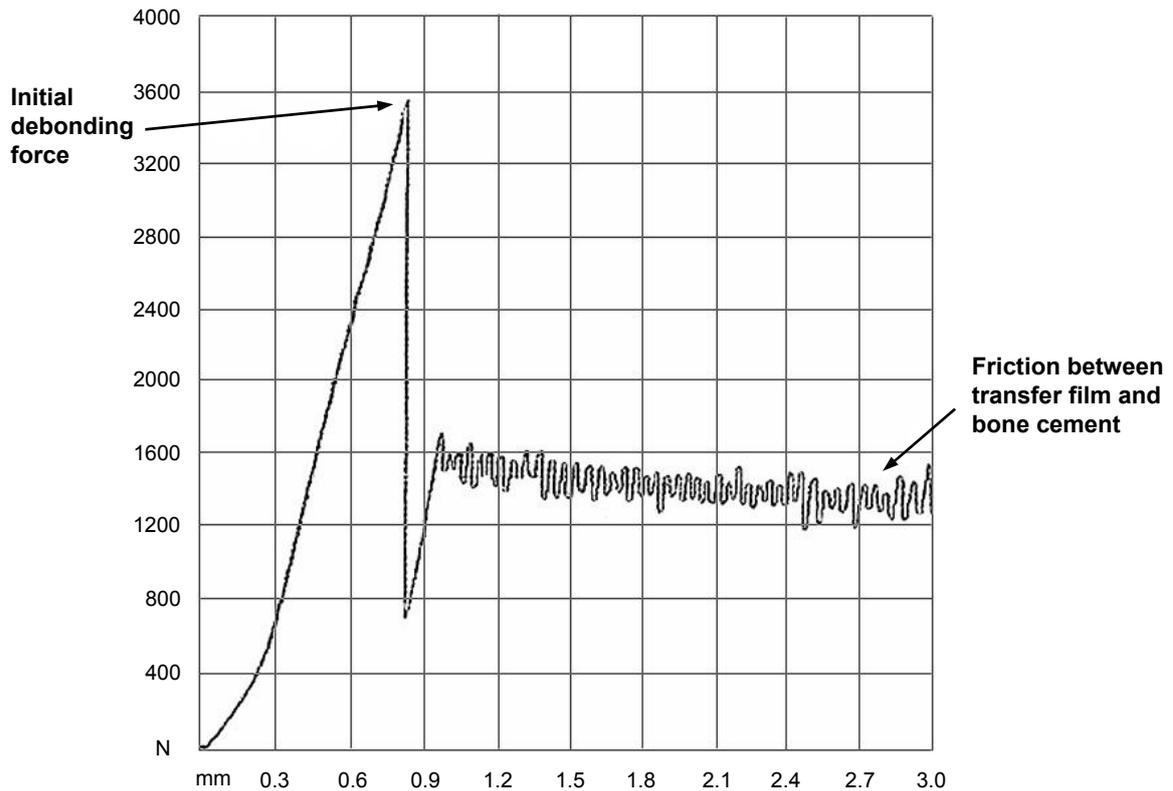
**Figure 4.16: A typical load–displacement plot for the pull out test**

A representative test result obtained from the Hounsfield Test Machine H20K–W displaying the load–displacement plot is exhibited in figure 4.16. The plot shows an initial linear increase of load with incremental displacement until a peak force value is reached. This point is defined as the initial debonding force. The force then drops to a lower value before cycling around 1.4kN until the rod is fully pulled out from the cement mantle where the force returns to zero.

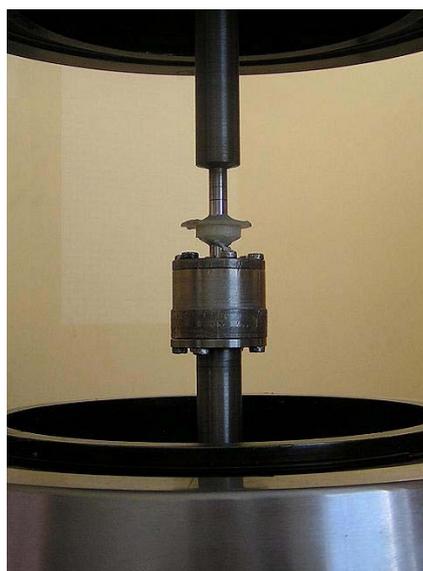
**(a)**

**Figure 4.17: (a) Pull out test performed on Instron Test Machine (b) Transfer films on the rod surface**

The cyclical force was considered to be unusual and an additional test using CMW 3 bone cement was repeated on an Instron Test Machine 1273 (Instron Ltd., High Wycombe, UK) in order to discount machine error. The experimental conditions were the same as previous pull out tests, figure 4.17 (a). This test again showed a similar result, i.e. an initial high debonding force followed by a cyclical force around a significantly lower value. Large areas of bone cement transfer films were detected on the rod surface, which were considered to be involved in the cyclical force reading, figure 4.17 (b).

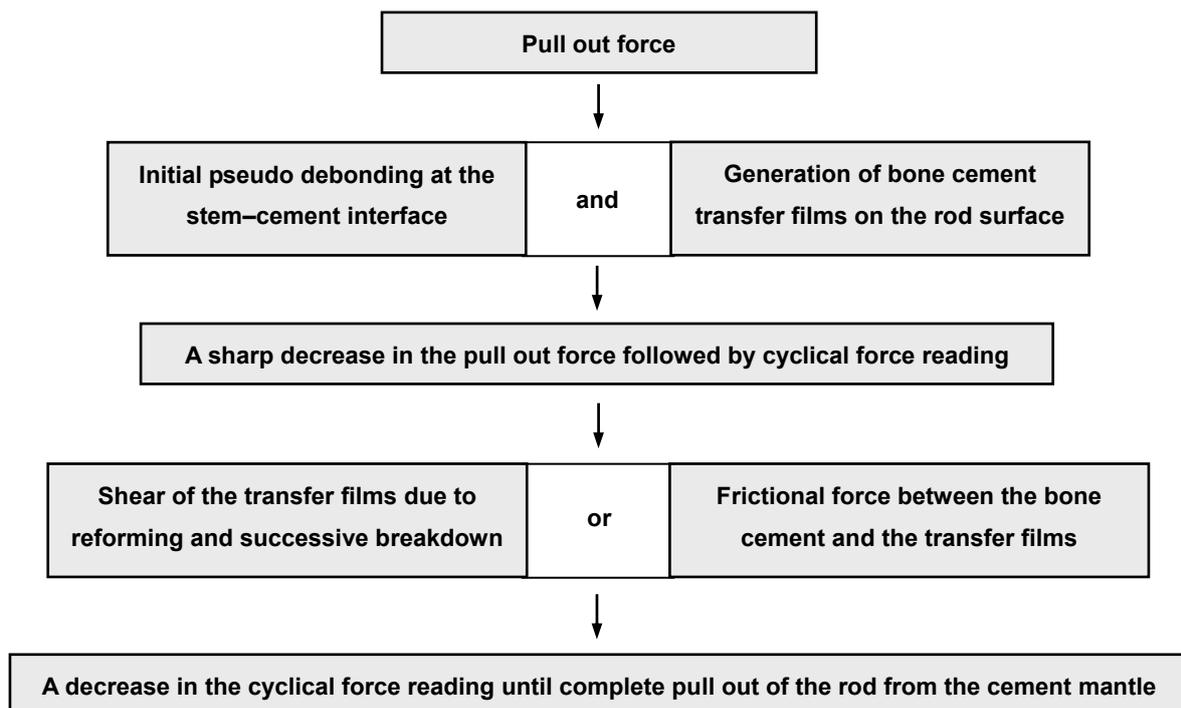
**Figure 4.19: The flow diagram showing the pull out process of the rod from the cement mantle**

polymer and this layer of similar material, irrespective of the composition of the substrate. On further sliding the polymer may continue to wear by adding new materials to the transfer films, since the interfacial bond to the counterface is often stronger than that within the bulk of the polymer itself. However, these transfer films whose thickness is of the order of several microns are usually removed subsequently as wear debris. This wear mechanism is also elucidated by Ludema (1996). Based on this theory, it was assumed that in the present study the frictional force build up began with the “clean” rod trying to move against the cement surface. This interface was strong and the force increased until interfacial failure occurred within the cement mantle, thus giving a pseudo debonding. Following this, transfer films formed and bone cement flowed over the cement transfer films, causing a drop in the measured force. It was further considered that the cyclical force was the result of subsequent breakdown of the interface due to shear of the transfer films followed by reforming and successive breakdown of new transfer films or frictional force between the bone cement and the transfer films. However, the total contact area between the rod and the bone cement was diminished gradually, resulting in a decrease of the cyclical force until the rod was completely pulled out. The failure process was accompanied by an audible sound. A flow diagram was given to describe the pull out process of the polished stainless steel rods from the cement mantle, figure 4.19.

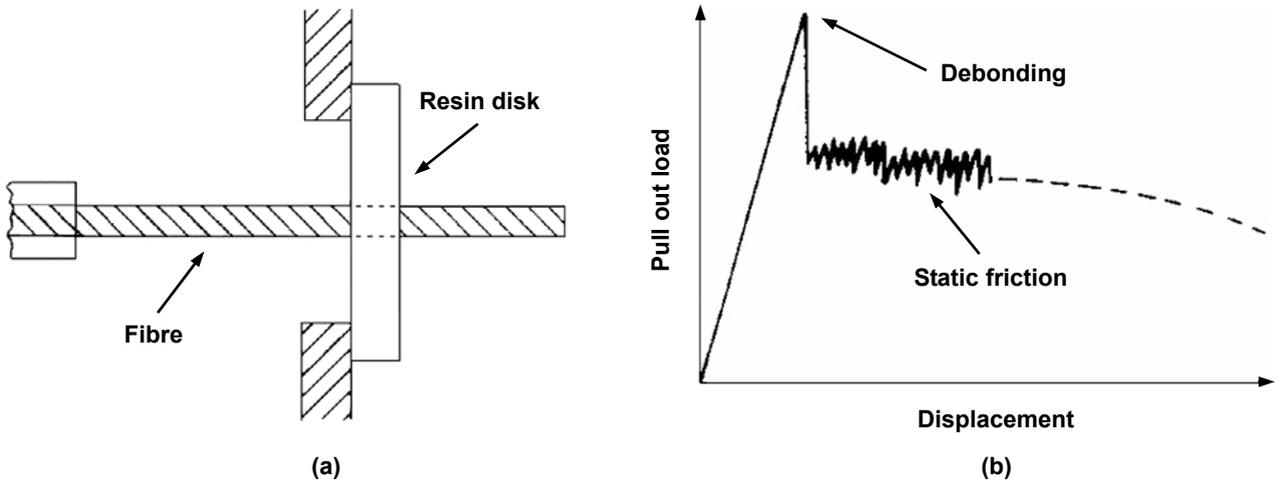
Figure 4.20: Pull out test of a cylindrical fibre from a resin disk (a) The fibre embedded in the resin disk (b) Typical load–displacement curve

A very similar load–displacement plot was noted by Hull (1981) during pull out of a cylindrical fibre from a resin disk, in which the cyclical element of the debonding curve was attributed to frictional forces caused by residual stresses and differential thermal contraction, figure 4.20. The evidence of the transfer films was also detectable on the stainless steel rod surface tested on the Hounsfield Test Machine. Figure 4.21 shows the 3D and 2D topography of the cement transfer films, measured by the Talysurf CCI interferometer at x50 magnification. The height of these transfer films was calculated to be about 10µm, using a Surfstand software V3.3.

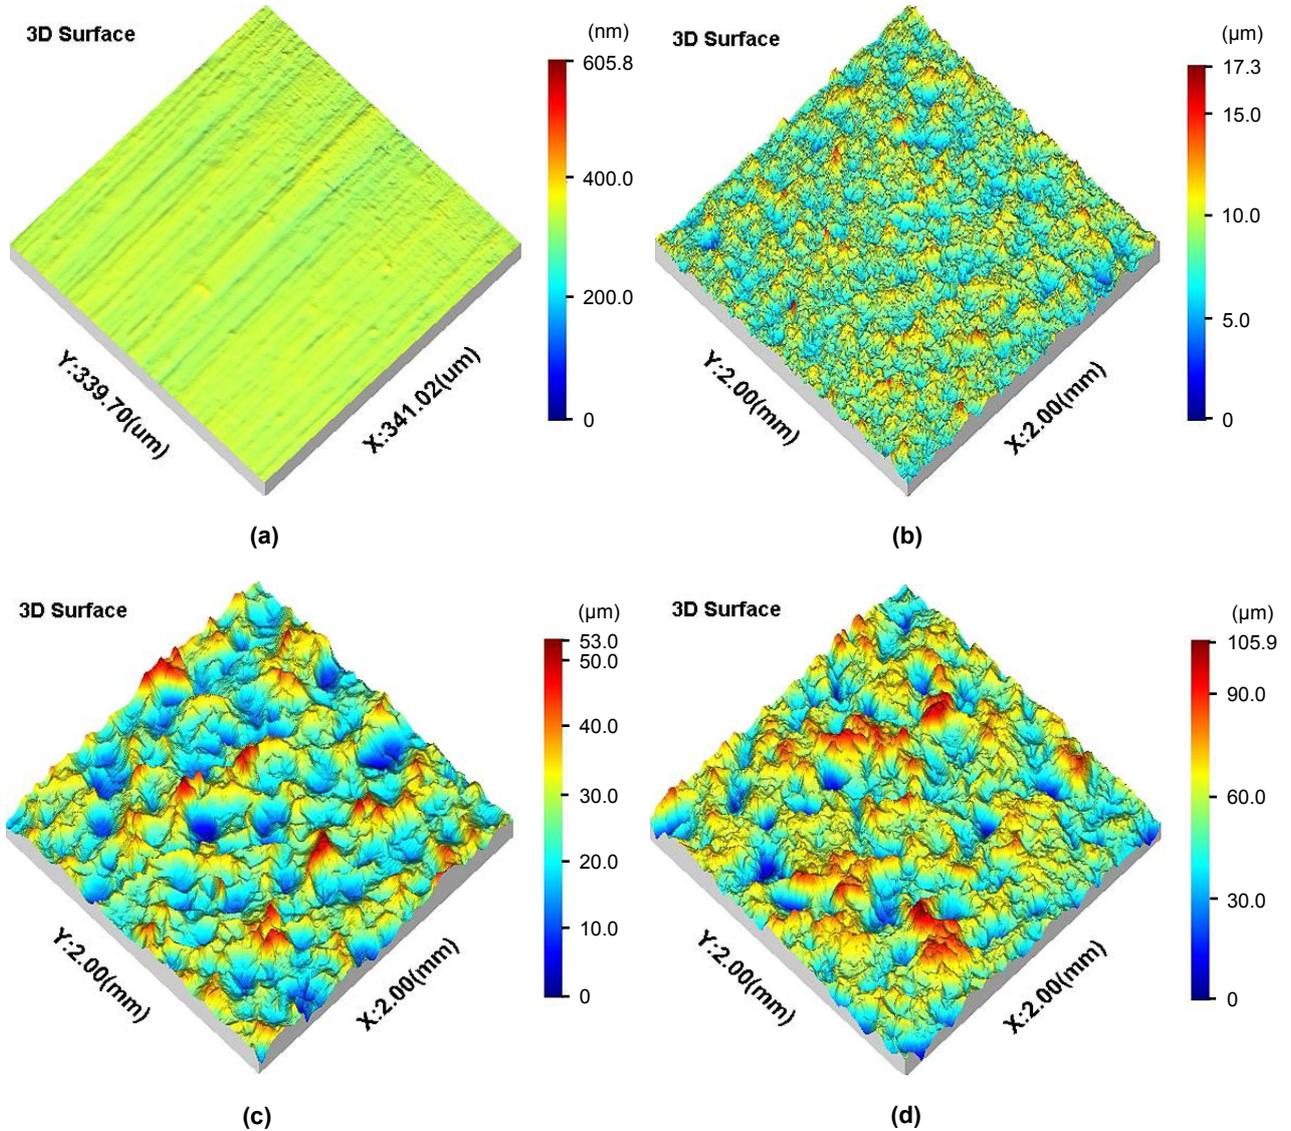
Figure 4.22: 3D surface topography of stainless steel rods before pull out test (a) Polished (b) Glass bead-blasted (c) Shot-blasted (d) Grit-blasted

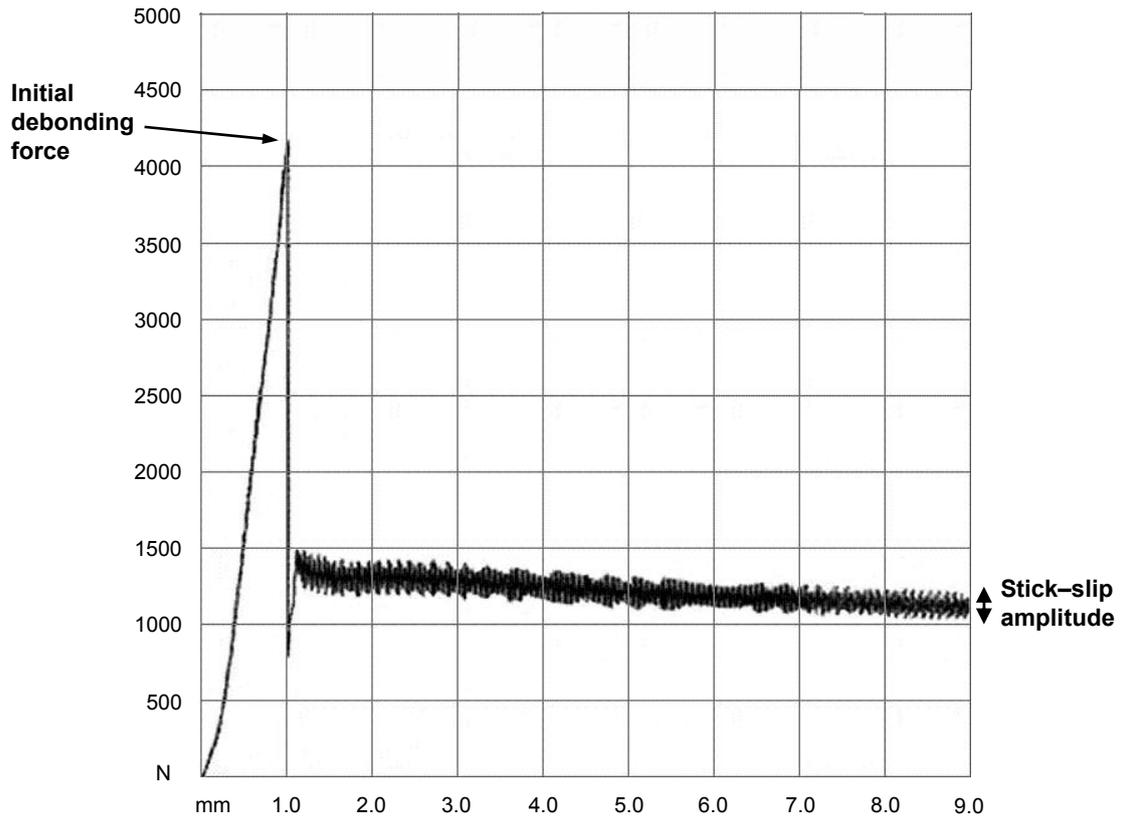
Figure 4.24: Typical load–displacement plot for pull out test of glass bead-blasted stainless steel rods

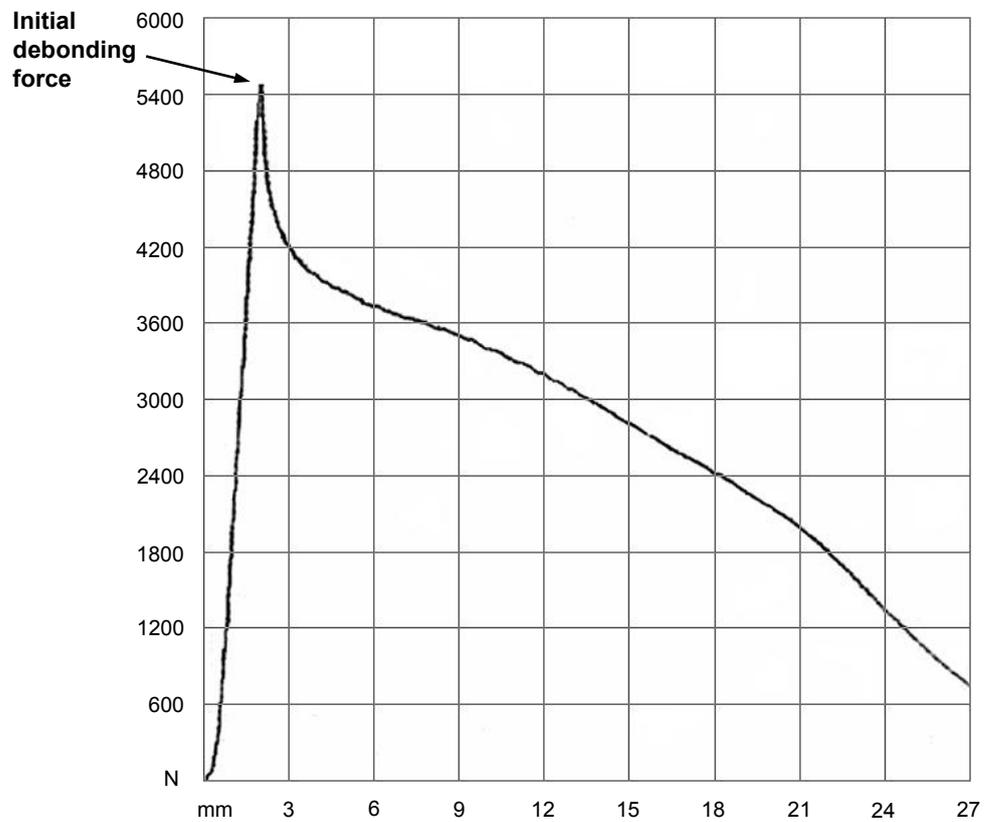
Figure 4.25: Typical load–displacement plot for pull out test of shot-blasted stainless steel rods
