**The Influence of Stem Design and Fixation Methods  
on the Lifetime of Total Hip Replacement**

**A thesis submitted to the University of Huddersfield in accordance with  
the requirements for the degree of Doctor of Philosophy**

The main purpose of this thesis is to study fretting wear mechanisms at the polished femoral stem–bone cement interface.

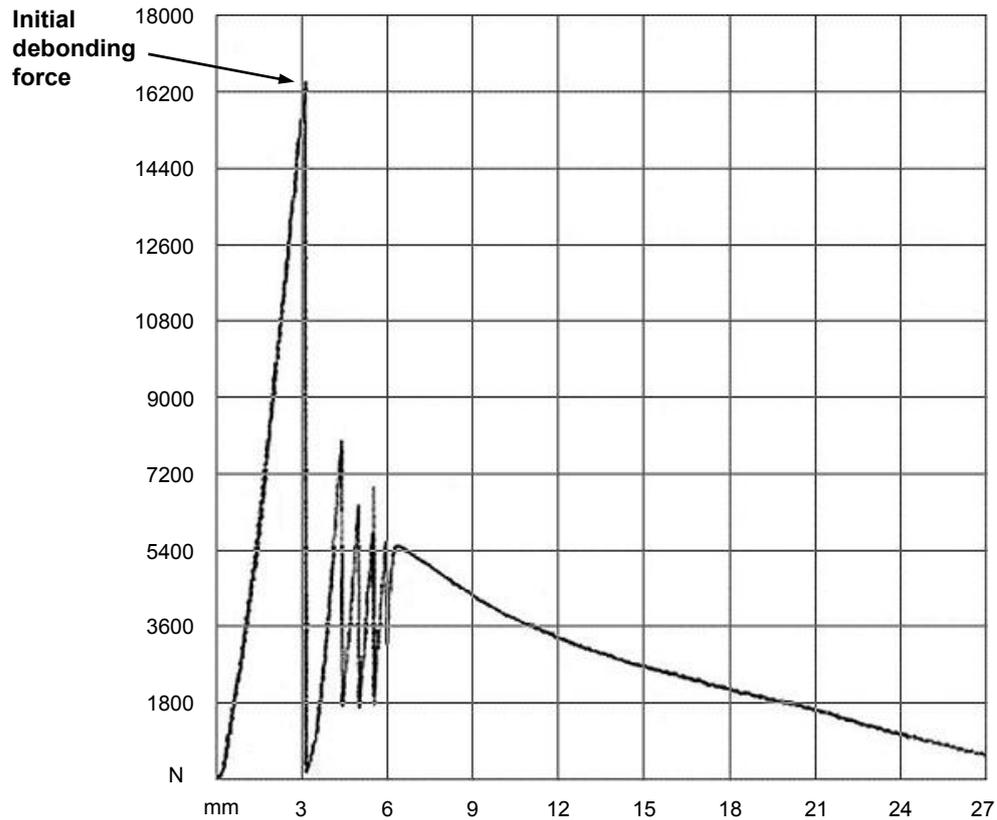
**Figure 4.26: Typical load–displacement plot for pull out test of grit-blasted stainless steel rods**

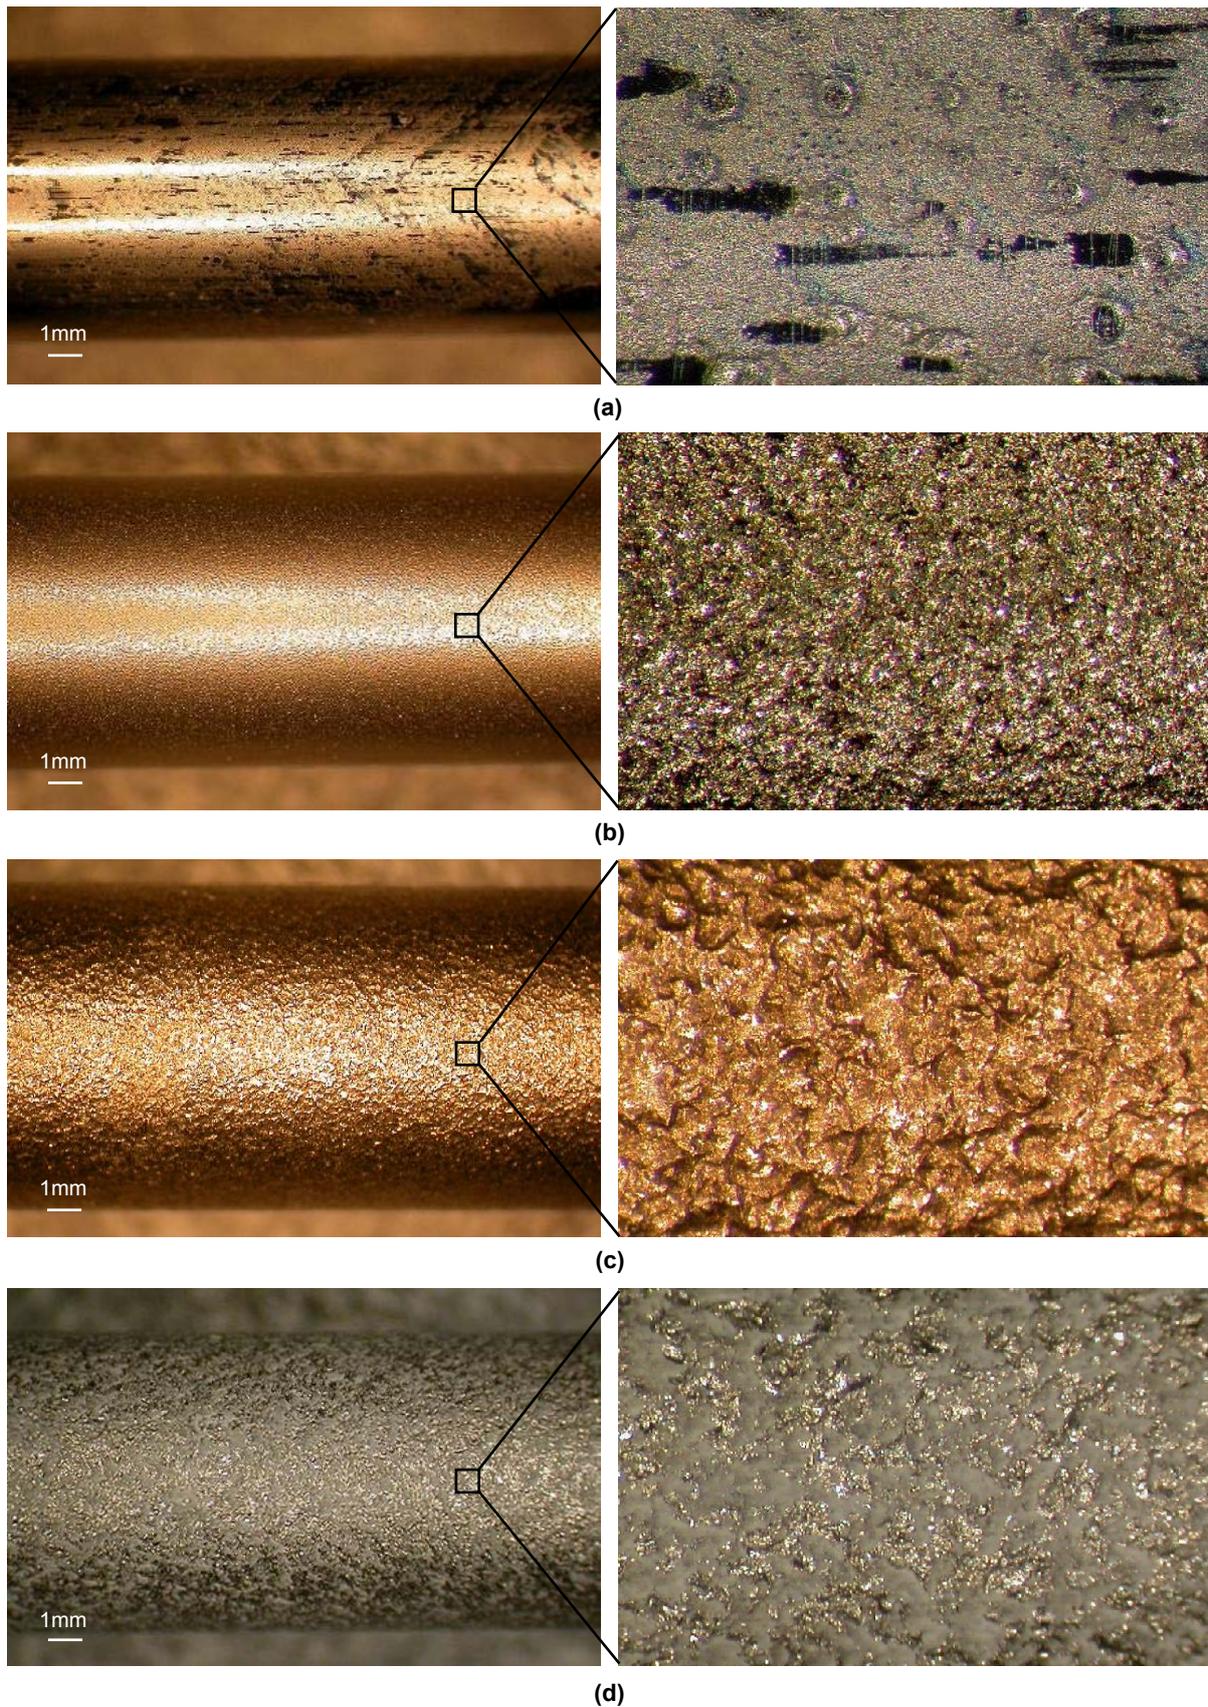
**Figure 4.27: Stainless steel rod surface after pull out test (a) Polished rod, the black substrate is the polished rod, and the lighter areas are the transfer films (b) Glass bead-blasted rod, no cement is present on the surface (c) Shot-blasted rod, no cement is present on the surface (d) Grit-blasted rod, the shiny substrate is the grit-blasted rod, and the grey covering is cement debris**

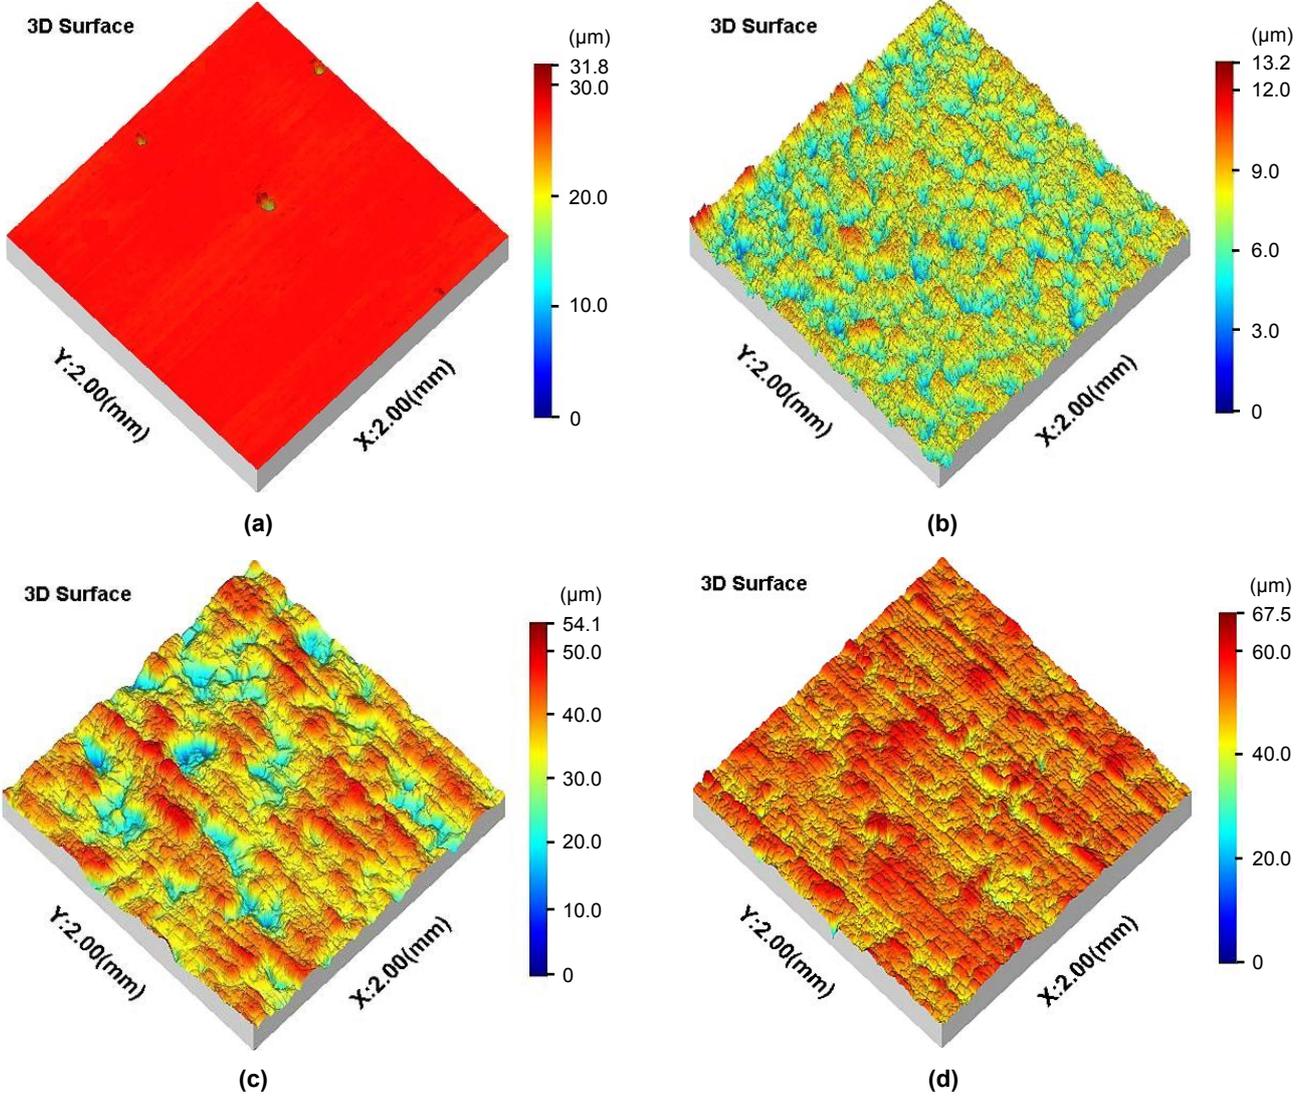
Figure 4.29: 3D surface topography of bone cement interfaced with stainless steel rods (a) Polished (b) Glass bead-blasted (c) Shot-blasted (d) Grit-blasted

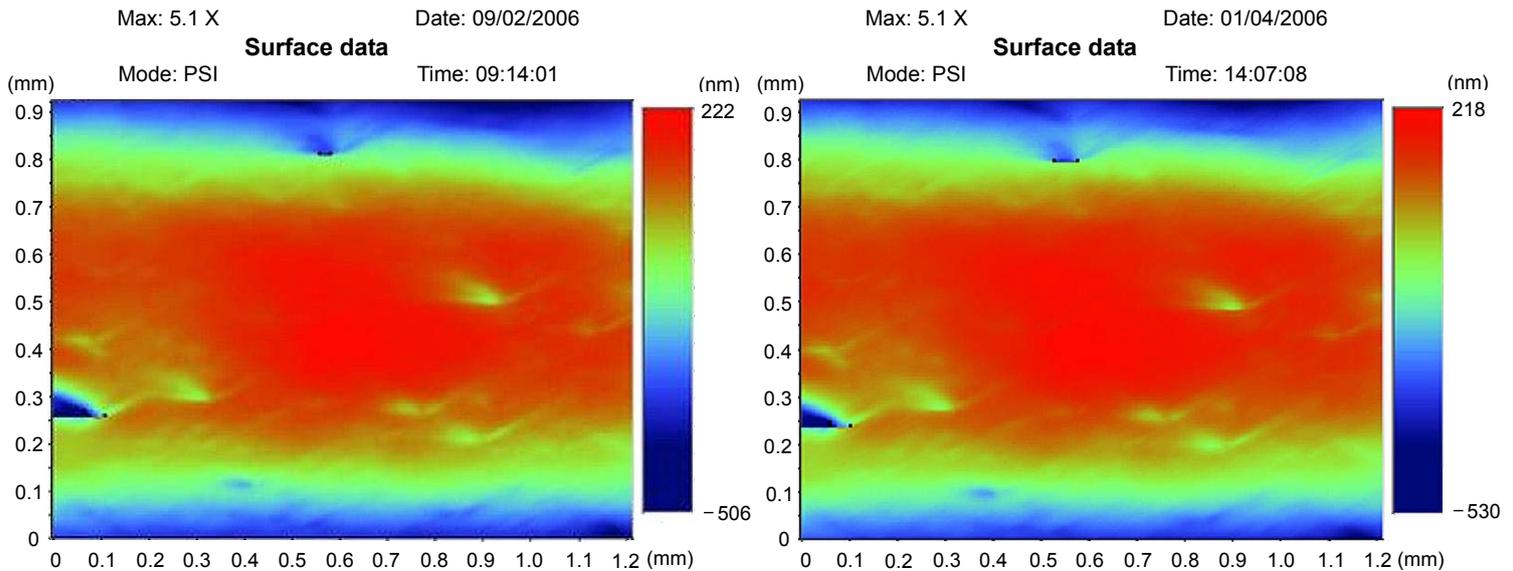
**Figure 5.5: Validation of the relocation system by two measurements taken at different time**

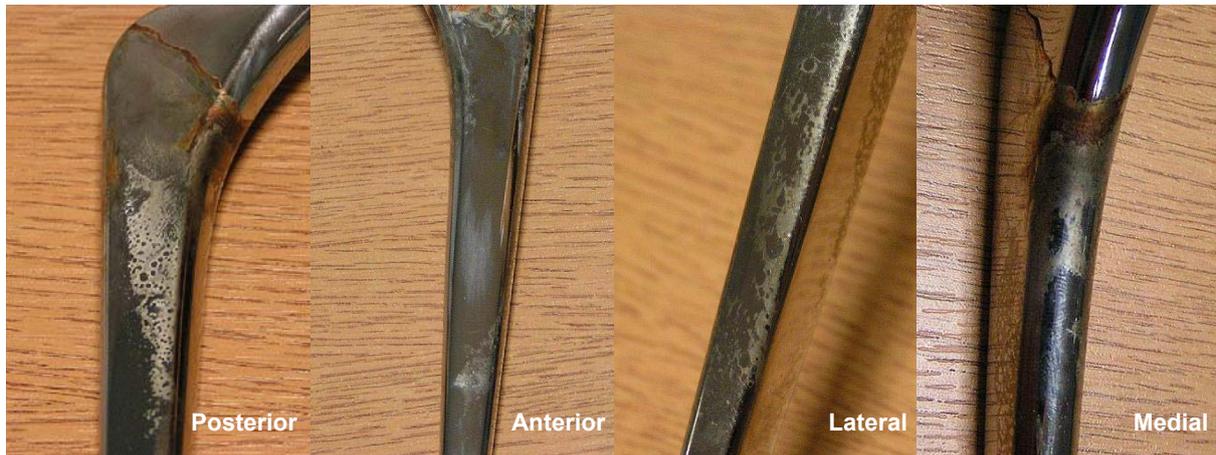
**Figure 5.6: Fretting wear generated on the femoral stem surface (Simulation I, use Simplex P cement)**

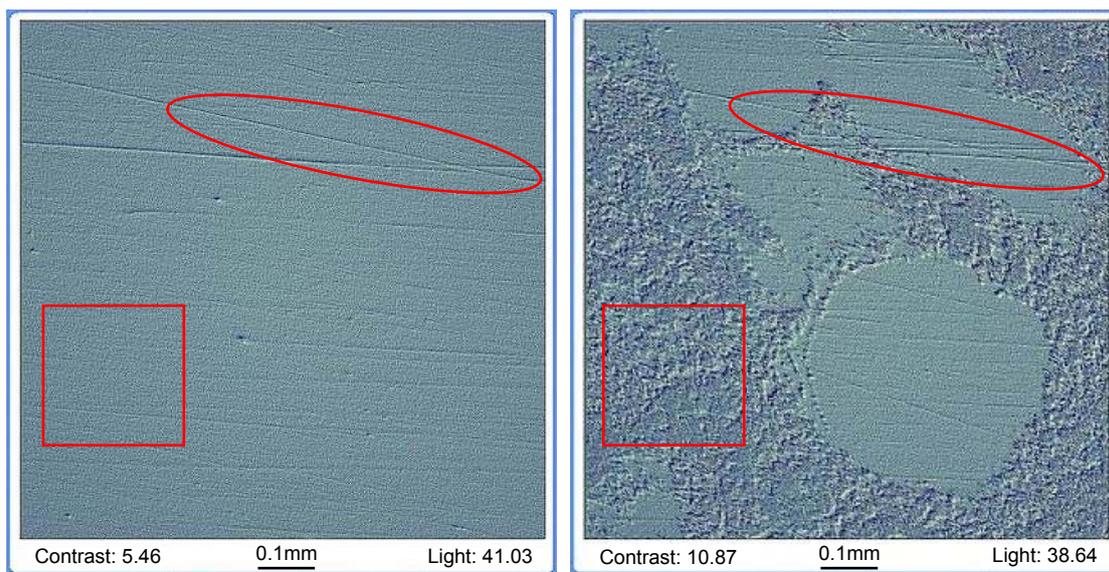
**Figure 5.8: Change of stem surface at the same position pre and post simulation (Simulation I, use Simplex P cement)**

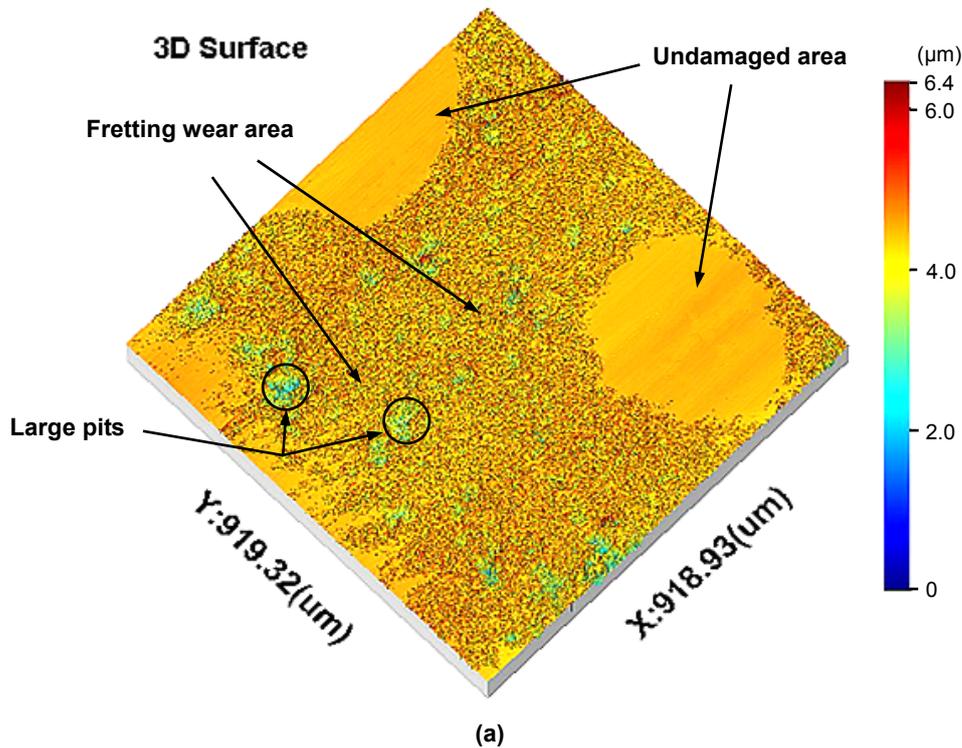
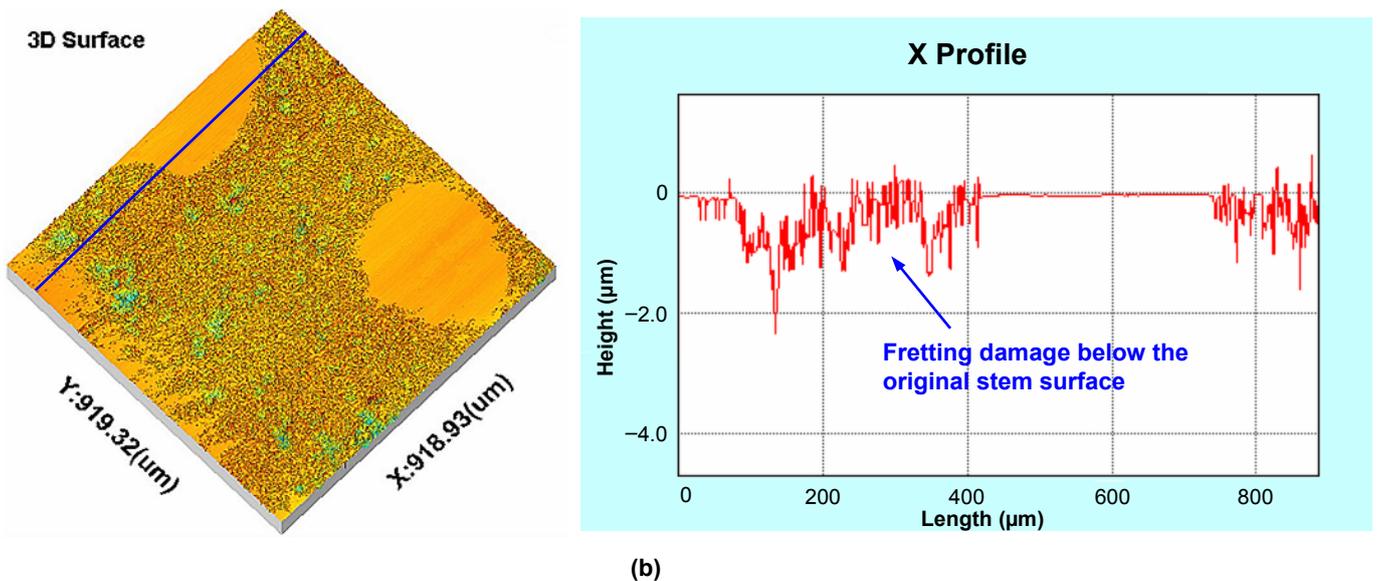
**Figure 5.9: (a) Comparison of fretting wear area and undamaged area on the femoral stem (b) 2D surface topography of the worn areas (Simulation I, use Simplex P cement)**

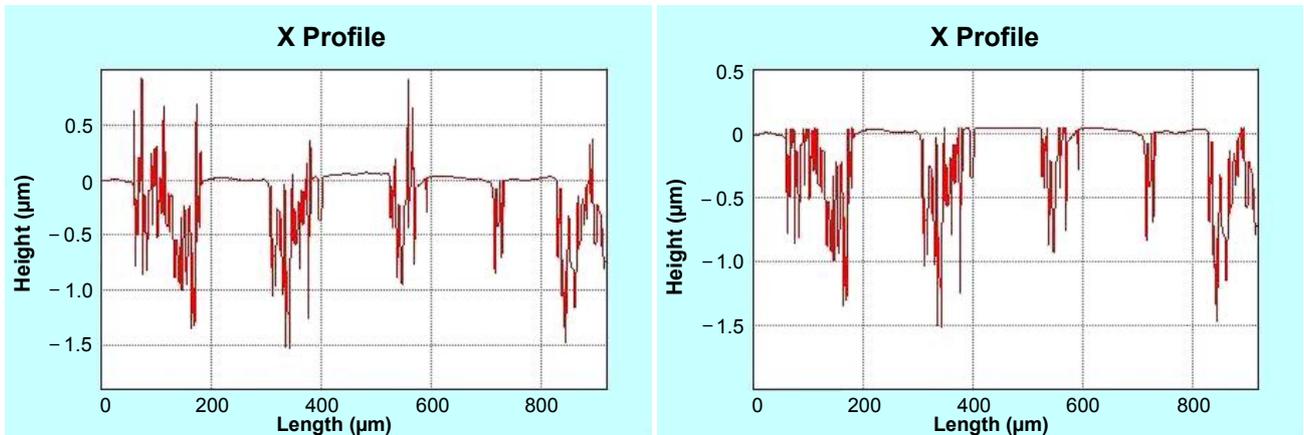
Figure 5.10: The thresholding process to remove potential wear debris above the original stem surface

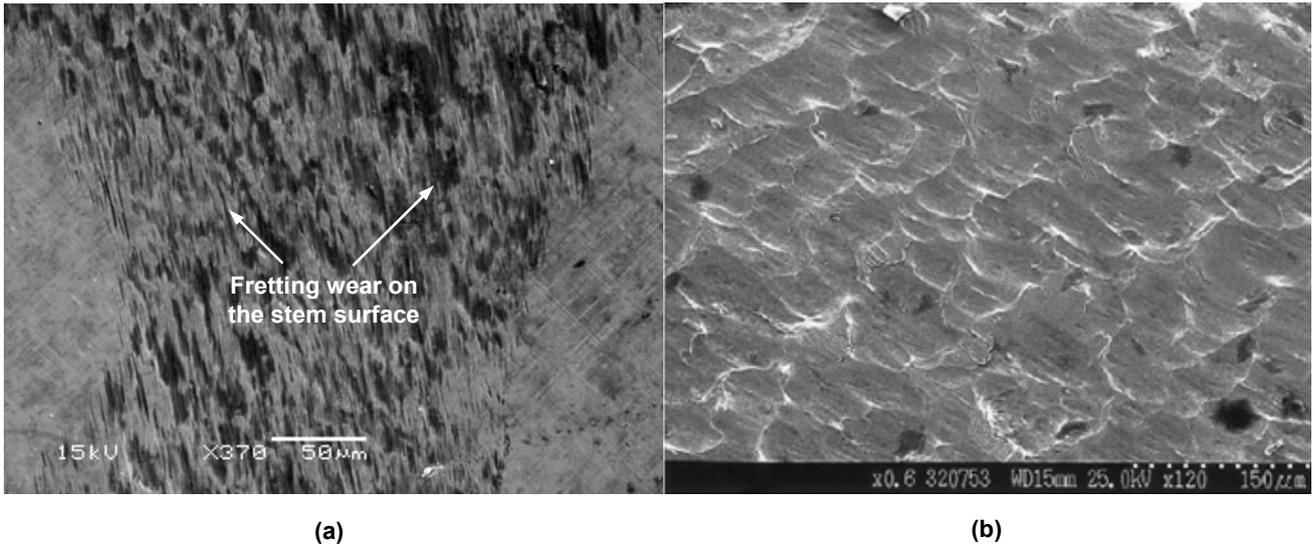
**Figure 5.15: Comparison of fretting zones between (a) Simulated Exeter femoral stem and (b) Explanted Exeter femoral stem (Simulation I, use Simplex P cement)**

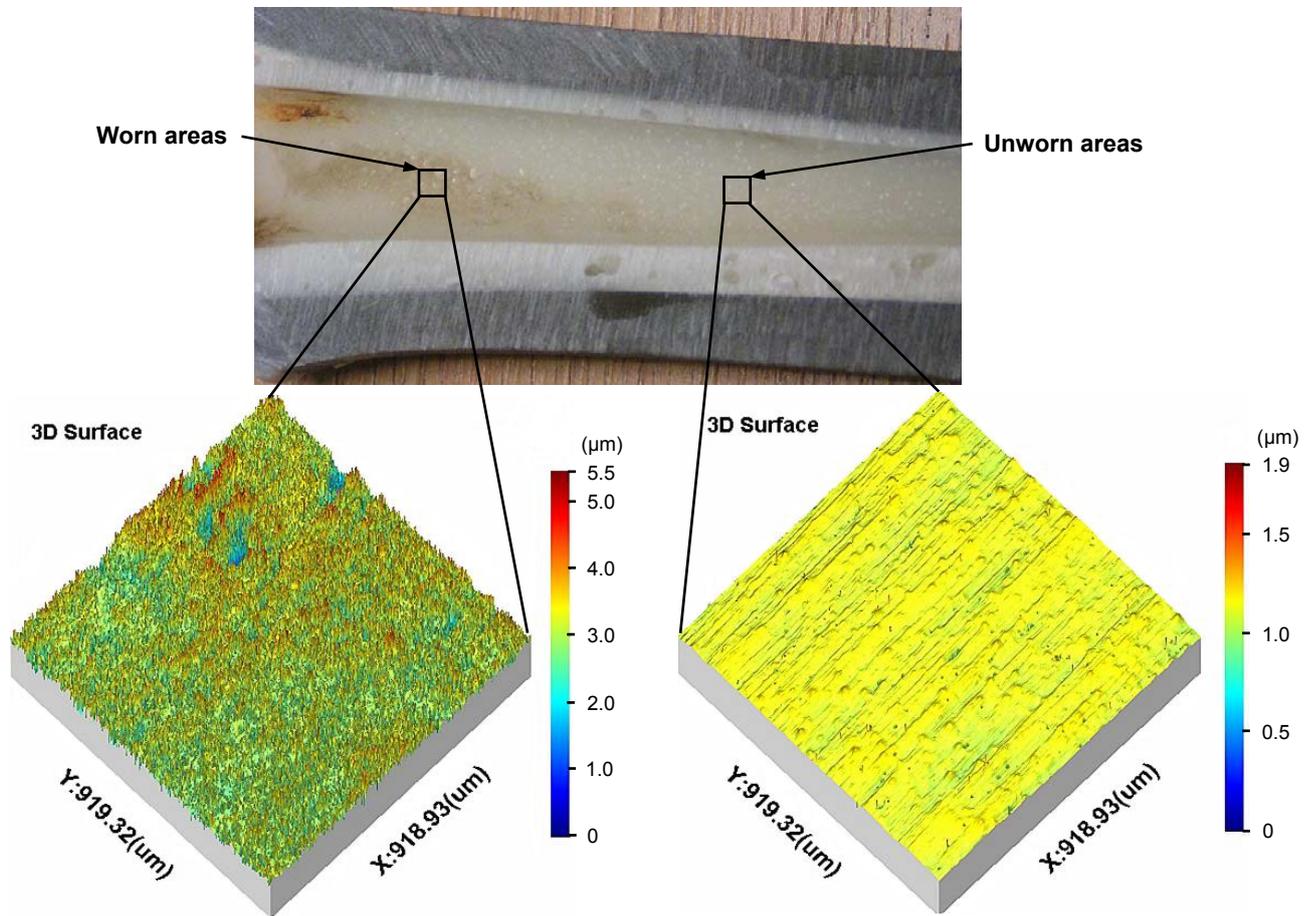
Figure 5.16: Comparison of worn and unworn areas on the Simplex P cement surface (Simulation I)

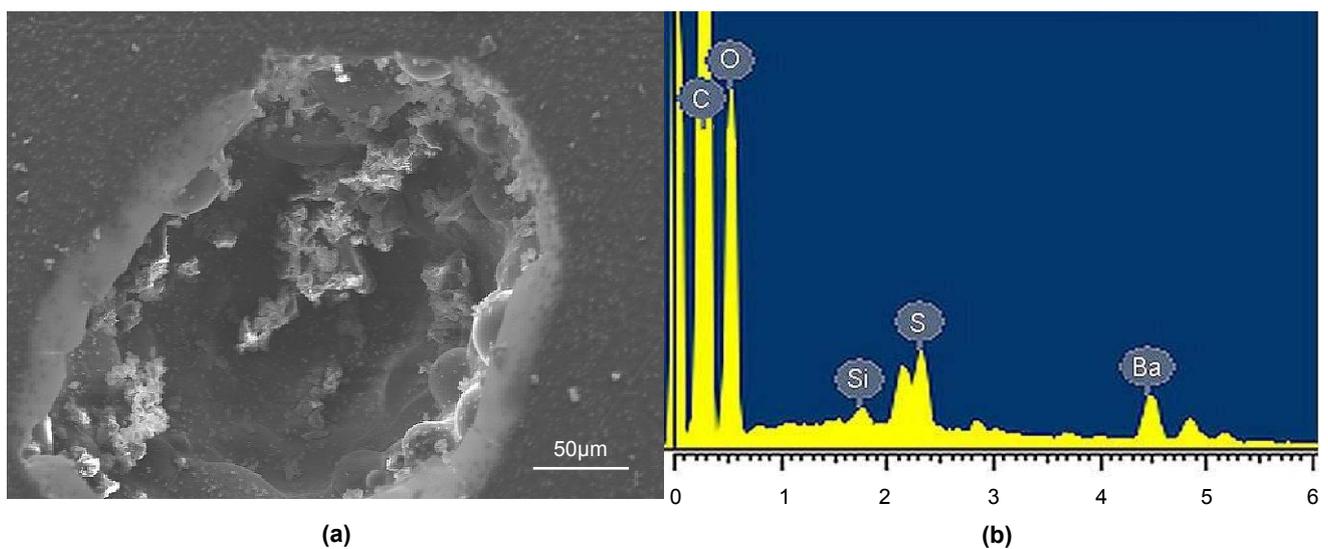
Figure 5.17: (a) SEM micrograph showing fretting debris located in the micropores (b) Corresponding EDX analysis (Simulation I, use Simplex P cement)

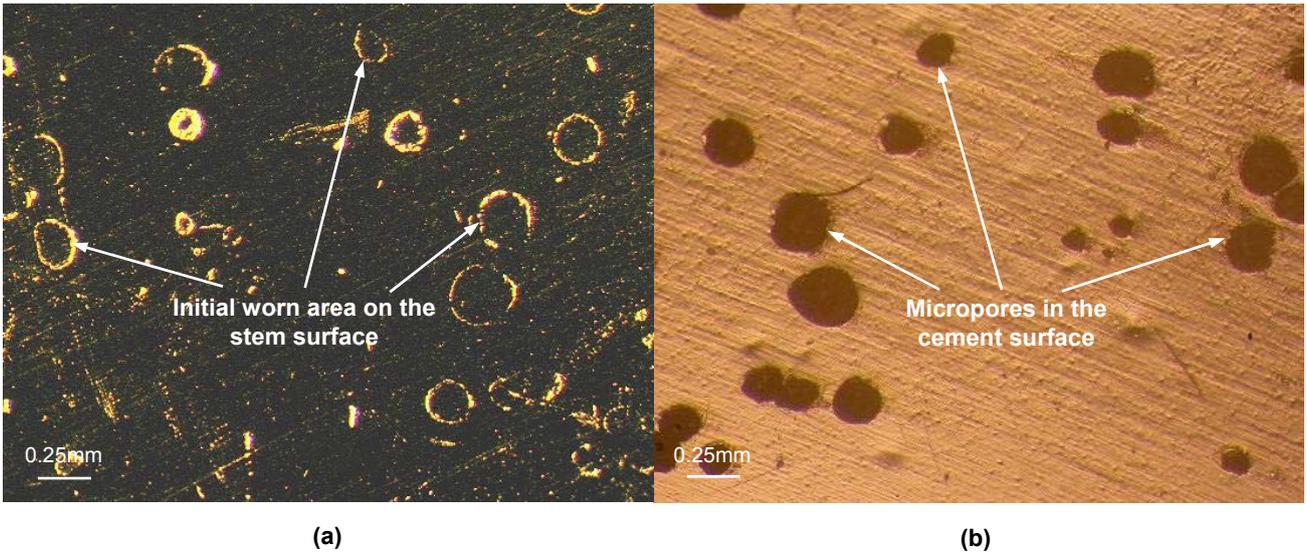
**Figure 5.19: Initiation of fretting wear on the stem surface and micropores in the cement surface (Simulation II, use Simplex P cement)**

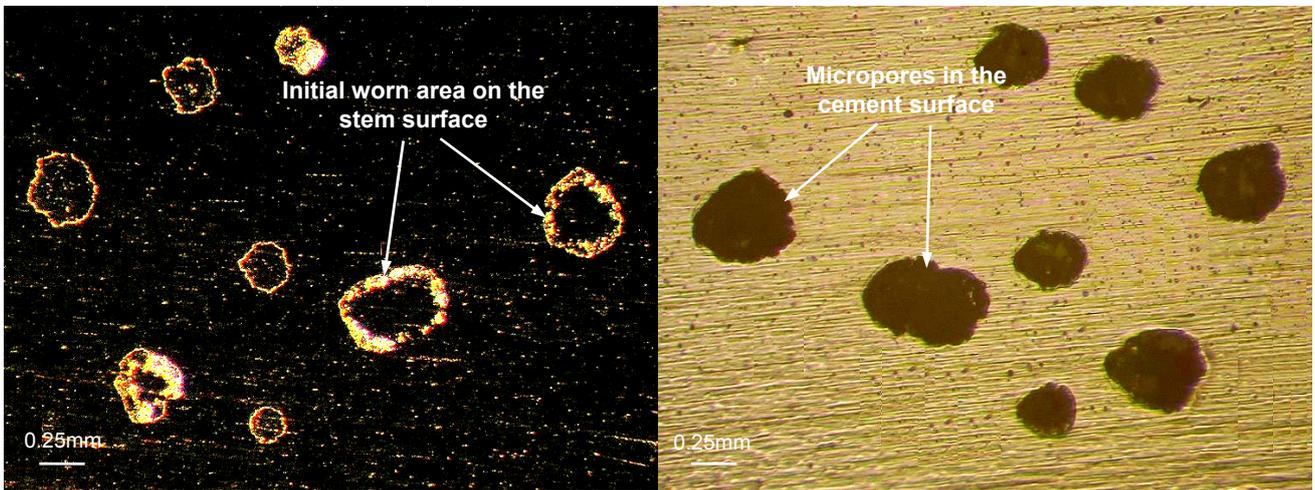
**Figure 5.20: Initiation of fretting wear on the stem surface and micropores in the cement surface (Simulation II, use Simplex P cement)**

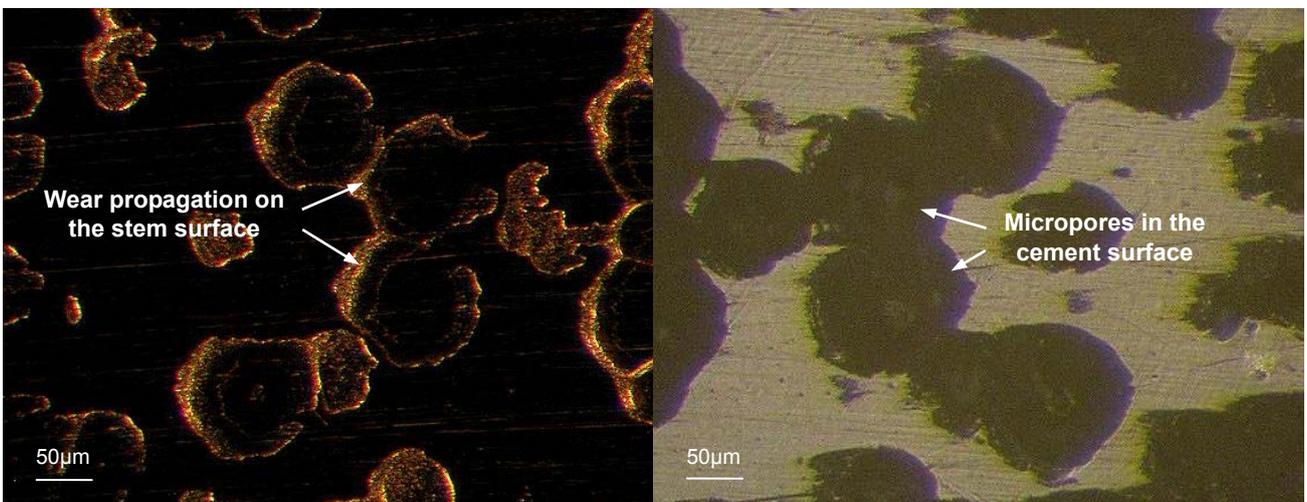
**Figure 5.21: Propagation of fretting wear on the stem surface and micropores in the cement surface (Simulation II, use Simplex P cement)**

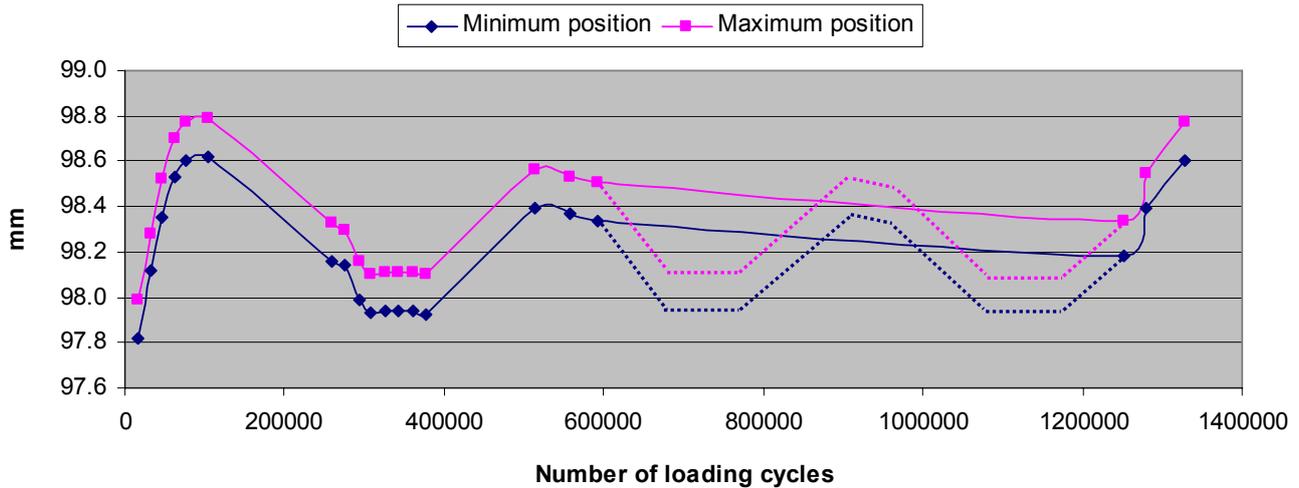
**Figure 5.23:** The maximum and minimum positions of the experimental specimen, note that the dashed line is fitted according to the tendency of the data (Simulation II, use Simplex P cement)

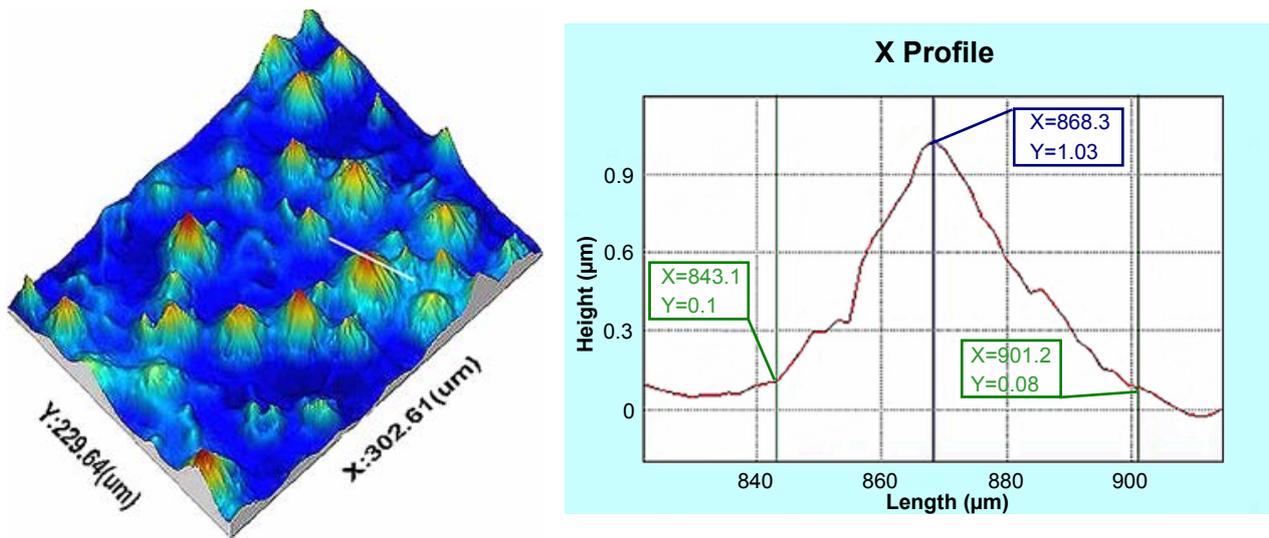
**Figure 5.24: Shrinkage bumps on the cement surface following polymerisation and its 2D profile**

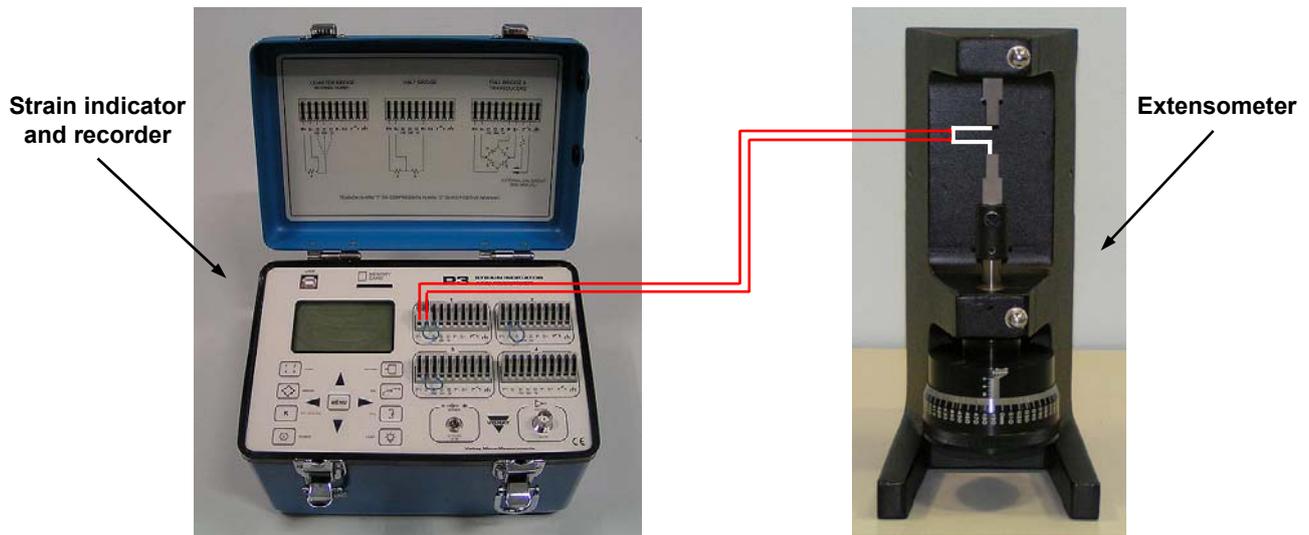
Figure 6.2: Calibration of the micromotion sensor using the extensometer

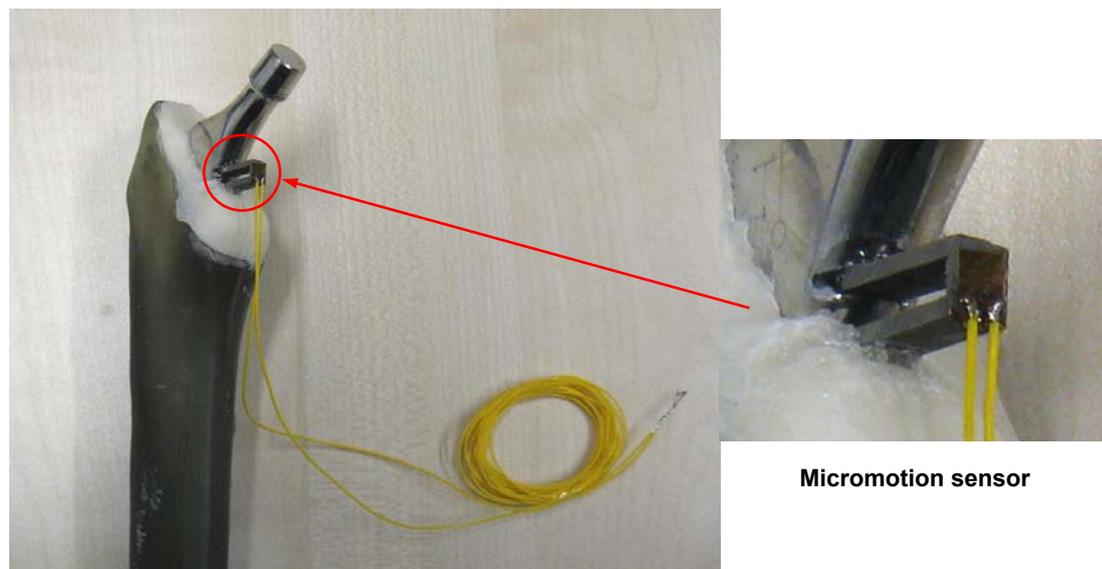
**Figure 6.4: The experimental specimen prepared for the present simulation**

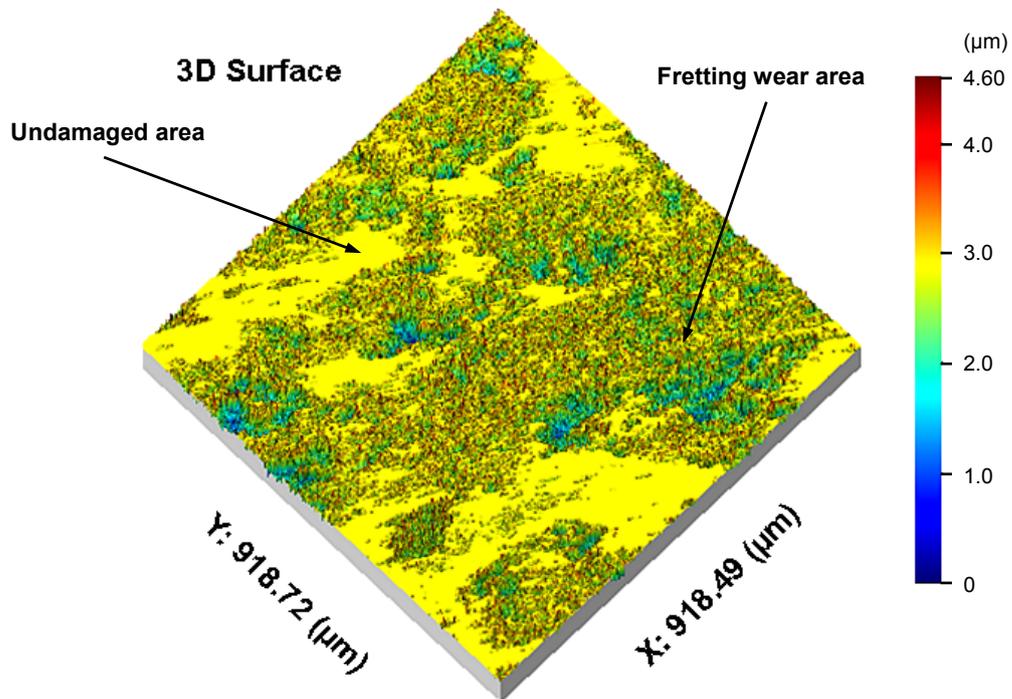
Figure 6.6: Generation of typical fretting pits on the femoral stem surface (Simulation III)

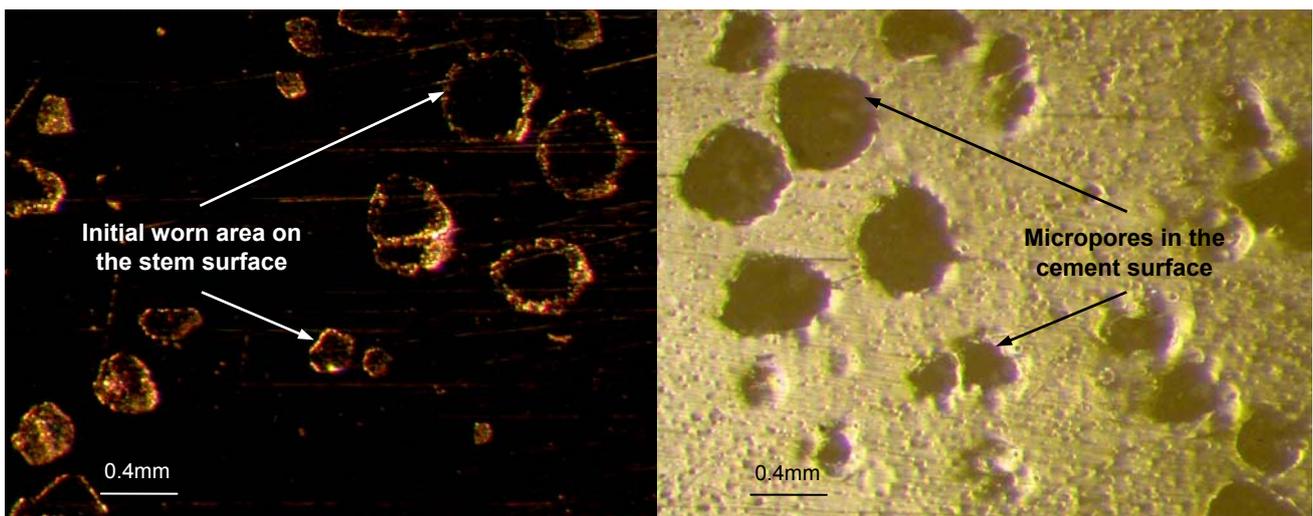
Figure 6.7: Initiation of fretting wear on the stem surface and micropores in the cement surface (Simulation III)

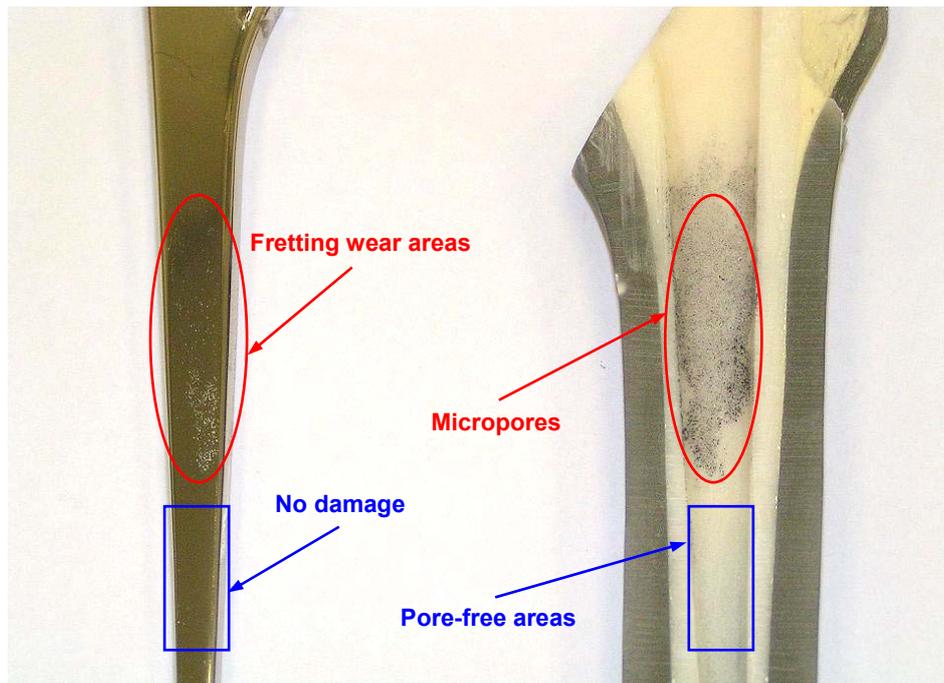
**Figure 6.8: The femoral stem and bone cement surfaces after simulation demonstrating an evident relationship between fretting wear damage and unworn areas on the stem surface and corresponding contact areas on the cement surface (Simulation III)**

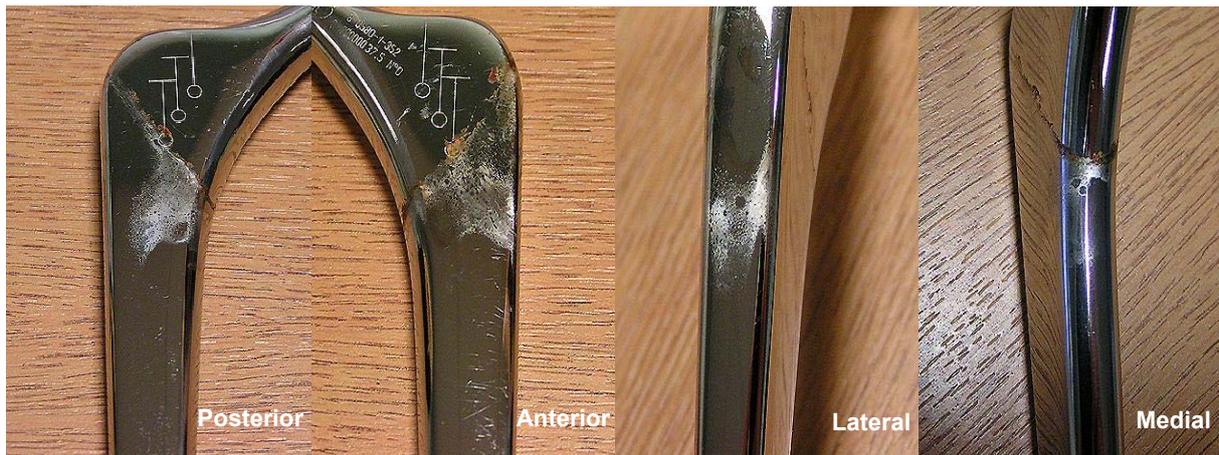
Figure 7.1: Fretting wear generated on the femoral stem surface (Simulation IV, use Simplex P cement)

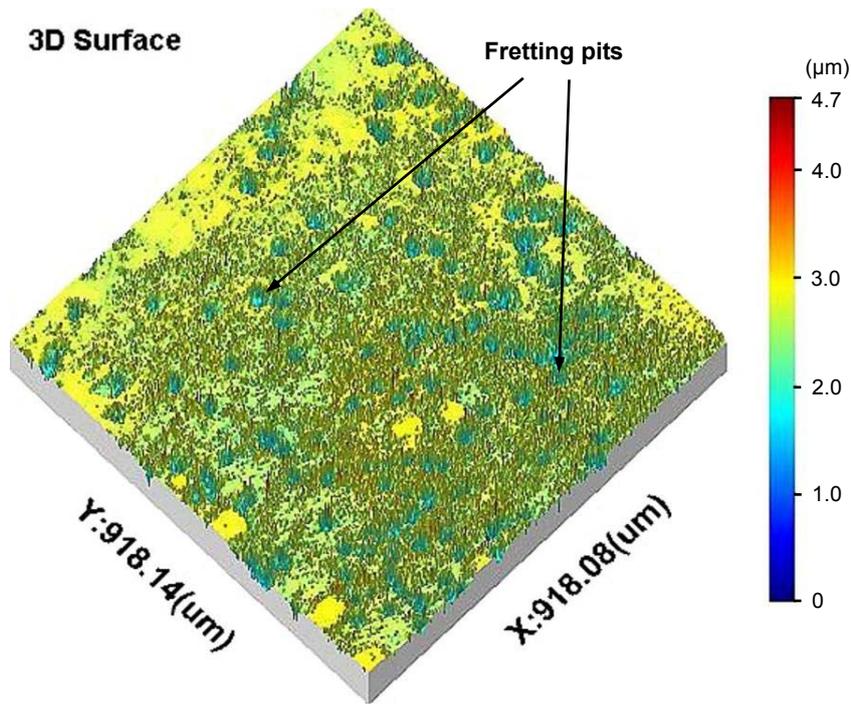
**Figure 7.2: Talysurf CCI measurement of worn areas on the stem surface (Simulation IV, use Simplex P cement)**

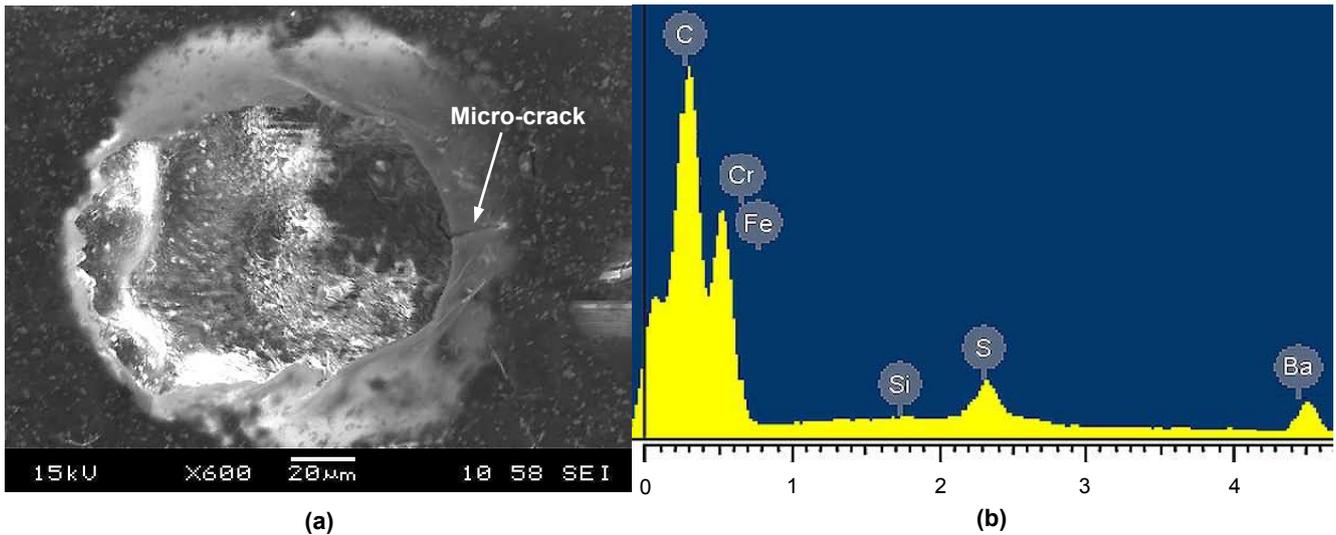
**Figure 7.5: (a) SEM micrograph of the micropores in the cement surface (b) EDX analysis (Simulation IV, use Simplex P cement)**

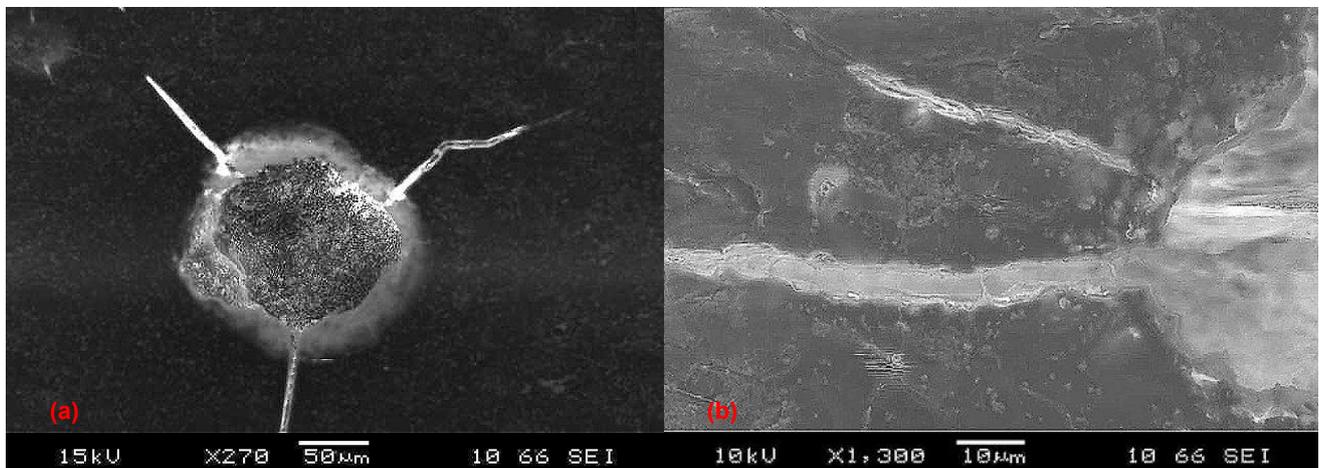
**Figure 7.7: Magnification of the two micro-cracks in figure 7.6**

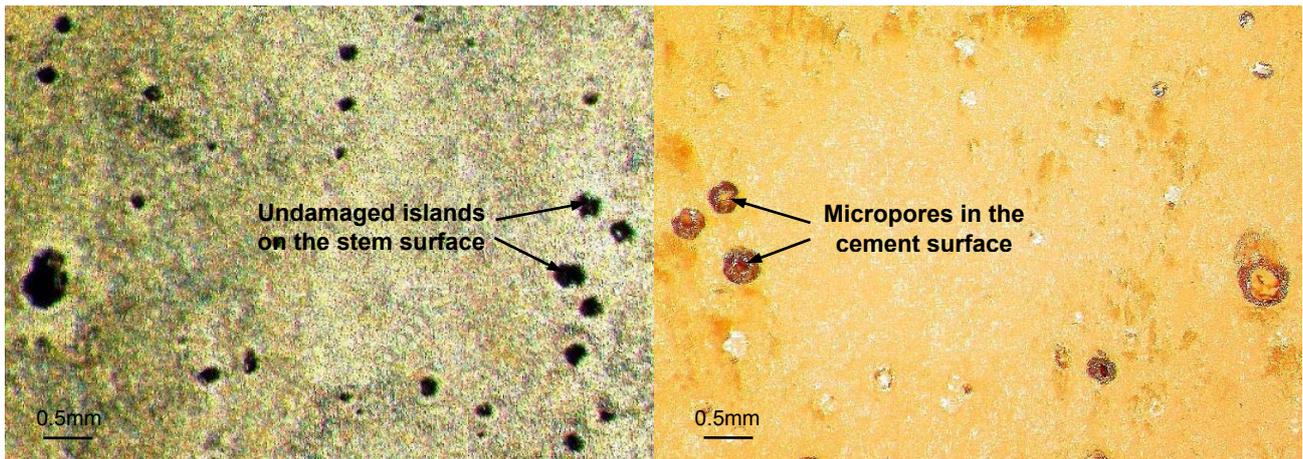
**Figure 7.8: Optical micrograph showing undamaged areas on the stem surface and micropores in the cement surface (Simulation IV, use Simplex P cement)**

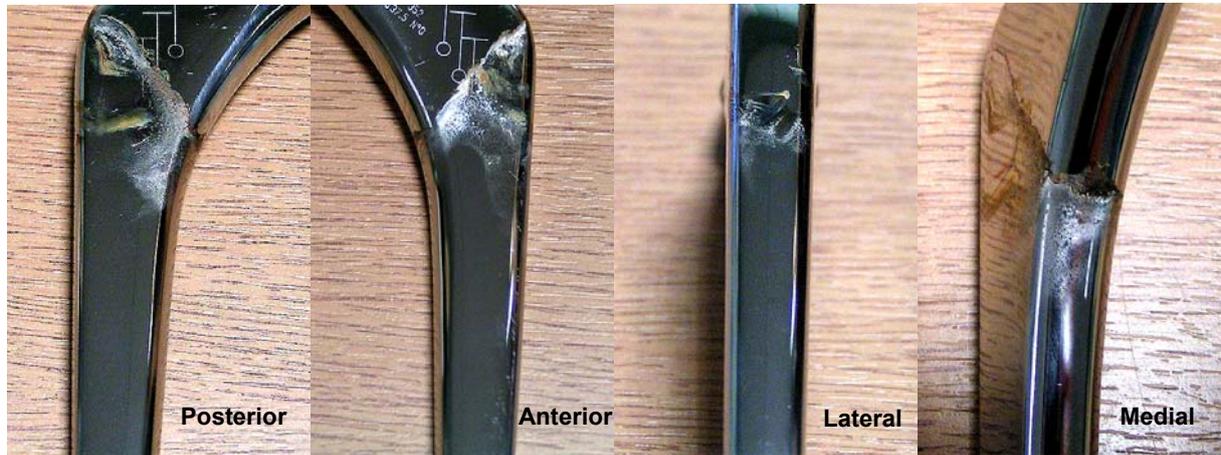
**Figure 7.10: Fretting wear generated on the femoral stem surface (Simulation V, use CMW 3 cement)**

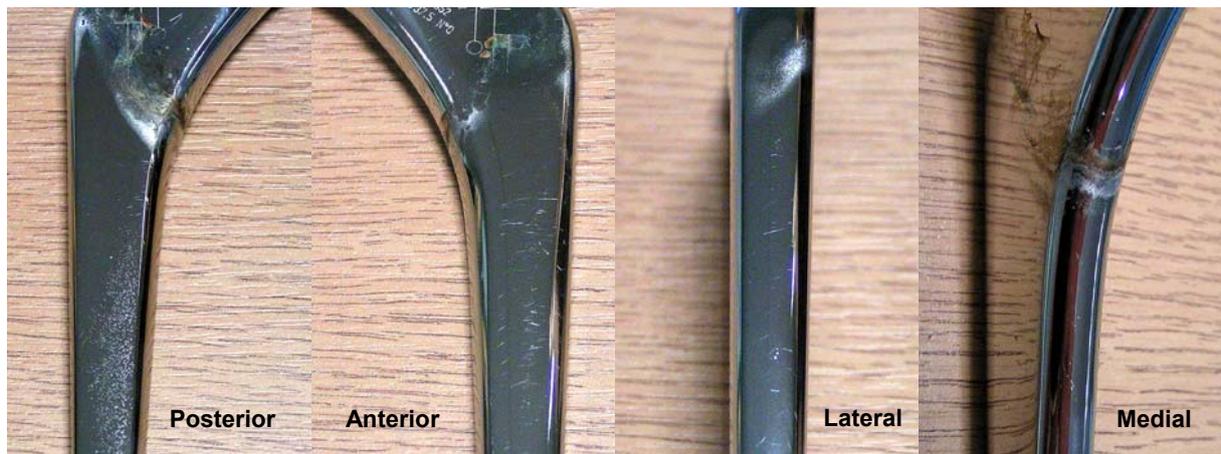
**Figure 7.11: Fretting wear generated on the femoral stem surface (Simulation VI, use CMW 3 cement)**
