**The Influence of Stem Design and Fixation Methods  
on the Lifetime of Total Hip Replacement**

**A thesis submitted to the University of Huddersfield in accordance with  
the requirements for the degree of Doctor of Philosophy**

The main purpose of this thesis is to study fretting wear mechanisms at the polished femoral stem–bone cement interface.

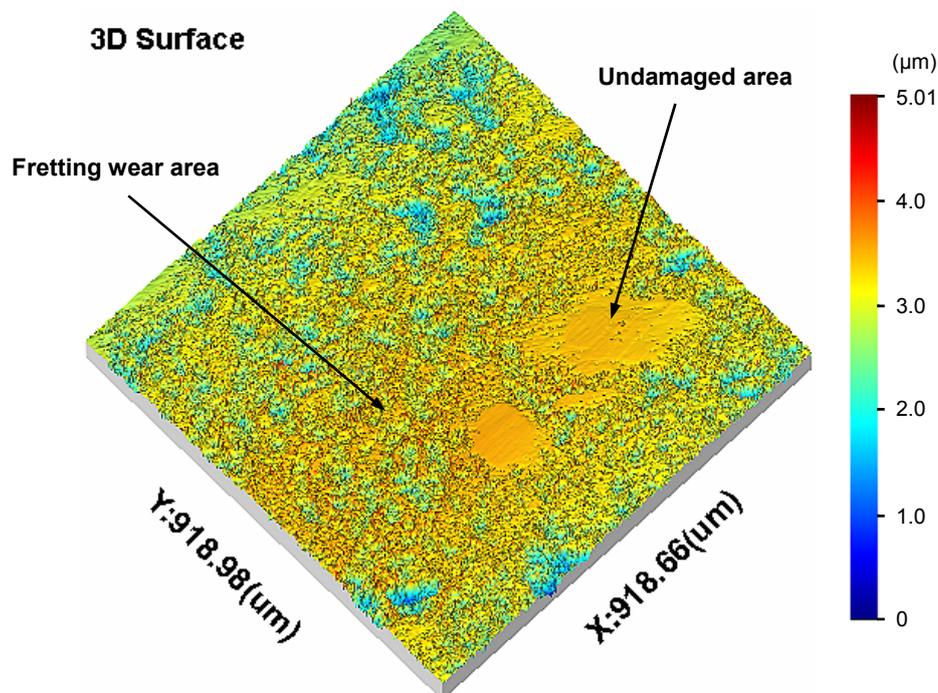
**Figure 7.12: Talysurf CCI measurement of worn areas on the stem surface (Simulation V, use CMW 3 cement)**

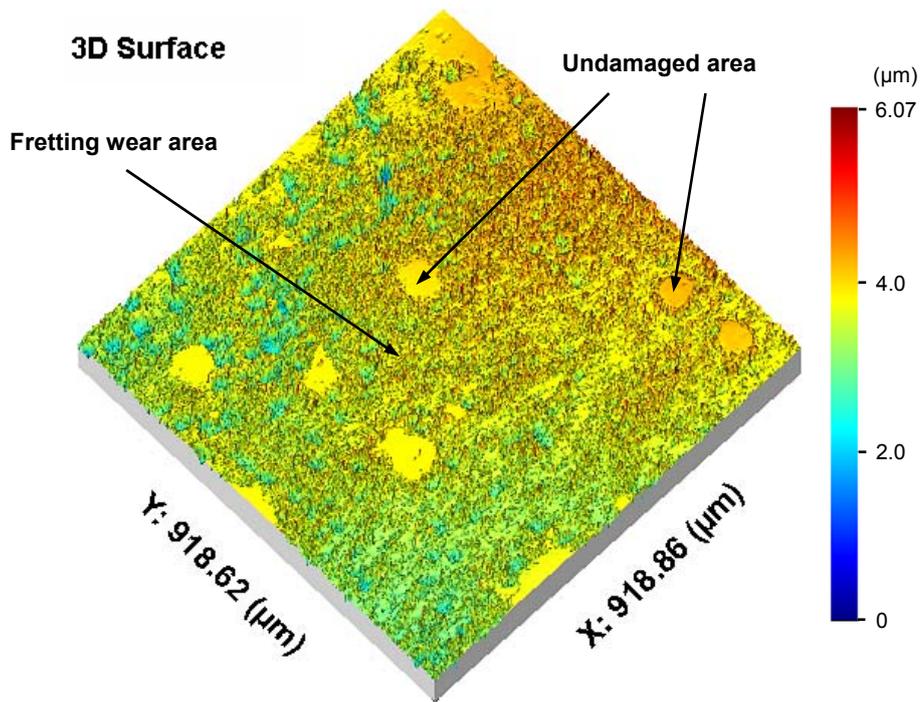
Figure 7.13: Talysurf CCI measurement of worn areas on the stem surface (Simulation VI, use CMW 3 cement)

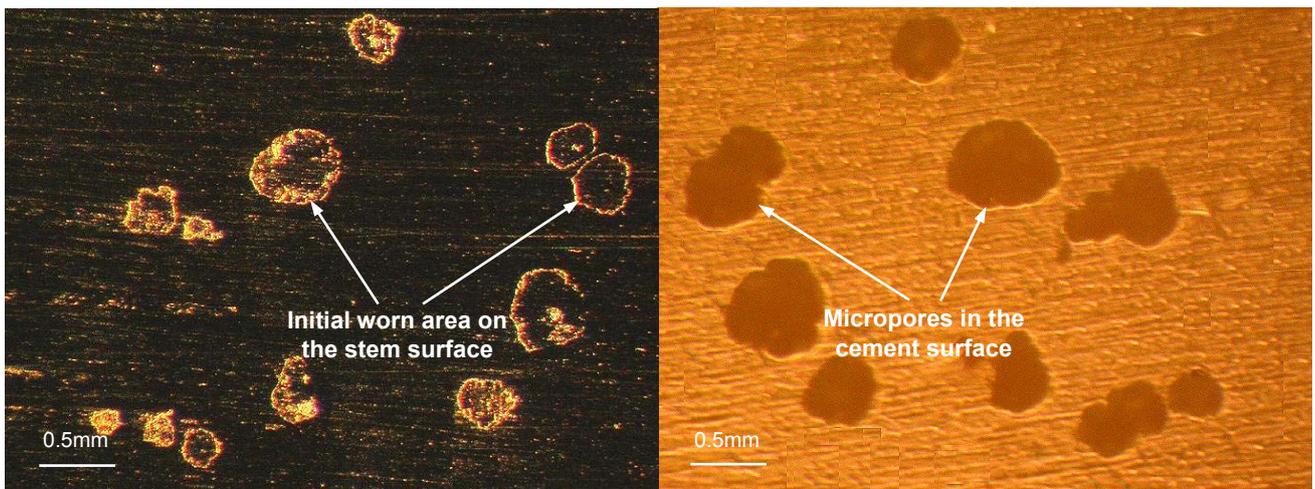
Figure 7.14: Initiation of fretting wear on the stem surface and micropores in the cement surface (Simulation V, use CMW 3 cement)

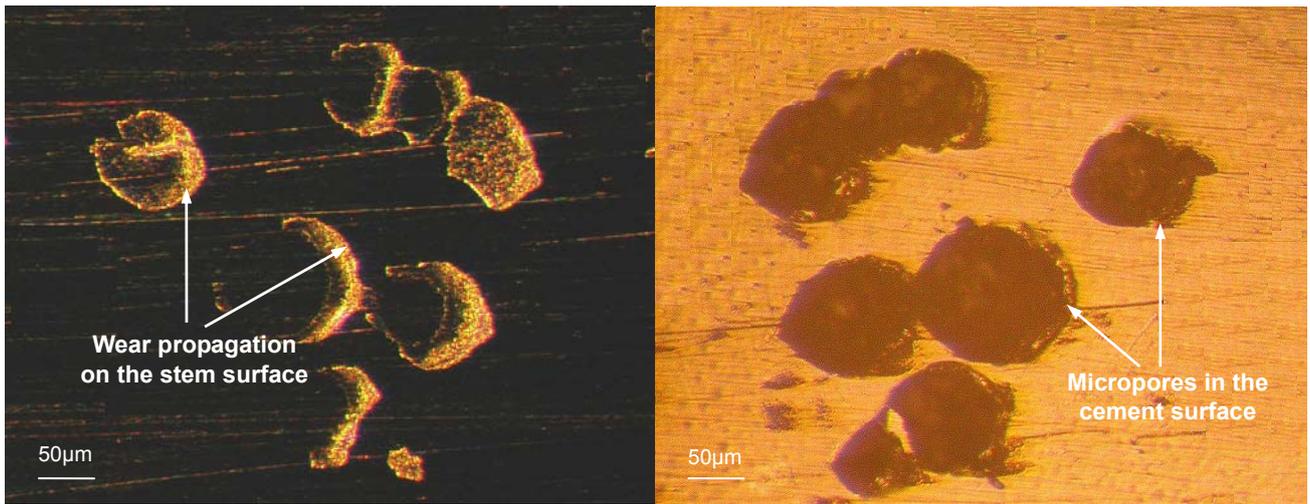
**Figure 7.15: Propagation of fretting wear on the stem surface and micropores in the cement surface (Simulation V, use CMW 3 cement)**

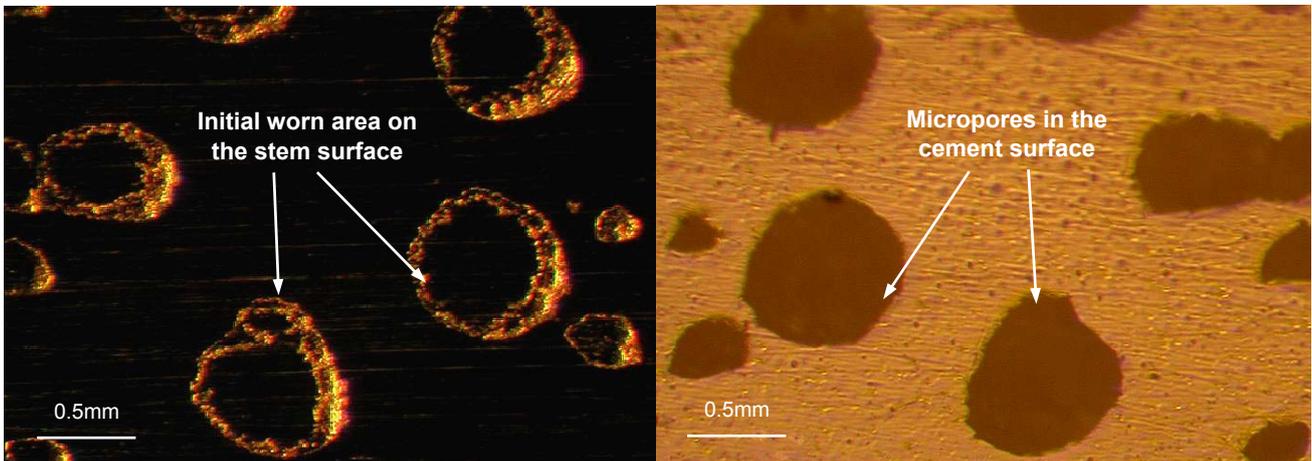
**Figure 7.16: Initiation of fretting wear on the stem surface and micropores in the cement surface (Simulation VI, use CMW 3 cement)**

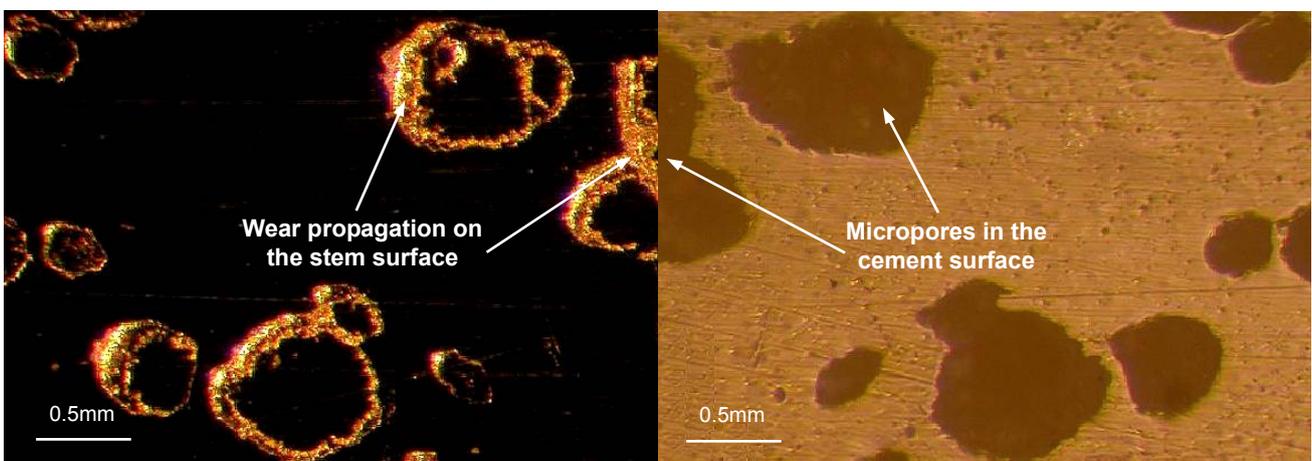
**Figure 7.17: Propagation of fretting wear on the stem surface and micropores in the cement surface (Simulation VI, use CMW 3 cement)**

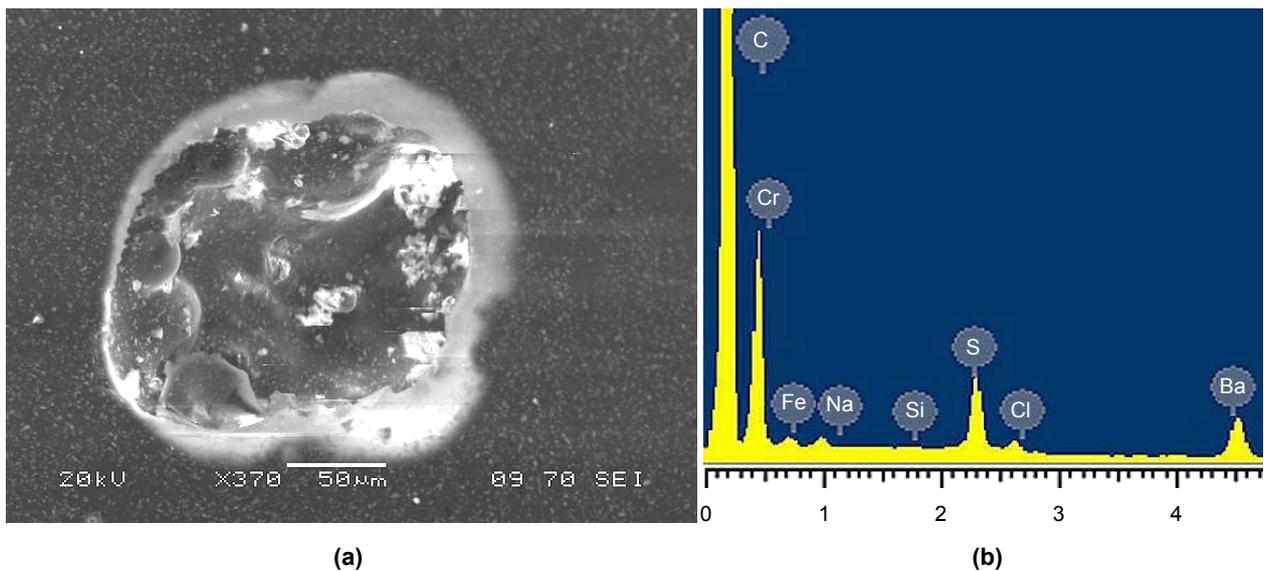
Figure 7.21: (a) SEM micrograph of the micropores in the cement surface (b) EDX analysis (Simulation VI, use CMW 3 cement)

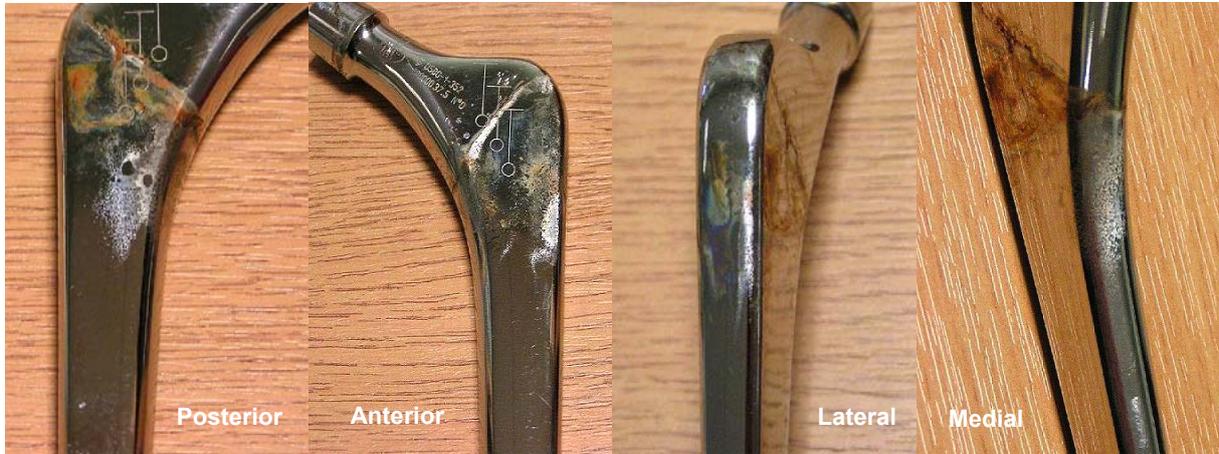
**Figure 7.22: Fretting wear generated on the femoral stem surface (Simulation VII, use Palacos R cement)**

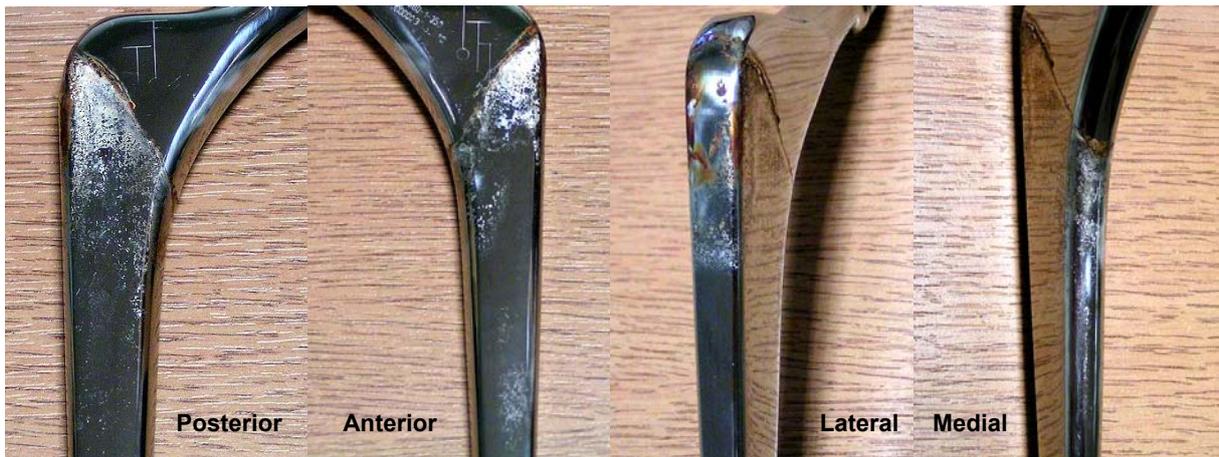
**Figure 7.23: Fretting wear generated on the femoral stem surface (Simulation VIII, use Palacos R cement)**

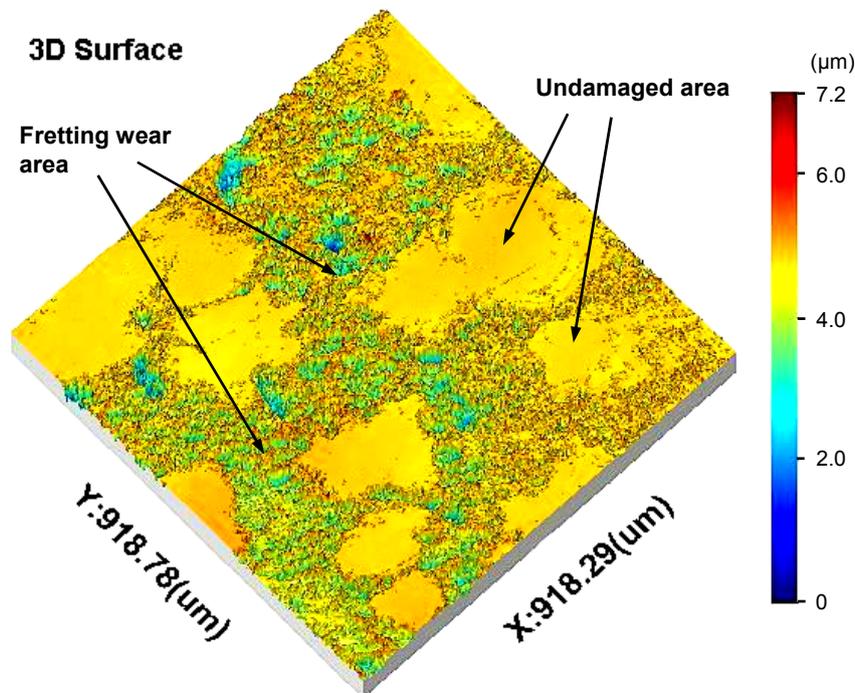
**Figure 7.24: Comparison of fretting wear area and undamaged area on the femoral stem (Simulation VII, use Palacos R cement)**

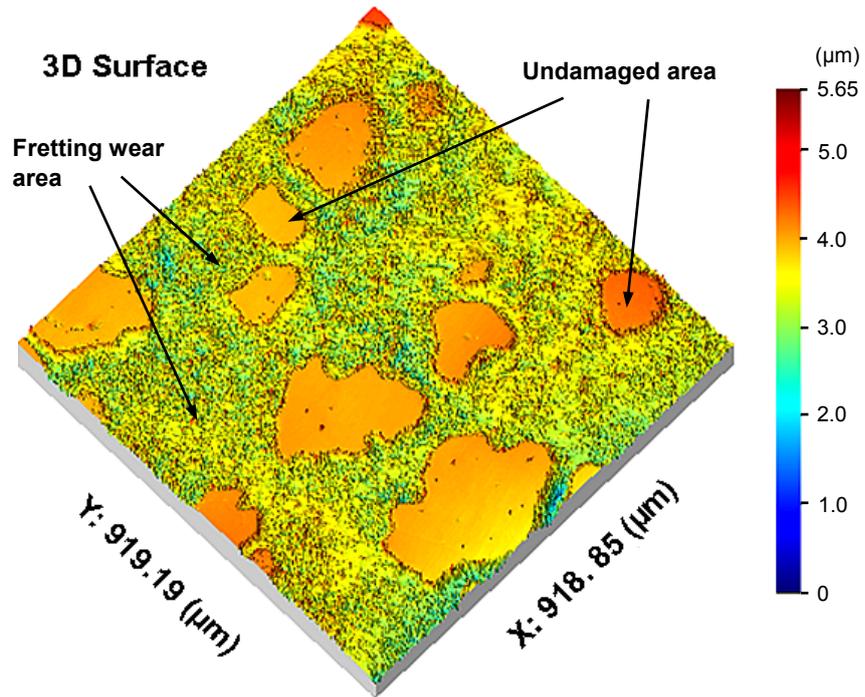
Figure 7.25: Comparison of fretting wear area and undamaged area on the femoral stem (Simulation VIII, use Palacos R cement)

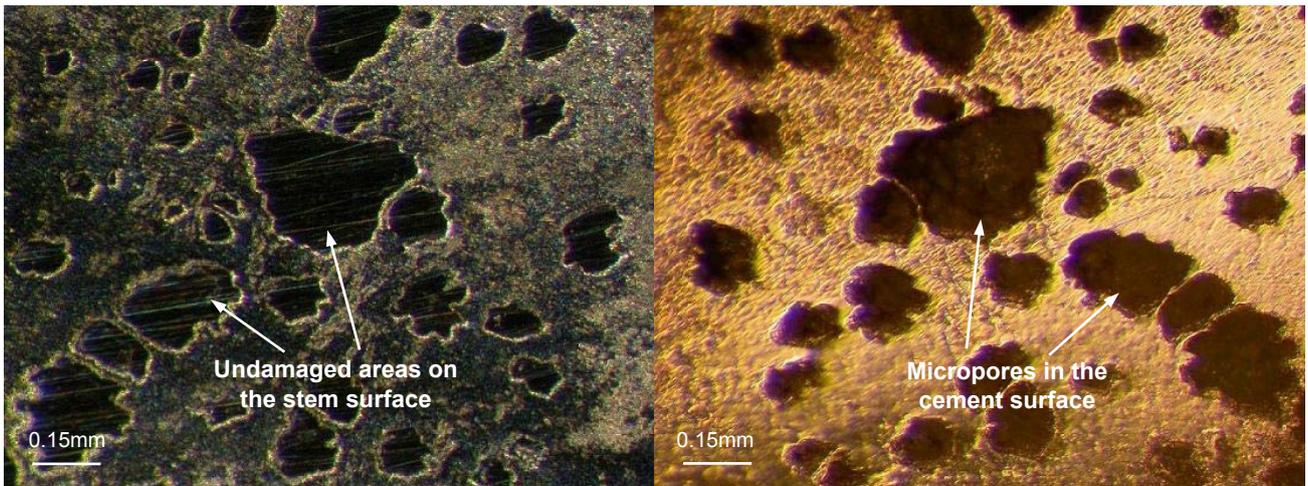
Figure 7.26: Optical micrograph showing undamaged areas on the stem surface and micropores in the cement surface (Simulation VII, use Palacos R cement)

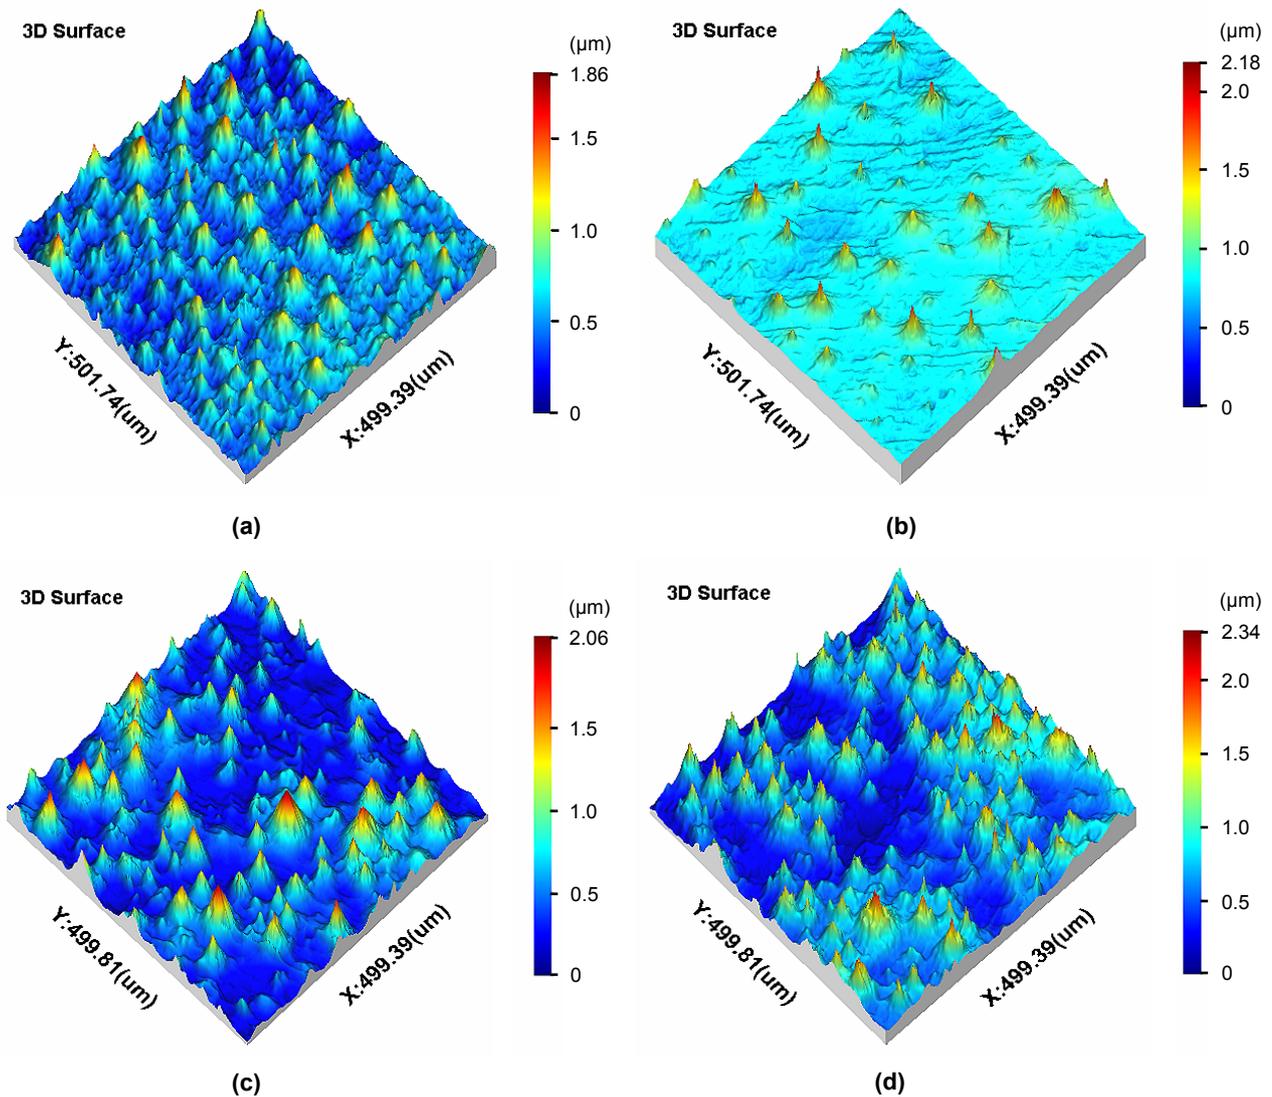
**Figure 8.1: Shrinkage bumps present on the common bone cement surfaces following polymerisation (a) Simplex P with tobramycin (b) Palacos R (c) CMW 1 (d) CMW 3**

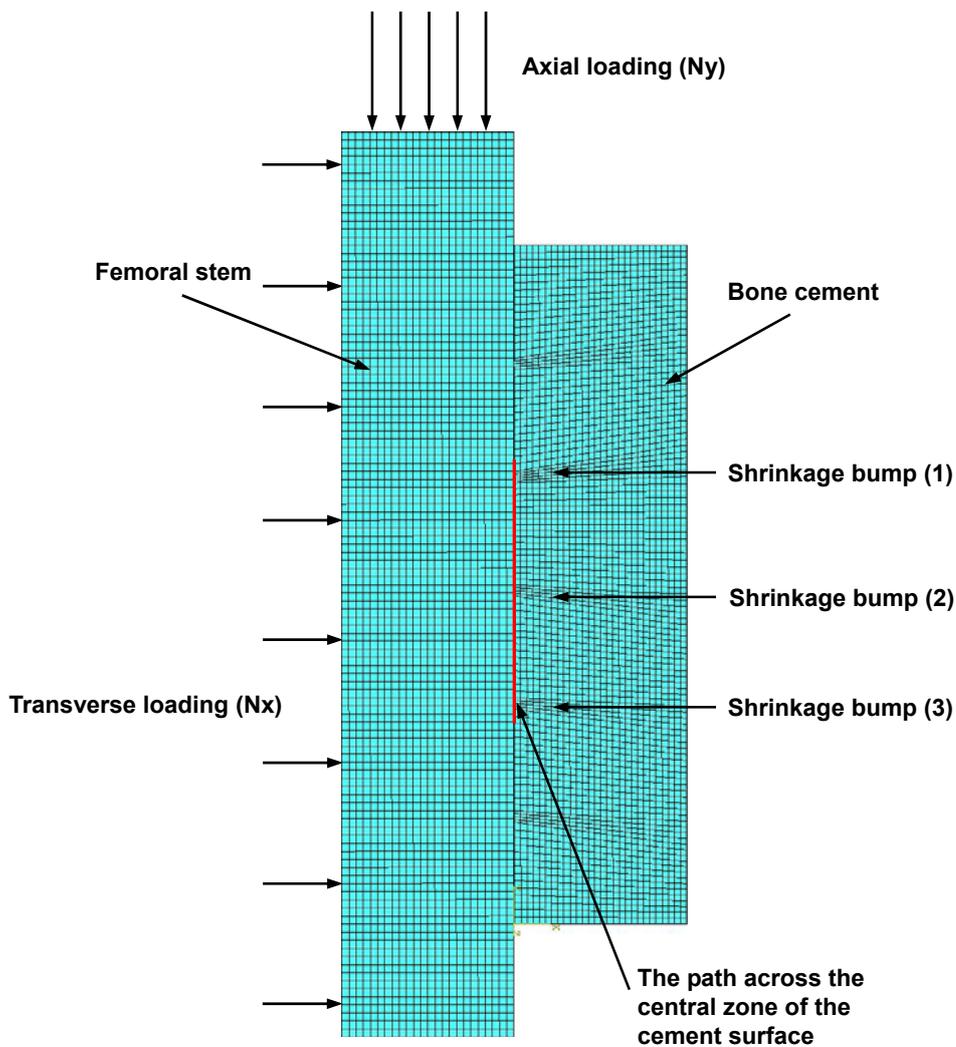
Figure 8.2: 2D finite element model simulating the interaction between the stem and the bumps

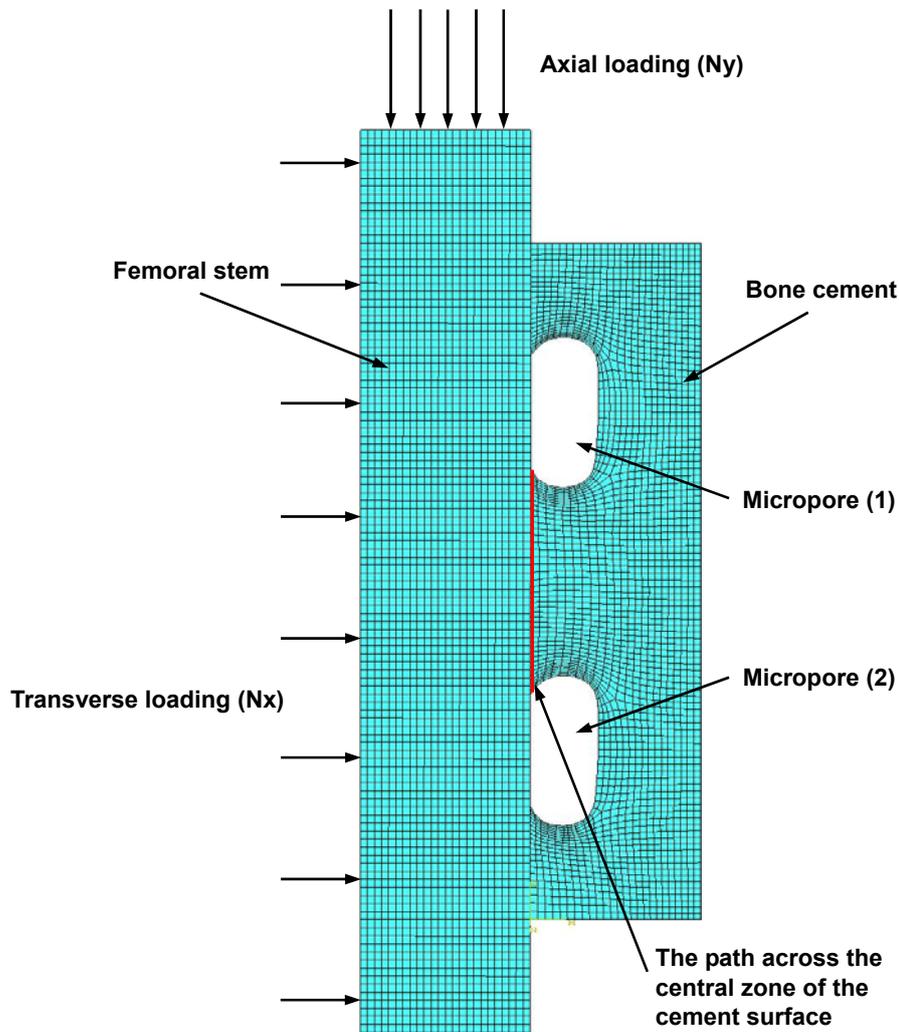
**Figure 8.3: 2D finite element model simulating the interaction between the stem and the micropores**

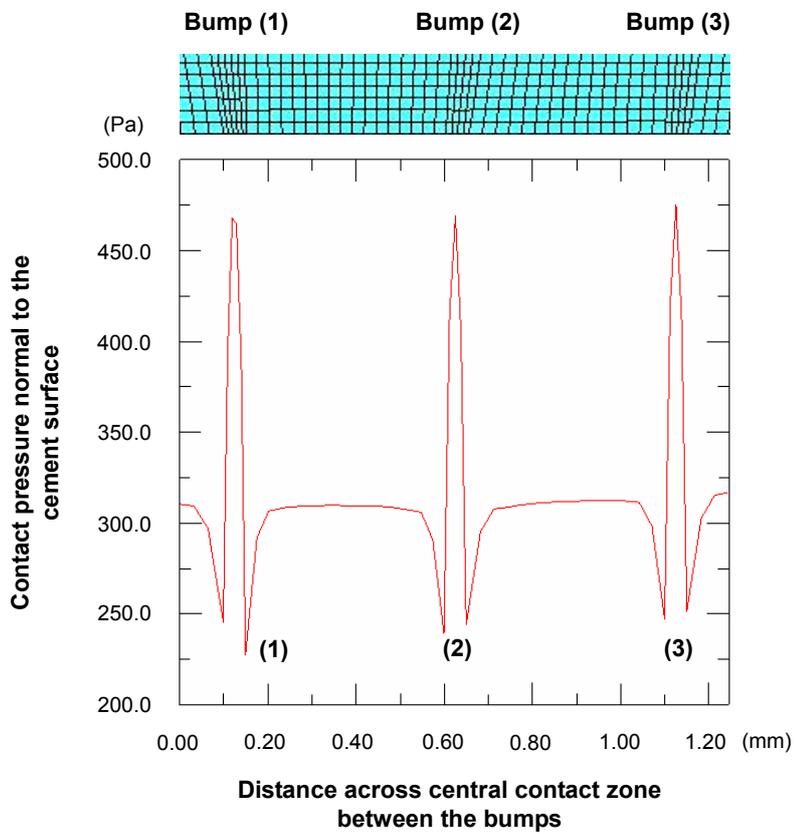
Figure 8.6: The contact pressure normal to the cement surface between the stem and the shrinkage bumps

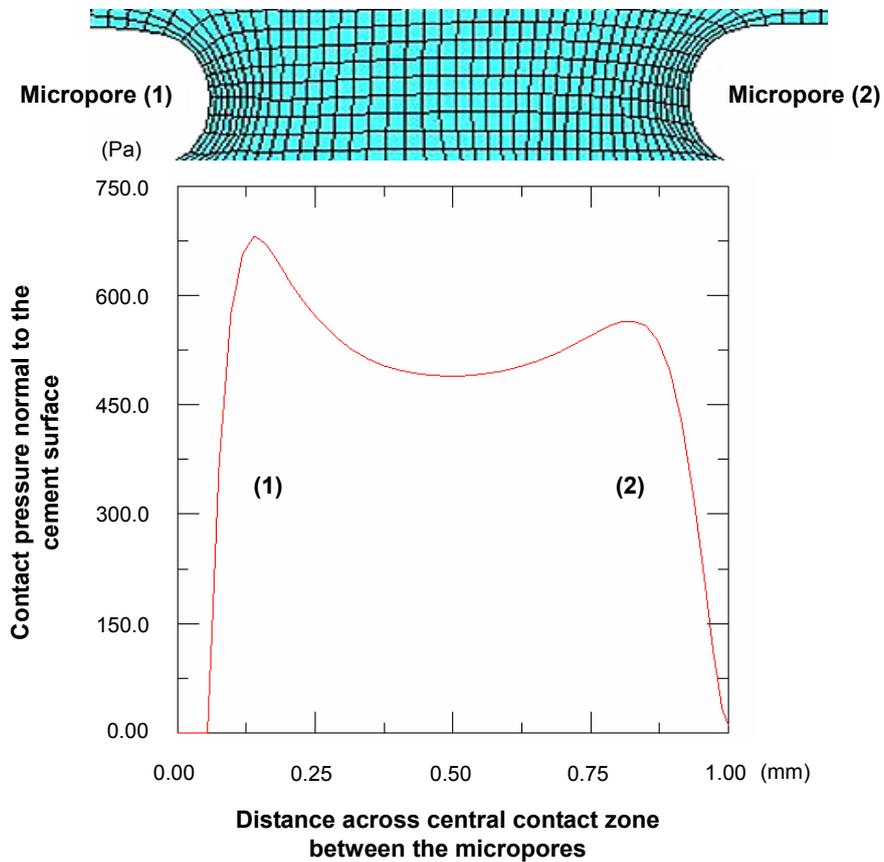
Figure 8.9: The contact pressure normal to the cement surface between the stem and the micropores

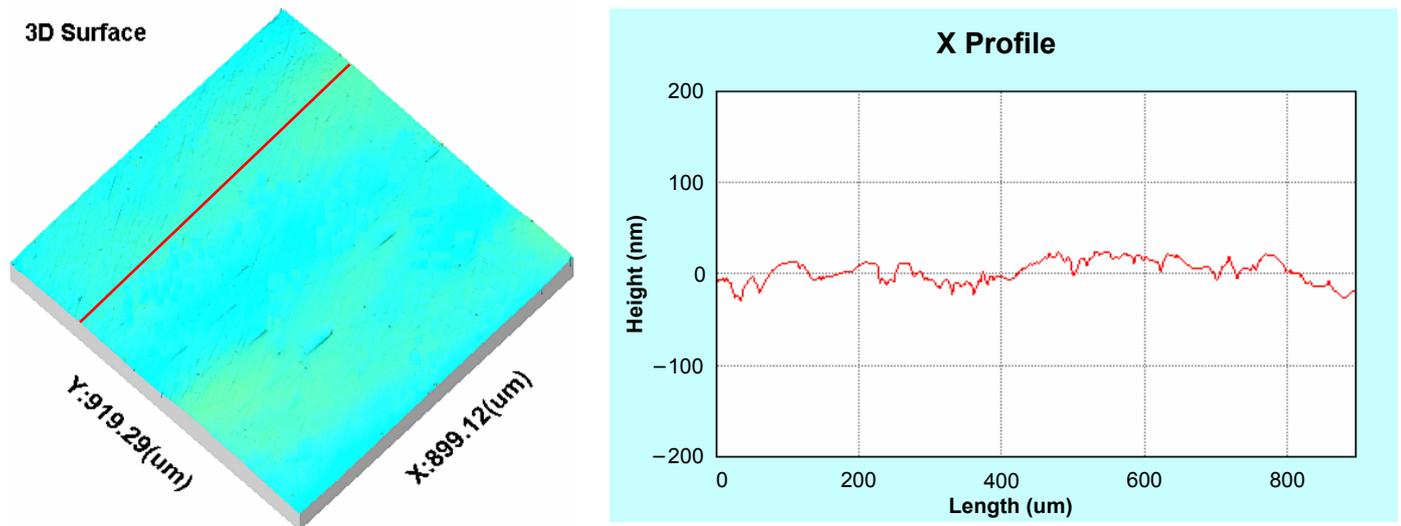
**Figure 8.14: The 2D surface profile of a commercial highly polished femoral stem with the variation in amplitude of about 40nm**

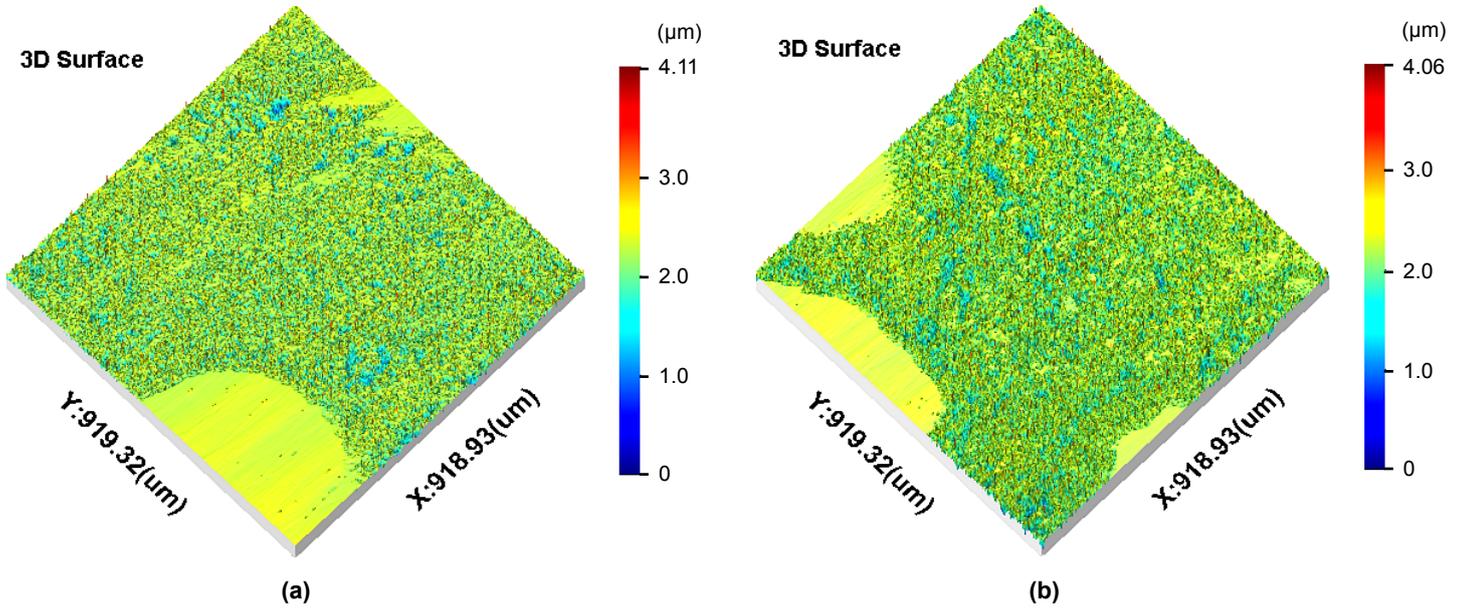
Examples of 3D surface topography of the worn areas of Gruen zone 6 on the femoral stem

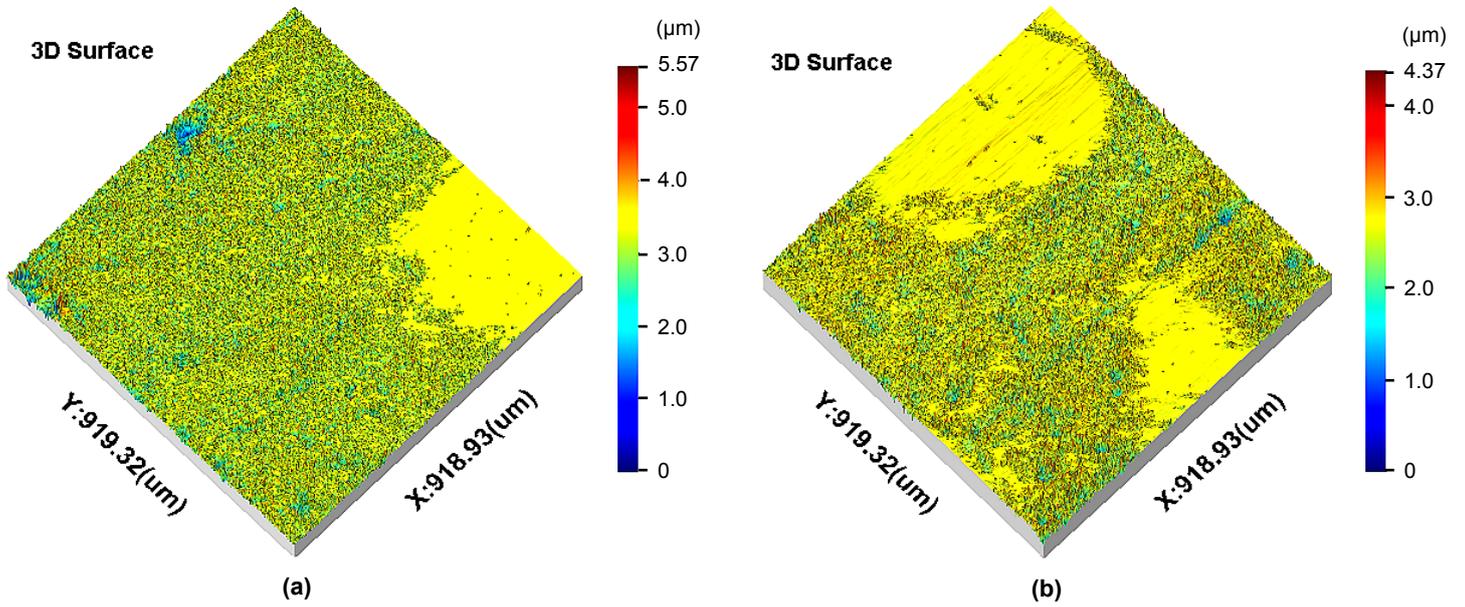
Example of 3D surface topography of the worn areas of Gruen zone 7 on the femoral stem
