Diagnosis of Centrifugal Pump Faults Using Vibration Methods

A. Albraik, F. Althobiani, F. Gu and A. Ball

Centre for Diagnostic Engineering, University of Huddersfield, HD1 3HD, UK

Keywords: Variable speed pump, pump performance, centrifugal pump

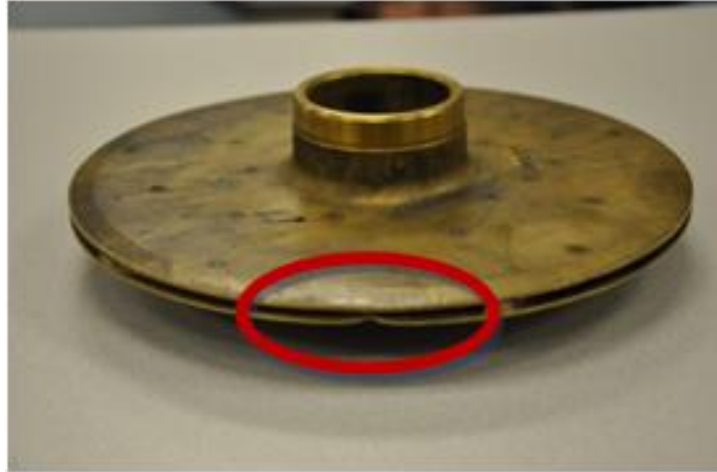
Figure 4.6. Impeller 4 with gap between two plates reduced to 0.3mm at a single point by a hammer blow.

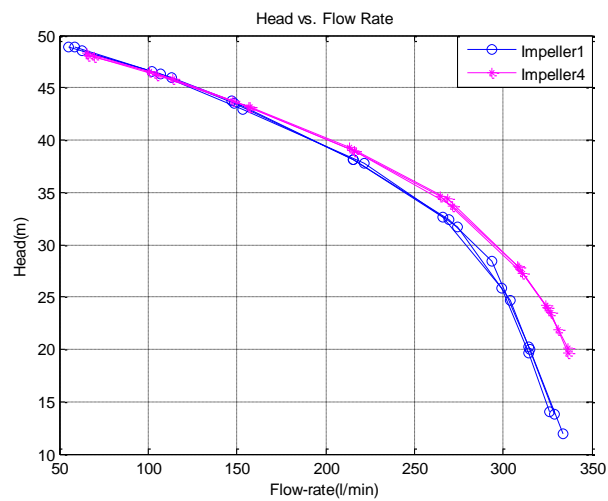
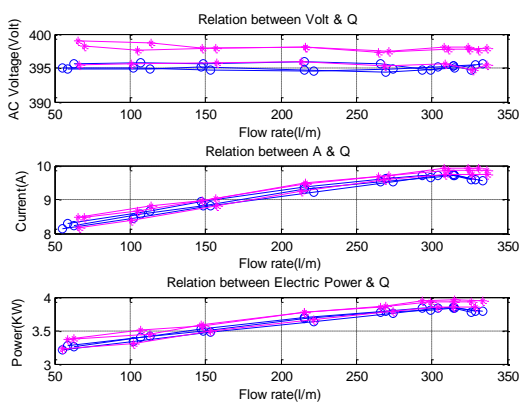
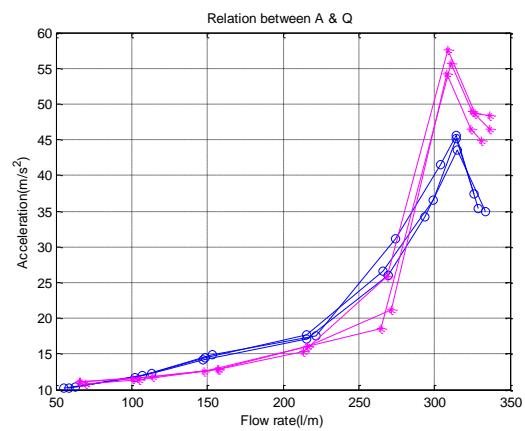
Figure 4.7. Collected data at different flow rates (impeller 1 vs impeller 4).

(a) Head vs flow rate.

(b) Voltage, current and power vs flow rate.

(c) Vibration acceleration vs flow rate.

Figure 4.7 (a) compares flow rate against head for the healthy impeller (blue line) with defective impeller 4: a hammer blow on its edge reduced the gap between two plates at that point to 0.3mm (red line). Impellers 1 and 4 are the same geometry. As previously, the faulty impeller provides a higher head compare to the healthy impeller on flow rate above about 150 l/m, the difference is very marked at flow rates above 300 l/m. Red consumes more AC volt compared to blue in Figure 4.7 (b), where current consumption is slightly higher in Red compared to Blue. Power consumption is high in Red compared to blue. In figure 4.7 (c), acceleration is found to be more in blue compared to red for the flow rate 100-275 (m/l). Above 275 (m/l) flow rate, acceleration is more in red compared to Blue. Acceleration in blue is almost linearly proportional between 50 to 220 (m/l) flow rate then, increases rapidly up to 320 (m/l) flow rate and after that decreases rapidly. Acceleration in red is almost linearly proportional between 50 to 275 (m/l) flow rate then, increases rapidly up to 315 (m/l) flow rate and then increases rapidly.

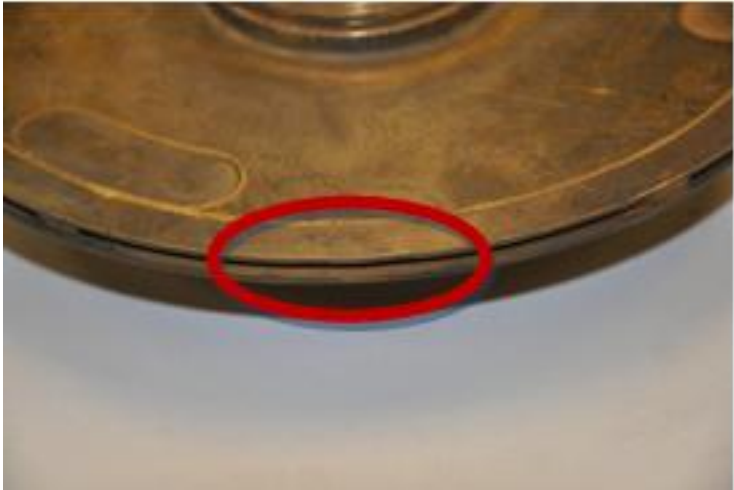
Figure 4.8. Impeller 5 with gap between two plates reduced by a hammer blow at three equally spaced points.

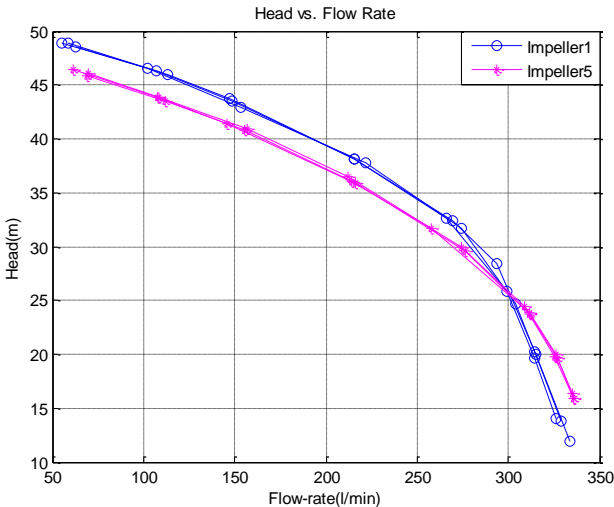
Figure 4.9. Collected data at different flow rates (impeller 1 vs impeller 5).

(a) Head vs flow rate.

(b) Voltage, current and power vs flow rate.

(c) Vibration acceleration vs flow rate.

Figure 4.9 (a) compares flow rate against head for the healthy impeller (blue line) with defective impeller 5: three equally spaced hammer blows around the circumference reduced the spacing to 2.6mm, 2.9mm and 3.0mm, respectively, as shown. Impellers 1 and 5 are the same geometry. Unlike the previous results, the healthy impeller produces a greater head up to about 300 l/m, for flows above this the defective impeller produced a higher head. Figure 4.9 (b) shows that the pump containing the faulty impeller consumes more power, requiring a higher AC voltage and current than the healthy pump. Figure 4.9 (c) shows that vibration acceleration is much greater in the pump with defective impeller for flow rates up to about 280 l/m between about 300 l/m and 325 l/m the vibration acceleration is greater for the healthy pump, but above 325 l/m the acceleration is much the same for both pumps.
