Defect Detection in Thin-film Photovoltaics; Towards Improved Efficiency and Longevity

Elrawemi, Mohamed, Blunt, Liam, Fleming, Leigh, Sweeney, Francis and Robbins, David (2014) Defect Detection in Thin-film Photovoltaics; Towards Improved Efficiency and Longevity. In: The Fifth International Renewable Energy Congress, 25th-27th March 2014, Hammamet, Tunisia.

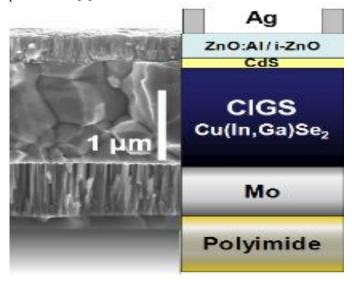
Fig. 1. Typical structure of flexible PV module (Courtesy of Flisom, Switzerland)

construction of Si solar cells hampers their economic integration into residential and commercial buildings; however, thin film solar cell technologies may prove to be most appropriate with respect to cost and ease of manufacture, and it is anticipated that the next generation of photovoltaic devices will be based entirely on thin film technologies. These cells are based on the material $CuIn_{1-x}Ga_xSe_2$ (CIGS) as the absorber layer (p-type) and they are the most efficient cells at the present time [2].

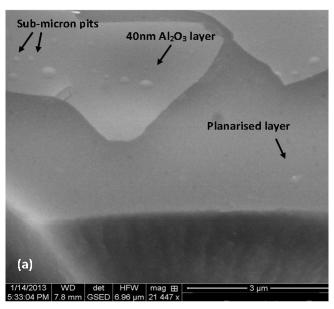
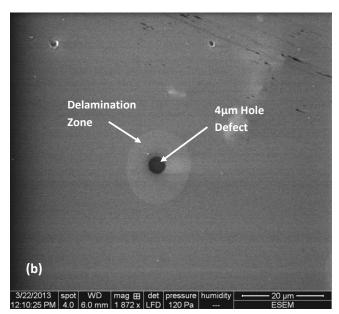
Fig. 4. ESEM of defects in Al_2O_3 barrier layer (a) Al_2O_3 /polymer cross-section, (b) typical hole type defect

investigate the Al_2O_3 /polymer structure, the low vacuum mode was employed using water vapour at pressures between 120 and 400 Pa. An off-axis large field detector was used to collect the amplified secondary electron signal emitted from the specimen; this detector has the advantage of providing images with a relatively large field-of-view. A cross-sectional electron micrograph was obtained near the edge of the Al_2O_3 /polymer structure as shown in Fig (4a). The image shows the 40-nm Al_2O_3 barrier layer that exhibits pit-like defects between 100 nm and 500 nm in diameter on the surface. In Fig (4b) an image of a typical hole defect, approximately 4 μ m in diameter, in the Al_2O_3 layer is shown. A region of differing contrast is observed in the area surrounding this hole; this is attributed to the delamination of the Al_2O_3 layer from the underlying polymer structure due to water penetration.

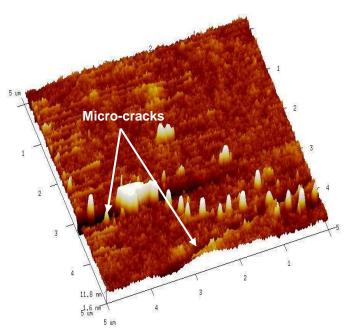
Fig. 5. AFM image-micro-crack type defect

Although the object targeting and the image acquisition can be more rapid using the SEM, polymers are difficult to examine as they have a tendency to rapidly charge, even with a conductive coating, resulting in beam divergence and image degradation. In contrast, AFM can analyse the samples with minimal sample preparation, thus preserving surface textures and allowing repeat analyses without the risk of charging. The AFM can produce an equal or higher data resolution image of an equivalent area, but with the addition of absolute X, Y and Z for any features. In this study, a Bruker Dimension Icon AFM was used as an independent measure of the Al₂O₃ ALD film. It allows much smaller defect sizes to be examined than would be possible by the SEM. It can also be used to determine the size of the cracks over the films which were not detectable by the CCI or the optical microscopy techniques. Fig 5 shows crack type defect captured by this technique.

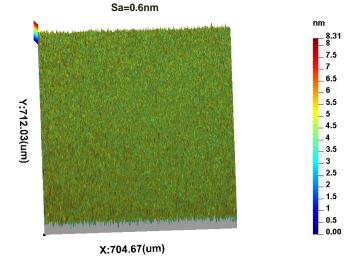
Fig. 6. Non-defective sample (Sa = 0.6nm)

The surface roughness average of a defect free sample Fig. 6 was measured to be ~0.6nm. Based on that, the Wolf Pruning method was conducted with prune conditions set for each sample in order to isolate only the largest defects. The criteria of being defined as a large defect was 6σ where Sq= 0.6nm height and $15\mu m$ width. Effective discrimination of significant and non-significant defects was recorded.

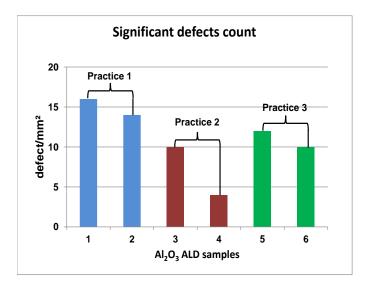
Fig. 7. Shows the significant defects count

The results in Fig 7. Showing significant defects count as analysed by the 'wolf pruning' method. Comparing each two sets of the samples results, feature segmentation analysis and the pruning condition of (6 σ where Sq= 0.6 nm height and 15µm width) have provided a clear evidence for the correlation of surface defects size, defect density, and the transmission of water vapour through the barrier coating layers. The investigation concludes that large defects are the dominant factor for determining the WVTR.
