Defect Detection in Thin-film Photovoltaics; Towards Improved Efficiency and Longevity

M. Elrawemi, L. Blunt, L. Fleming, and F. Sweeney

Centre for Precision Technologies
University of Huddersfield
Huddersfield, UK
E-mail: U0950234@hud.ac.uk

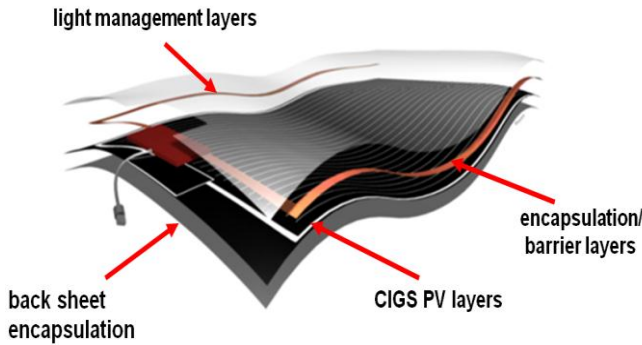
Flexible solar modules comprise four functional layer groupings as shown in Fig 2. The main focus of the investigation in this paper is the barrier layer which is incorporated in the encapsulation layers. This layer is typically formed from a planarised Polyethylene Naphthalate (PEN) sheet with an amorphous Al₂O₃ barrier coating <50 nm thick. The Al₂O₃ barrier coating is produced by Atomic Layer Deposition (ALD). The ALD is a controlled layer-by-layer deposition technique that enables the deposition of thin, smooth, and highly conformal films with atomic layer precision and typical thickness ranges between 1 and 100 nm [4].

Fig. 2. Schematic of the flexible PV Module (Courtesy of Flisom, Switzerland)

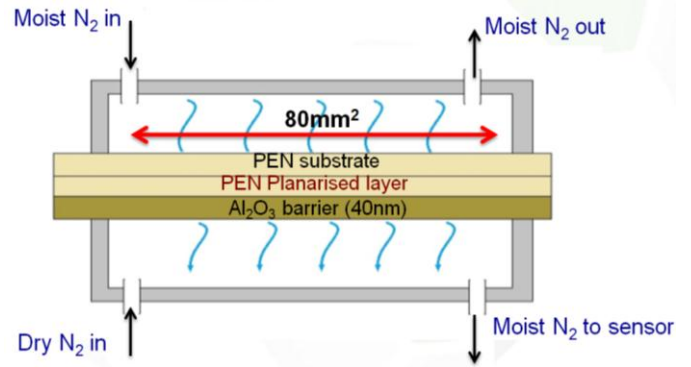
Prior to the surface measurements, the samples were measured for water vapour transmission rate (WVTR) using Isostatic standard test instrumentation (MOCON®) at specified conditions (38°C and 90% RH respectively). This method involves the test specimen being held in a sealed chamber such that it separates two sides of the chamber as shown in the Fig 3.

Fig. 3. Schematic representation of WVTR test

On one side of the sample a highly saturated wet environment is maintained at a constant temperature, whilst on the other, a dry nitrogen carrier gas is passed to a coulometric phosphorous pentoxide sensor where water vapour which enters is converted to a measurable charge [5].

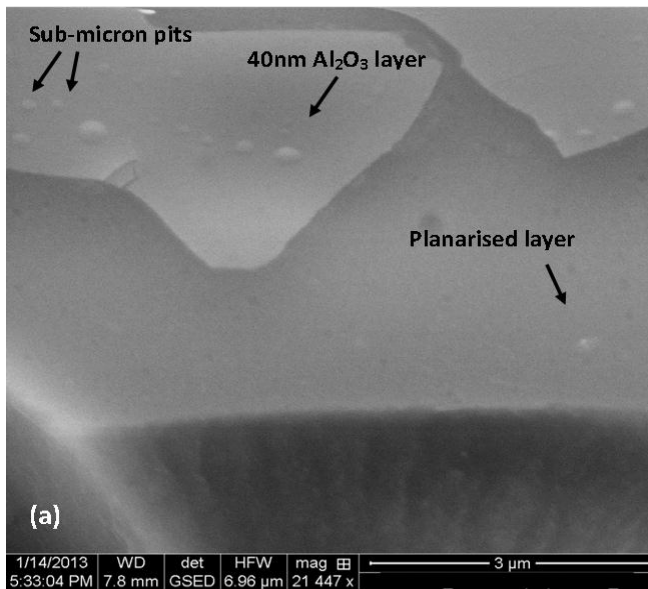
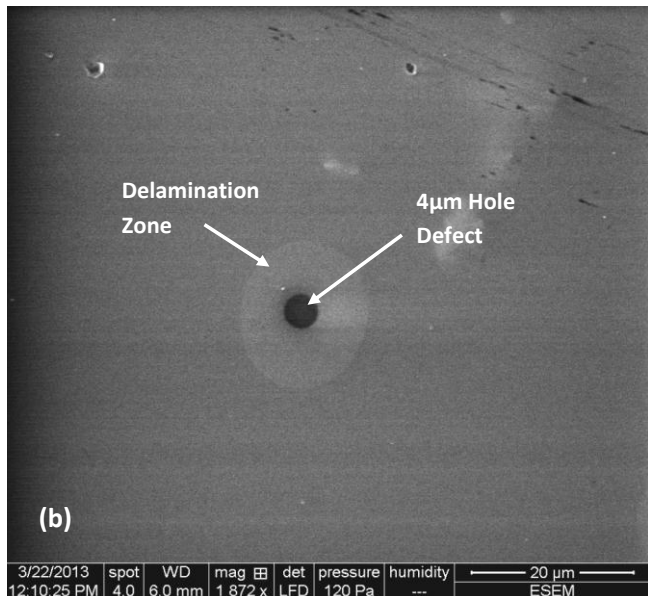
investigate the Al_2O_3 /polymer structure, the low vacuum mode was employed using water vapour at pressures between 120 and 400 Pa. An off-axis large field detector was used to collect the amplified secondary electron signal emitted from the specimen; this detector has the advantage of providing images with a relatively large field-of-view. A cross-sectional electron micrograph was obtained near the edge of the Al_2O_3 /polymer structure as shown in Fig (4a). The image shows the 40-nm Al_2O_3 barrier layer that exhibits pit-like defects between 100 nm and 500 nm in diameter on the surface. In Fig (4b) an image of a typical hole defect, approximately 4 μm in diameter, in the Al_2O_3 layer is shown. A region of differing contrast is observed in the area surrounding this hole; this is attributed to the delamination of the Al_2O_3 layer from the underlying polymer structure due to water penetration.

Fig. 4. ESEM of defects in Al_2O_3 barrier layer (a) Al_2O_3 /polymer cross-section, (b) typical hole type defect

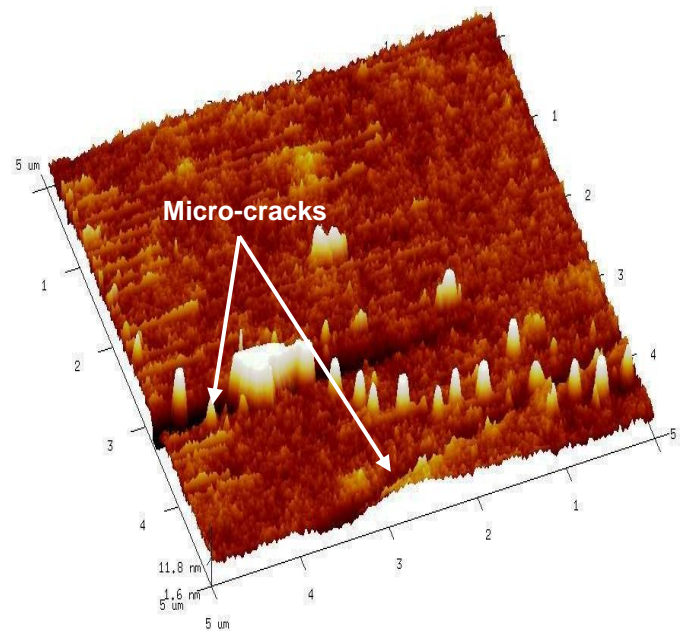
Although the object targeting and the image acquisition can be more rapid using the SEM, polymers are difficult to examine as they have a tendency to rapidly charge, even with a conductive coating, resulting in beam divergence and image degradation. In contrast, AFM can analyse the samples with minimal sample preparation, thus preserving surface textures and allowing repeat analyses without the risk of charging. The AFM can produce an equal or higher data resolution image of an equivalent area, but with the addition of absolute X, Y and Z for any features. In this study, a Bruker Dimension Icon AFM was used as an independent measure of the Al_2O_3 ALD film. It allows much smaller defect sizes to be examined than would be possible by the SEM. It can also be used to determine the size of the cracks over the films which were not detectable by the CCI or the optical microscopy techniques. Fig 5 shows crack type defect captured by this technique.

Fig. 5. AFM image-micro-crack type defect

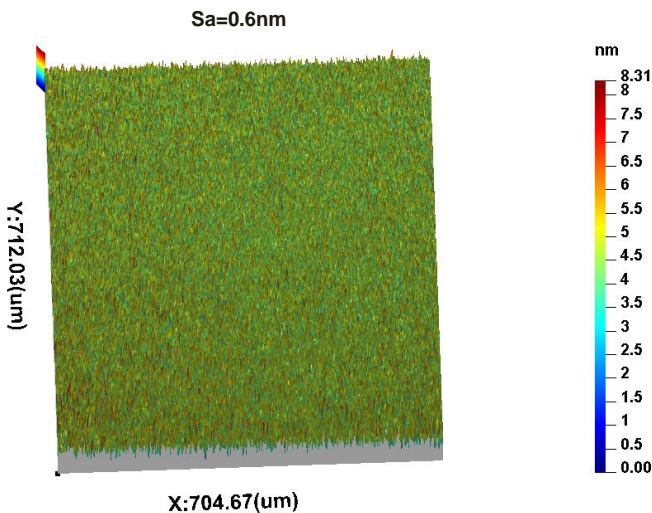
The surface roughness average of a defect free sample Fig. 6 was measured to be ~0.6nm. Based on that, the Wolf Pruning method was conducted with prune conditions set for each sample in order to isolate only the largest defects. The criteria of being defined as a large defect was 6σ where $S_q = 0.6\text{nm}$ height and $15\mu\text{m}$ width. Effective discrimination of significant and non-significant defects was recorded.

Fig. 6. Non-defective sample ($S_a = 0.6\text{nm}$)

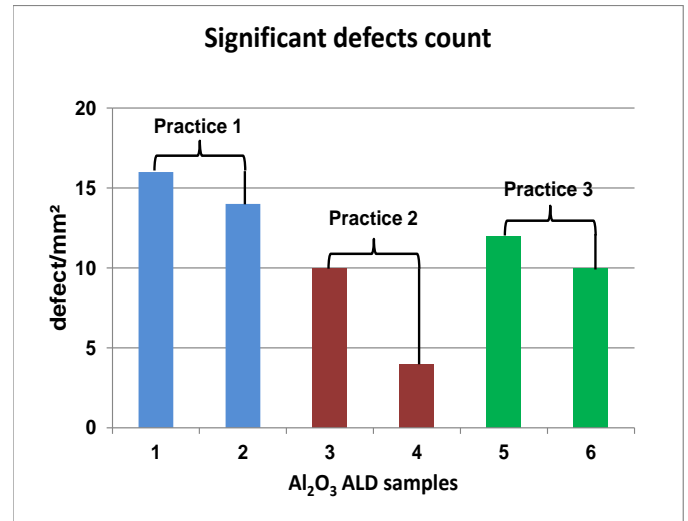
The results in Fig 7. Showing significant defects count as analysed by the 'wolf pruning' method. Comparing each two sets of the samples results, feature segmentation analysis and the pruning condition of (6σ where $S_q = 0.6\text{nm}$ height and $15\mu\text{m}$ width) have provided a clear evidence for the correlation of surface defects size, defect density, and the transmission of water vapour through the barrier coating layers. The investigation concludes that large defects are the dominant factor for determining the WVTR.

Fig. 7. Shows the significant defects count
