Walton, Karl, Blunt, Liam, Fleming, Leigh, Goodhand, Martin and Lung, Hang (2014) A real parametric characterisation of ex-service compressor blade leading edges. *Wear*, 321. pp. 79-86. ISSN 00431648

# Areal parametric characterisation of ex-service compressor blade leading edges

In-service the degradation of compressor blade leading edges can have a disproportional effect on compressor efficiency. The high surface curvature in this region makes quantifying the surface finish of this sensitive and prominent region difficult. An automated technique that characterises the roughness of the leading edge in terms of areal parameters is presented. A set of ex-service blades of differing sizes are used to demonstrate the procedure. Improved characterisation of this blade region will allow engine companies to better understand where in-service deterioration has the greatest effect and inform them as to how they might minimise the effect. The present work shows that the leading edges of compressor blades exhibit a significantly higher characteristic surface roughness than other blade regions, and the spatial distribution of peaks in this characteristic roughness is detailed. In addition

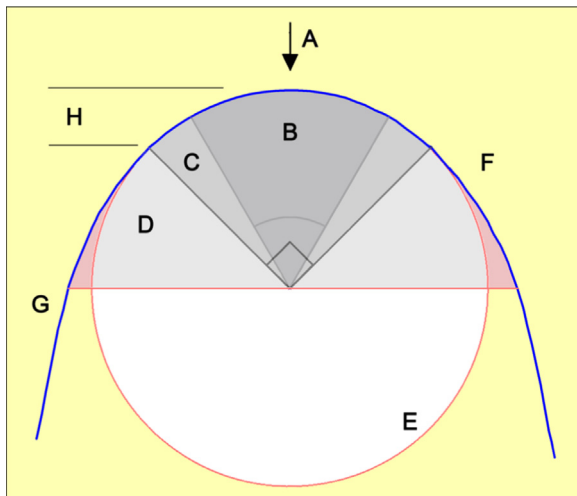
**Fig. 2.** Leading edge region cross-section schematic; (A) instrument optical axis (zero angle of attack) (B) central 60° frontal field of leading edge, (C) central 90° frontal field of leading edge, (D) nominal frontal field of whole leading edge, (E) circle fitted to nominal leading edge circular profile, (F) approximate blend point of leading edge into blade suction or pressure side (see Fig. 1), (G) leading edge flank, (H) approximate depth of measurement field.

Fig. 2 details the approximate frontal (zero angle of attack) projected region of a typical leading edge that it is possible to capture both practically and with robust surface roughness data. Additionally the flanks of the edge can be captured, but this must be done with a minimum of two extra measurement fields perhaps 60° either side of zero. Due to the complex geometry of leading edges see Fig. 5 it is not practical to combine or spatially register the resulting fields, thus limiting their usefulness. Additionally, section 3.1 indicates these flank regions exhibit a transitional (non-uniform) surface roughness character and thus are not homogeneous; homogeneity being a prerequisite for areal parametric characterisation [16]. Hence

with a single instrument field employed at close to zero angle of attack the central 60° to 90° arc of the edge (corresponding to central 1/2 to 2/3 of the projected frontal leading edge area) was captured, see Fig. 2. Surface regions at flank angles extending beyond this range offer increasingly poor data quality, and increased residual form to remove. Suitably fixed and aligned by goniometer for; pitch, yaw and angle of attack, a minimum vertical scan height and maximum traverse length were achieved for a given measurement traverse (see Fig. 5).
