Assessing the material loss of the modular taper interface in retrieved metal on metal hip replacements

Paul J Bills^{1,3}, R Racasan¹, P Tessier^{1,2}, LA Blunt¹

¹EPSRC Centre for Innovative Manufacturing in Advanced Metrology, University of Huddersfield, Queensgate, Huddersfield. HD1 1DH. UK

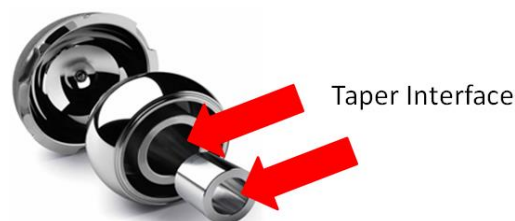
Figure 1 Metal-on-metal hip replacement taper interface

Total hip replacement is considered to be the operation of the century with over 71,000 primary procedures performed annually in the UK alone [1-2]. Large head metal on metal hips (LHMOM) and hip resurfacings accounted for 15% of hip replacements used in primary operations in 2006-2008. Following higher than normal revision rates reported (13.6% at 7 years) for these type of implant compared to other designs the use of metal on metal decreased to 5% in 2011 [2]. A LHMOM hip comprises of a monobloc acetabular cup and a modular head that is secured to the femoral stem through a taper interface (see fig. 1).

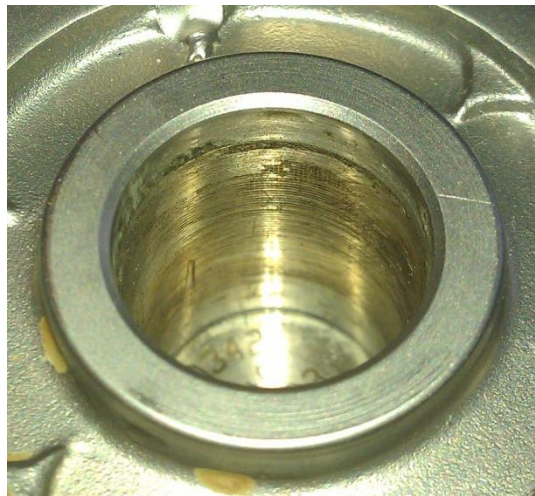
Figure 2 Retrieved metal-on-metal femoral head showing clear delineation of damage to taper surface.

Most previous studies relied on either the visual assessment of taper damage (which can be clearly seen in figure 2) or measurement by means of coordinate measuring machines [5,10]. The main limitation of visual inspection and microscopy is that it does not provide a quantitative assessment of wear. Coordinate measuring machines enable the assessment of wear volume but even the use of very small styli such as one of a commonly used 1mm diameter have the potential of acting as a mechanical filter to any surface with significant topography as would be observed in the case of a roughened taper surface.

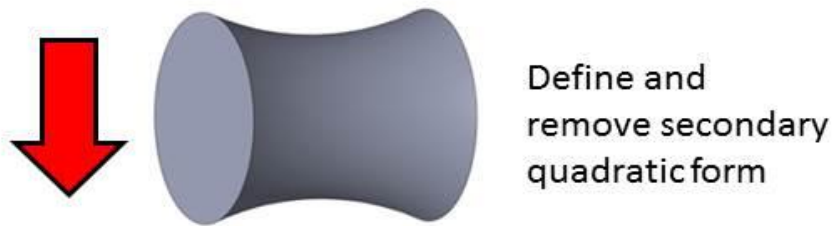
Figure 3 Removal of form deviation from a measured taper using Matlab protocol

The raw data is analysed through a number of procedures controlled through the application of a set of software tools developed in Matlab (The Mathworks Inc., Natick, USA). Following data capture the profile data is stitched and rolled out to give a rectangular areal map of the taper surface. The first step of the analysis is to level the surface map and remove the conical form using a linear least squares fit to all of the data. Figure 3 details the levelling and form removal process, figure 3a shows a primary unlevelled surface profile, figure 3b shows the surface profile with conic form removed.

The surface to be levelled from is selected (shown as green highlighted area in figure 3b) and the type of levelling (linear or quadratic) is then superimposed. The quadratic fit is suitable for components that show signs of 'barrelling' or 'hogging' caused by the manufacturing process, such as the case shown in figure 3b. The resulting levelled profile is then shown in figure 3c.

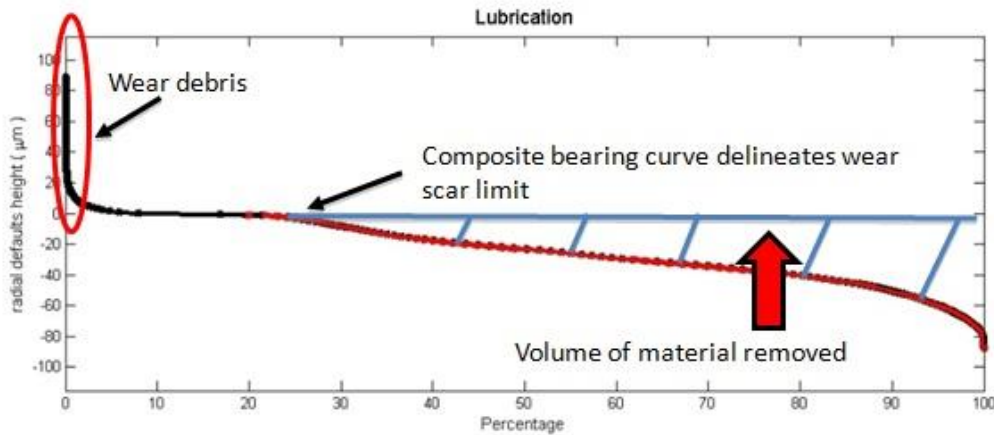
Figure 5 Abbott-Firestone curve showing area of wear debris and identification of material loss

The curve presented in figure 5 is generated based on the measurement data presented in figure 4. It is important to note the high aspect ratio at the left part of the curve which is due to debris sat on the taper surface. Due to the small volumes being measured this must be removed from the analysis as it has the potential to skew the volume calculation significantly. This determined volume of removed material highlighted in figure 5 is correlated with the cone form parameters that were determined at the first step of the levelling and fitting process defined in section 2.2.
