Assessing the material loss of the modular taper interface in retrieved metal on metal hip replacements

Abstract. Measuring the amount of material loss in the case of revised hip replacements is considered to be a prerequisite of understanding and assessing the true *in vivo* performance of the implant. This paper outlines a method developed by the authors for quantifying taper material loss as well as more general taper interface parameters. Previous studies have mostly relied on visual inspection to assess the material loss at the taper interface, whereas this method aims to characterize any surface and form changes through the use of an out-of-roundness measurement machine. Along with assessing the volumetric wear, maximum linear penetration and taper contact length can also be determined. The method was applied to retrieved large head metal-on-metal femoral heads in order to quantify the material loss at this junction. Material loss from the female femoral head taper can be characterized as a localized area that is in contact with the stem taper surface. The study showed that this method has good repeatability and a low level of interoperator variation between operators.

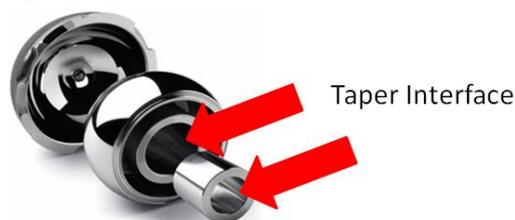
Figure 1 Metal-on-metal hip replacement taper interface

Total hip replacement is considered to be the operation of the century with over 71,000 primary procedures performed annually in the UK alone [1-2]. Large head metal on metal hips (LHMOM) and hip resurfacings accounted for 15% of hip replacements used in primary operations in 2006-2008. Following higher than normal revision rates reported (13.6% at 7 years) for these type of implant compared to other designs the use of metal on metal decreased to 5% in 2011 [2]. A LHMOM hip comprises of a monobloc acetabular cup and a modular head that is secured to the femoral stem through a taper interface (see fig. 1).

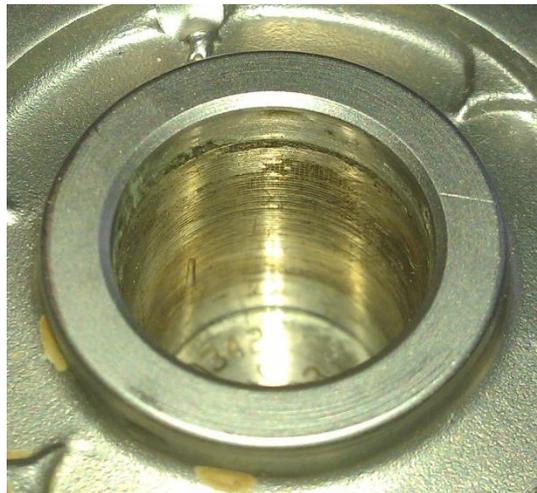
Figure 2 Retrieved metal-on-metal femoral head showing clear delineation of damage to taper surface.

Most previous studies relied on either the visual assessment of taper damage (which can be clearly seen in figure 2) or measurement by means of coordinate measuring machines [5,10]. The main limitation of visual inspection and microscopy is that it does not provide a quantitative assessment of wear. Coordinate measuring machines enable the assessment of wear volume but even the use of very small styli such as one of a commonly used 1mm diameter have the potential of acting as a mechanical filter to any surface with significant topography as would be observed in the case of a roughened taper surface.

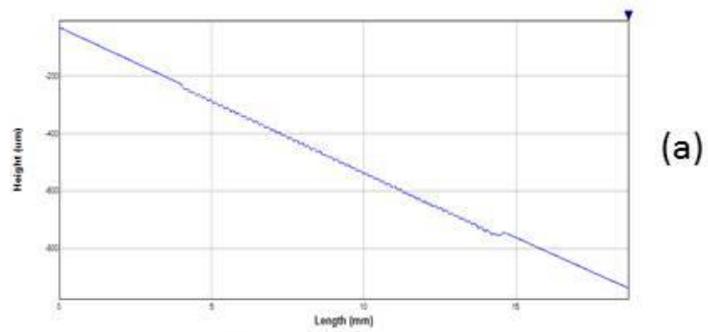
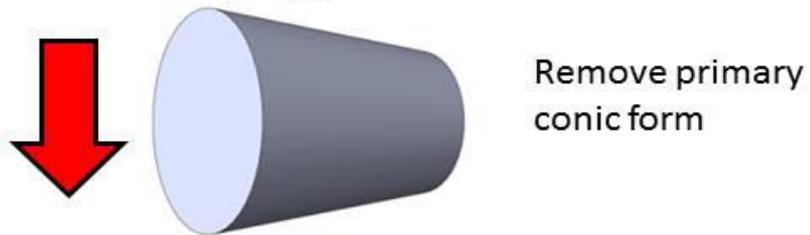
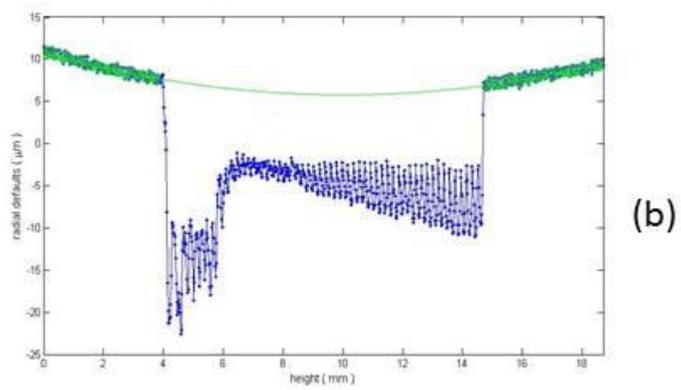
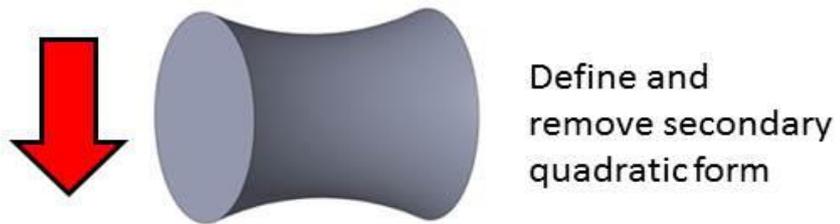
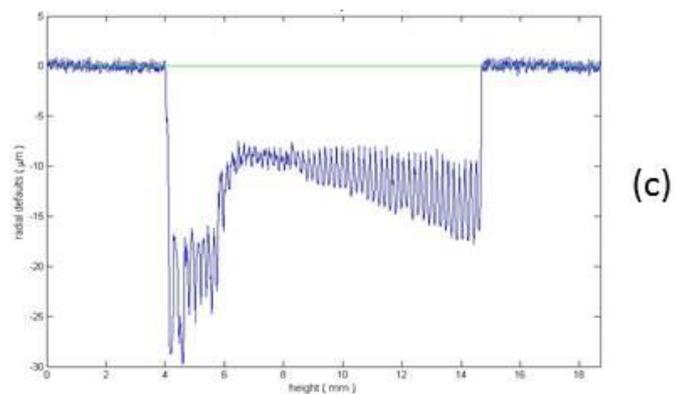
Figure 3 Removal of form deviation from a measured taper using Matlab protocol

The raw data is analysed through a number of procedures controlled through the application of a set of software tools developed in Matlab (The Mathworks Inc., Natick, USA). Following data capture the profile data is stitched and rolled out to give a rectangular areal map of the taper surface. The first step of the analysis is to level the surface map and remove the conical form using a linear least squares fit to all of the data. Figure 3 details the levelling and form removal process, figure 3a shows a primary unlevelled surface profile, figure 3b shows the surface profile with conic form removed.

The surface to be levelled from is selected (shown as green highlighted area in figure 3b) and the type of levelling (linear or quadratic) is then superimposed. The quadratic fit is suitable for components that show signs of 'barrelling' or 'hogging' caused by the manufacturing process, such as the case shown in figure 3b. The resulting levelled profile is then shown in figure 3c.

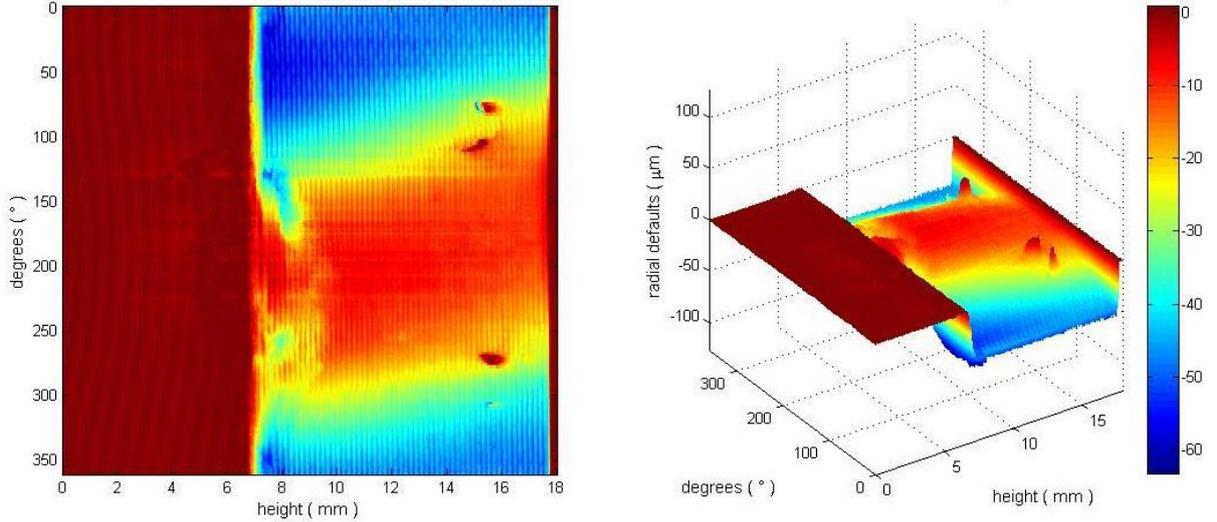
Figure 4 Example of levelled and fitted taper surface map

At this point the volume of material loss can be calculated. The x axis of figure 4 describes the measured height of the taper in mm while the y axis describes the degree spacing of the vertical plots from 0-360 degrees. The Matlab model corrects for scaling on the y axis to take into account the shape of the cone by recovering the slope data from the original straightness profiles and producing a surface map such as shown in figure 4.

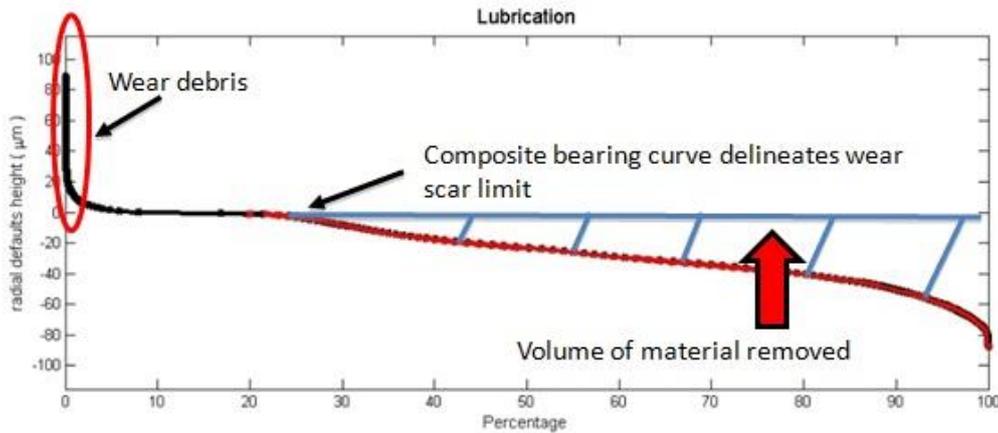
Figure 5 Abbott-Firestone curve showing area of wear debris and identification of material loss

The curve presented in figure 5 is generated based on the measurement data presented in figure 4. It is important to note the high aspect ratio at the left part of the curve which is due to debris sat on the taper surface. Due to the small volumes being measured this must be removed from the analysis as it has the potential to skew the volume calculation significantly. This determined volume of removed material highlighted in figure 5 is correlated with the cone form parameters that were determined at the first step of the levelling and fitting process defined in section 2.2.

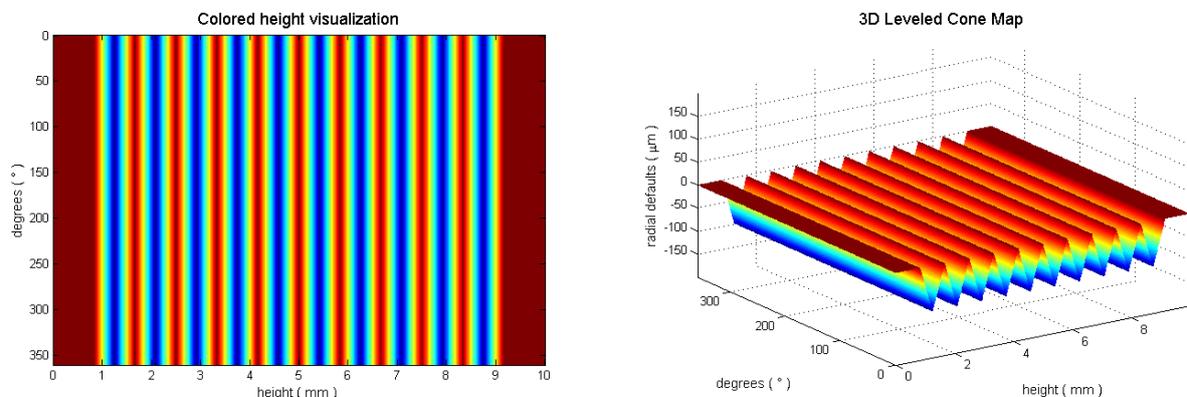
Figure 6 Virtual taper data file containing a region of material loss

The virtual taper surface was generated with a taper length of 10mm. A material loss region was simulated in a section of the taper with a length of 8mm and an equal depth of 100 μm as seen in figure 6 below. The material loss region consisted of a sawtooth pattern that repeats for 10 consecutive instances. The file consists of 360 vertical traces and each trace contains 2500 data points which is representative of a taper measurement dataset from the Talyrond out-of-roundness measurement machine.

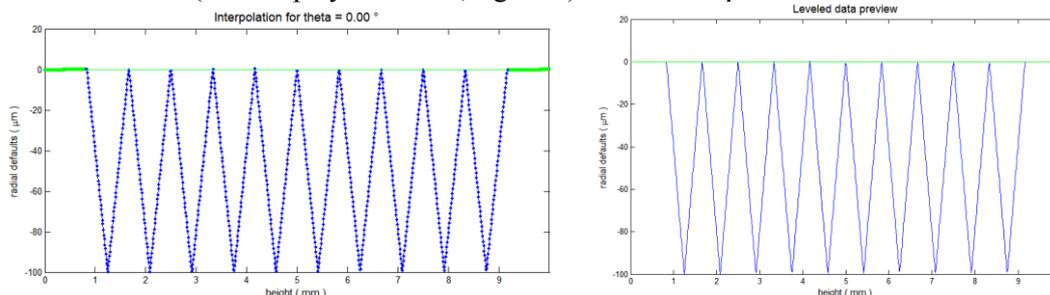
Figure 7 Levelling process showing selected unworn data in green (left) and subsequent fitting (right)

The fitting procedure was carried out as previously detailed and by excluding the data in the area of simulated material loss (data displayed in blue, figure 7) area an adequate fit was obtained.

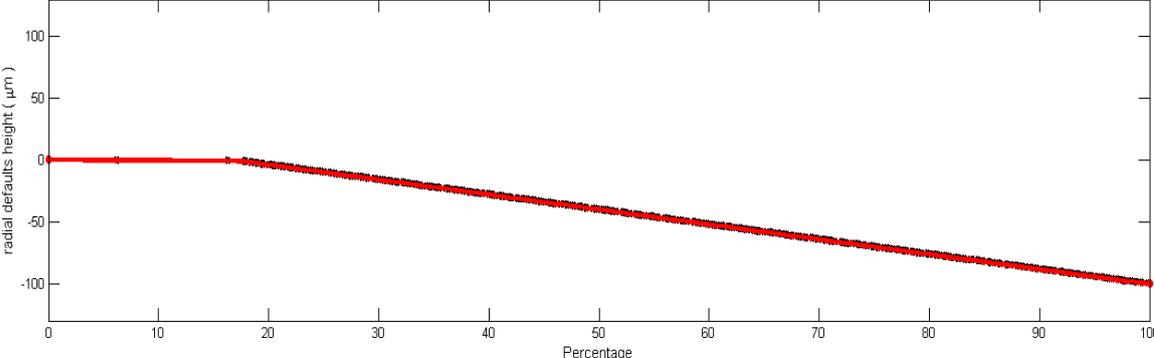
Figure 8 Bearing area curve shows the distribution of point heights in relation to the fitting plane

Based on the levelled dataset a bearing area curve is generated to determine the volume of material loss. The image below, figure 8, shows the representation of the bearing area curve where zero defines

the levelled surface plane and the y axis shows the height difference from that plane. The determined volume of material loss using the analysis method is 16.25 mm³. This was found to be accurate to two decimal places to the theoretical volume determined through numerical integration.

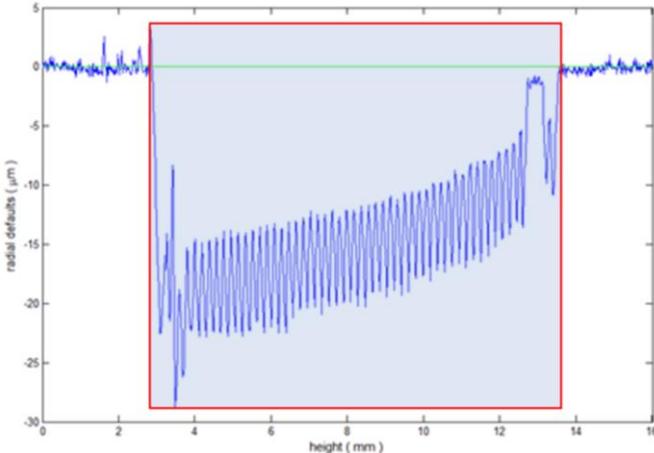
Figure 9 – Extracted profile from measured taper surface – area of contact highlighted.

Upon analysis it was clear that whereas areas to the distal and proximal end of the taper surface exhibited a relatively smooth surface finish with low amplitude texture, the area of contact showed evidence of material loss and a distinct higher amplitude textured imprint (see figure 9, above, highlighted area) with a wavelength, in this case, of approximately 0.2mm. Accumulated corrosion debris was identified at the distal end of each head taper. In the case of sample 3 shown as the lower image in figure 10 the debris forms a continuous band along the distal end of the taper. Further debris was present in localised small patches of the contact area of the taper. These could not be readily removed from the analysis and further cleaning of the component was not possible.

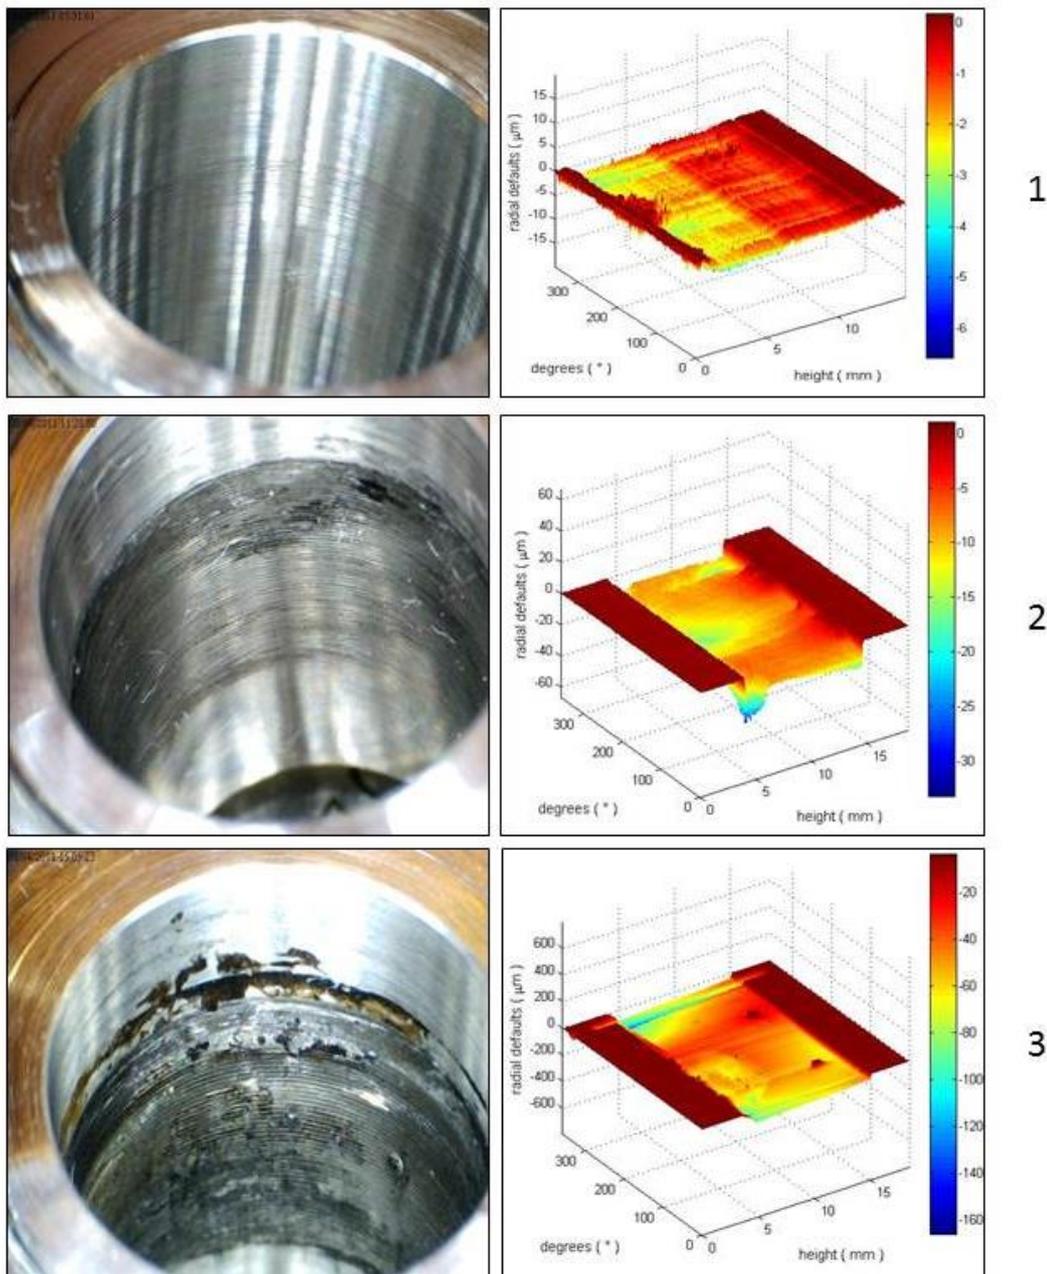
Figure 10 Taper measurements compared to visual Goldberg [9] score.

These cases seem to indicate that there could be a correlation between the volumetric and linear material loss in the case of the taper although a sample of a much greater size would need to be undertaken to verify this. Maximum linear values occur at the distal end of the taper in all three cases. There are signs of asymmetric wear in sample 3 which could be attributed to a toggling effect which has been previously described [5].
