Tickhill Castle Revisited: An Assessment of The Repair Strategy

## Tickhill Castle revisited

On a recent revisit it was encouraging to see that conservation work carried out on a ruined South Yorkshire castle in the 1980s had stood the test of time.

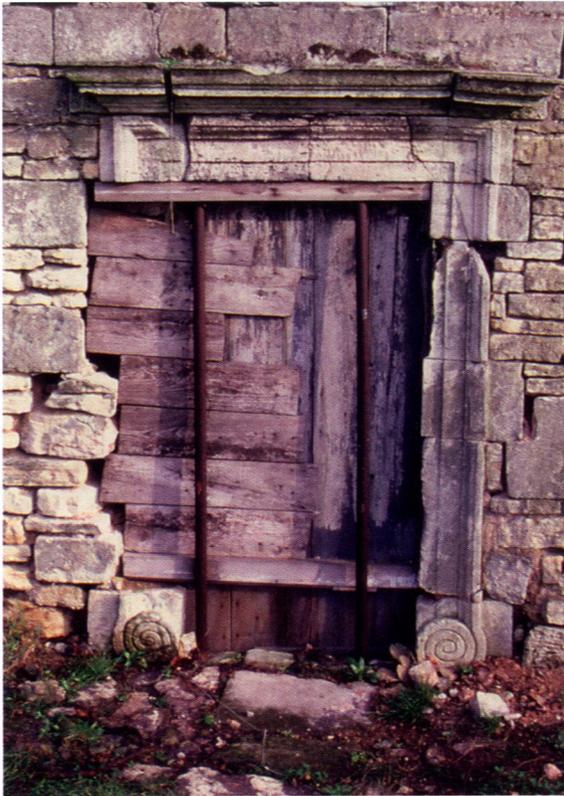
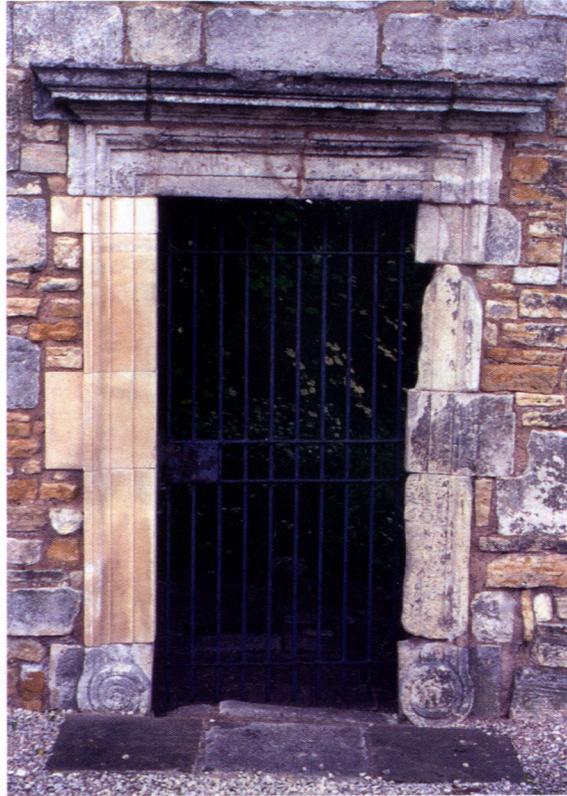
*A doorway in the north bailey wall, before and after repair*

It was encouraging to see that the mortars used in the 1980s had stood the test of time and had prevented significant plant recolonisation. The replacement stone to the doorway through the curtain wall has also mellowed, while still evident as an honest repair. The more recent work from 2005-6 using authentic lime mortars appears to have been successful too.

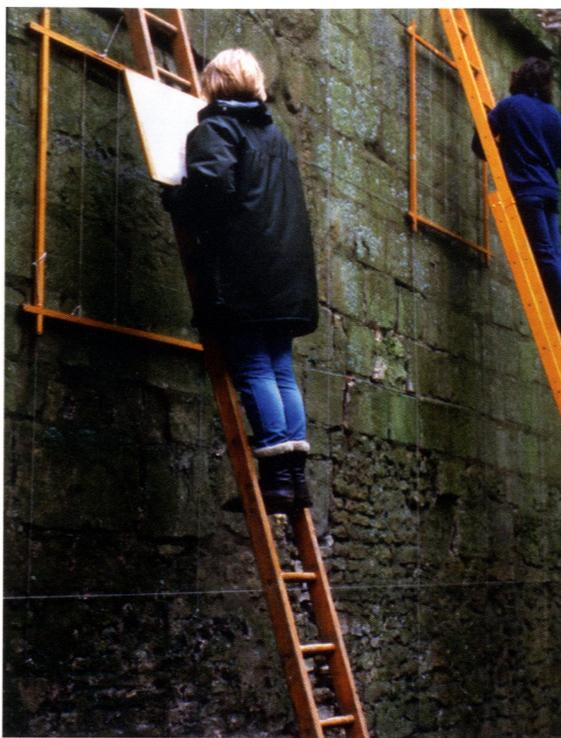
*Left: Recording the inside of the Gatehouse using planning frames*

and funded by the Manpower Services Commission, and supervised by the author on behalf of the County Archaeological Service. The recording began in the late summer of 1983. Ten-metre stretches of masonry were drawn at 1:20 in advance of a phased repair, starting with the bailey wall. A manual system of drawing was used by creating a one-metre string grid across the walls and a wooden frame positioned in front of each square. The strings on the frames were at 20cm intervals to make it easy for the surveyors to record the information on graph paper. For taller sections of masonry a primitive form of rectified photography was used, with the grid transferred to the photographs printed up to 1:20.

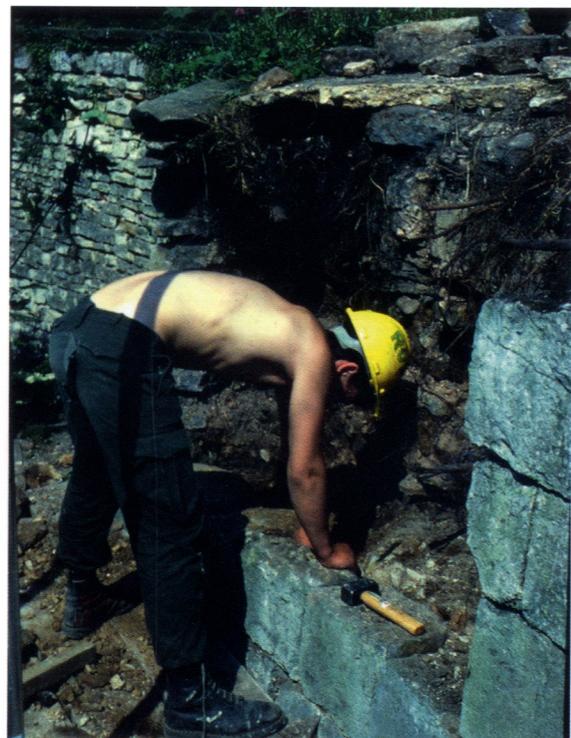
*Right: Removing invasive root systems from the bailey wall beneath the old cement capping*

Earlier repairs to the castle had used cement-based mortars. The tops of the walls had been capped with a very hard mortar containing round quartzite pebbles, affectionately known as 'scabby cap'. It had been subject to significant splitting, caused by slight differential movement of the walls, and invaded by plants and trees, especially where the capping was thinned on top of the ashlar facings. One plant that had been particularly invasive was Valerian, whose large tubers

swelled as the plants died back each autumn. Trees had also become established on some of the masonry, requiring some of the ashlars to be removed for the core of the wall to be repaired. A system of letters was used to identify courses and each stone numbered to ensure correct reinstatement. The old capping was replaced by cambered stonework set in mortar 'rough racking', to ensure that water was kept away from the core of the walls.
