The Influence of Wheel/Rail Contact Conditions on the Microstructure and Hardness of Railway Wheels

Paul Molyneux-Berry ^{1)*}, Claire Davis ²⁾ and Adam Bevan ¹⁾

1) Institute of Rail Research, School of Computing and Engineering, University of Huddersfield

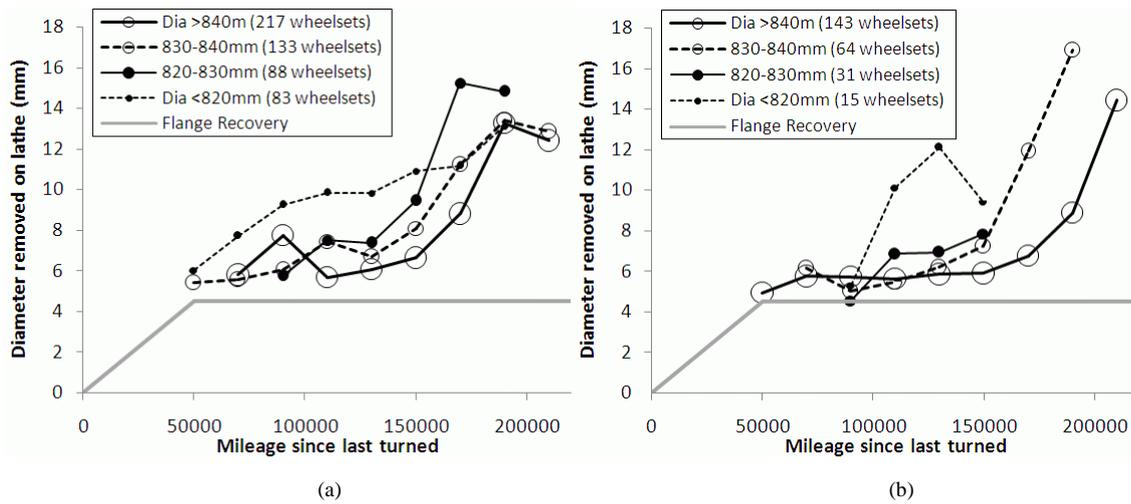
Fig. 1: Influence of wheel diameter on average depth of material removal at reprofiling, as a function of mileage since last turned. This example is for the leading wheelset 1, which is most commonly affected by RCF. Wheels turned because of other damage types (e.g. flats) or for parity are excluded. (a) Wheels from all manufacturers, (b) Wheels from only one manufacturer. It is usually necessary to remove approximately $\phi 5\text{mm}$ to recover the flange thickness; deeper cuts indicate that RCF damage has propagated more deeply. Both graphs show a trend that RCF becomes serious more quickly on wheels of smaller diameter.

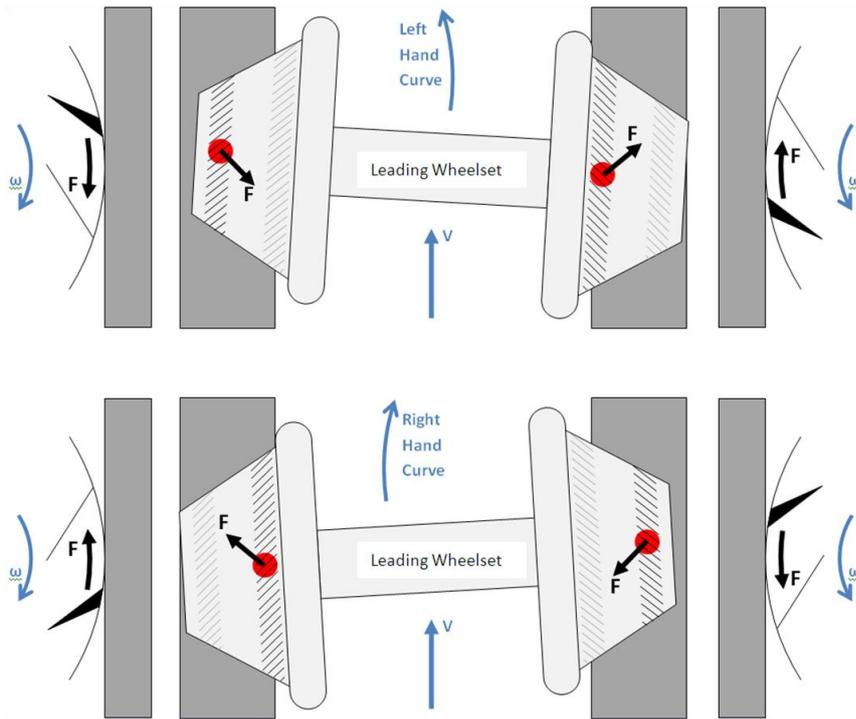
Fig. 5. Orientation of leading wheelset on left and right hand curves, showing position of wheel/rail contact, direction of tangential force, and formation of two bands of cracks. The cracks near the flange of the wheel tend to be forced closed before contacting the rail, and do not tend to propagate deep into the wheel. In contrast, the cracks near the field side of the wheel are forced open before they contact the rail; fluid entrapment and pressurisation in the contact can propagate these cracks into the underlying material.

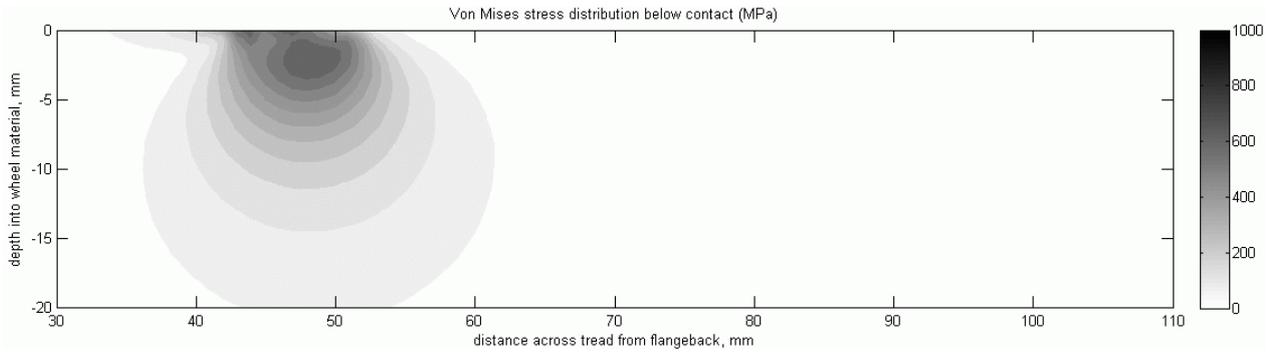
Fig. 6(a). Typical sub-surface stress field in the flange root, Region C

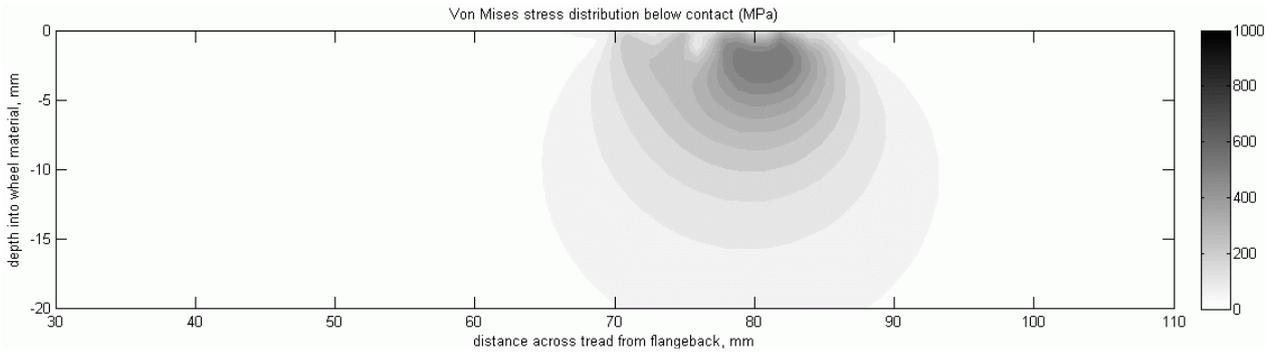
The peak of the stress distribution in Region D is sub-surface as shown in Figure 6(b), but generally of sufficiently low magnitude that it does not cause significant damage. Exceptionally, some individual wheels on the observed fleet of trains exhibit sub-surface transverse cracks in this region as shown in Figure 7. Following removal of the damaged material by turning, this has been found to recur on the same wheel. Because this is a rare but recurrent effect on the observed fleet and has not been observed on the opposite wheel of the same axle as an affected wheel, it is more likely to be influenced by a manufacturing or material defect in the wheel than by operating conditions or bogie set-up.

Fig. 6(b). Typical sub-surface stress field in the running band, Region D

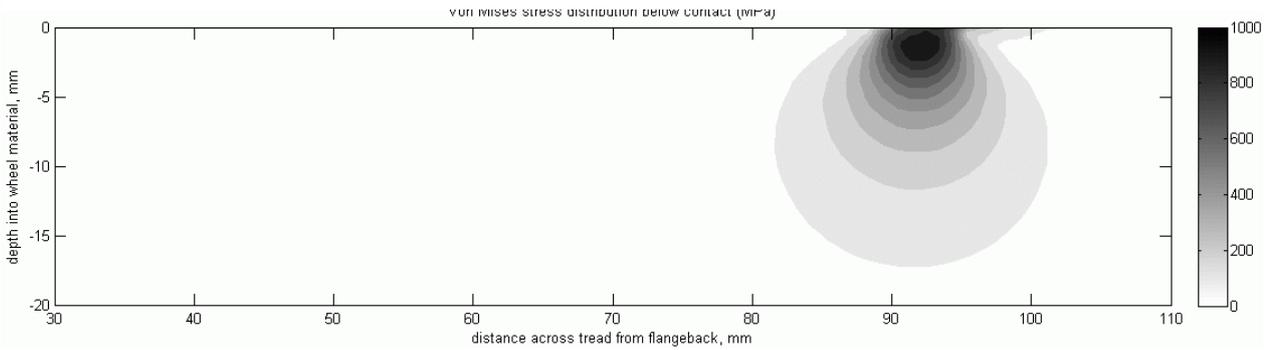
Fig. 6(c). Typical sub-surface stress field in the RCF band, Region E

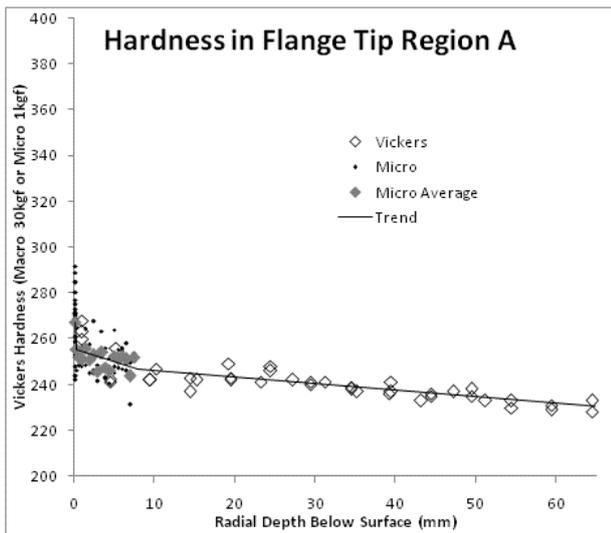
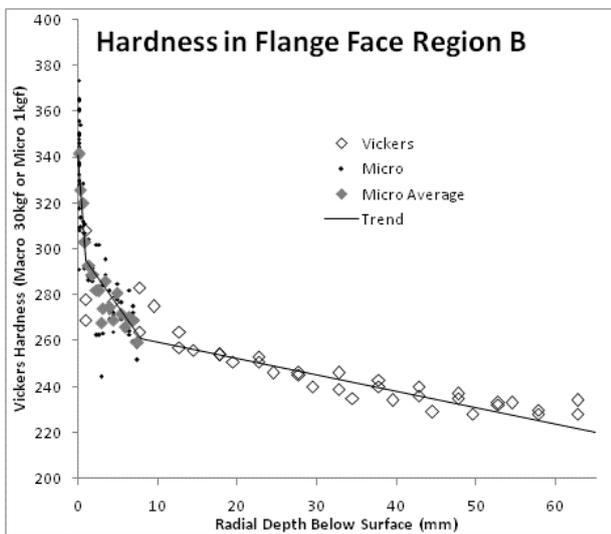
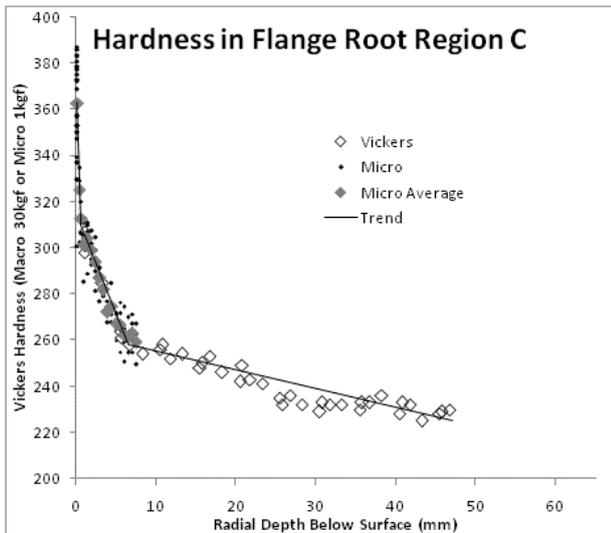
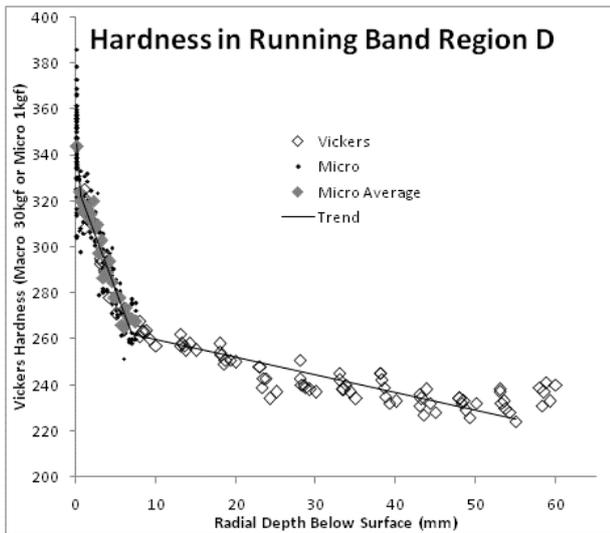
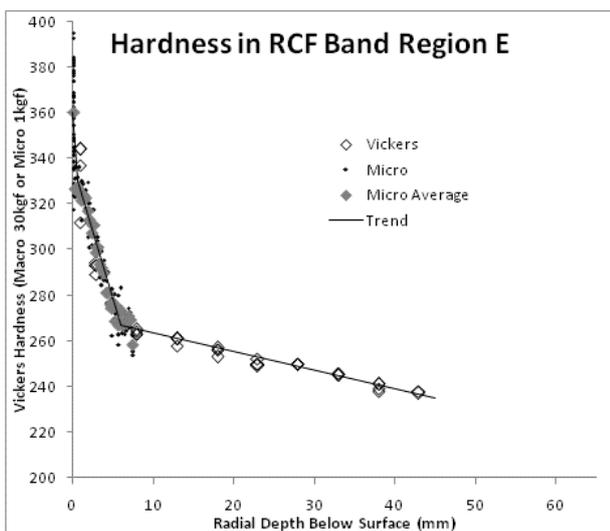
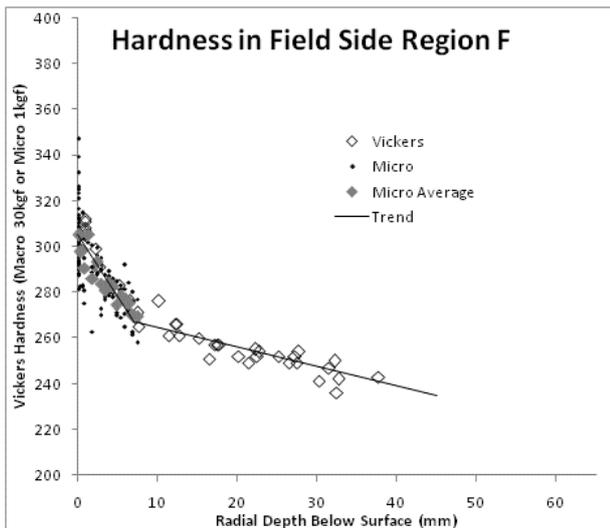
The 1-7mm depth band between these two areas shows a very distinct hardness gradient in Figure 9, especially underlying the zones of frequent wheel/rail contacts (regions C, D, E), but is not so obviously deformed at the microstructural level.

Fig. 9(a) Hardness Trend, Regional DMU, Flange Tip (A)

Fig. 9(b) Hardness Trend, Regional DMU, Flange Face (B)

Fig. 9(c) Hardness Trend, Regional DMU, Flange Root (C)

Fig. 9(d) Hardness Trend, Regional DMU, Running Band (D)

Fig. 9(e) Hardness Trend, Regional DMU, RCF Band (E)

Fig. 9(f) Hardness Trend, Regional DMU, Field Side (F)

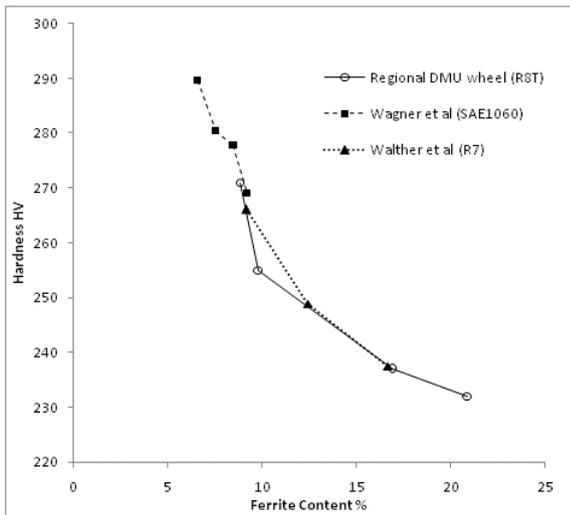
Fig. 21 Relationship between PE ferrite fraction and hardness.

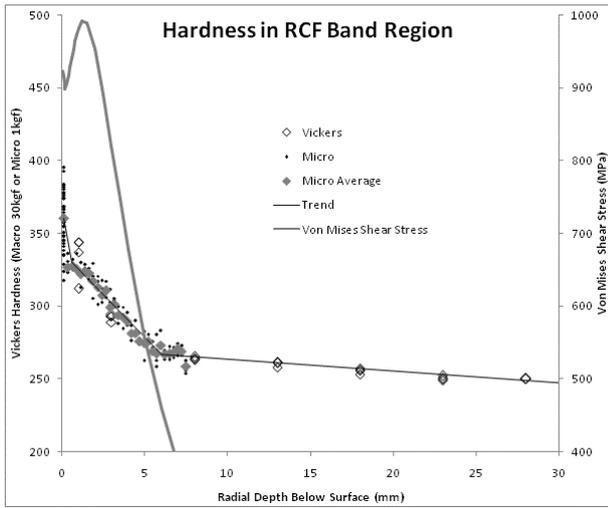
Figure 23 (for the RCF band) compares the measured hardness values to the maximum von Mises shear stress at a given depth derived from the simulations (Figure 7). The Vickers hardness value of the material is approximately half the yield stress in shear ^[38] so the parameters have been plotted on scaled axes to give an effective comparison. It is clear from Figure 23 that the depth of the hardening effect corresponds closely to the depth at which the applied shear stress exceeds the shear stress of the undeformed material.

Fig. 23 RCF Band: Relationship between predicted maximum von Mises shear stress and hardness in worn wheel.
