The Influence of Wheel/Rail Contact Conditions on the Microstructure and Hardness of Railway Wheels

Paul Molyneux-Berry,¹ Claire Davis,² and Adam Bevan¹

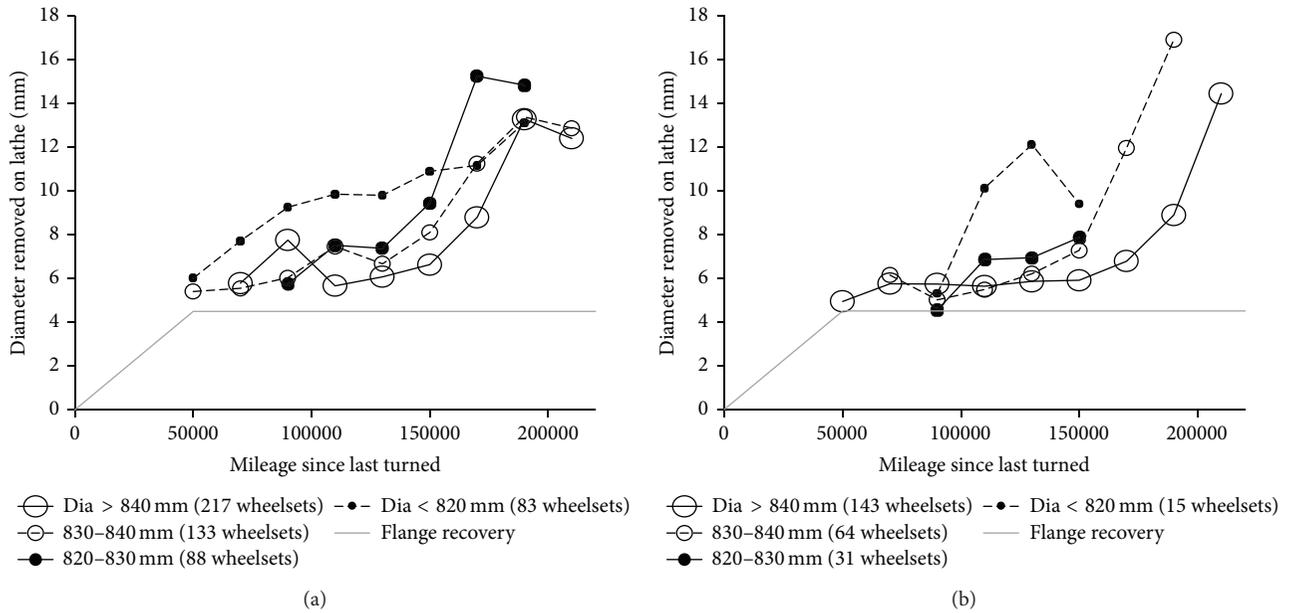
FIGURE 1: Influence of wheel diameter on average depth of material removal at reprofiling, as a function of mileage since last turned. This example is for the leading wheelset 1, which is most commonly affected by RCF. Wheels turned because of other damage types (e.g., flats) or for parity are excluded. (a) Wheels from all manufacturers. (b) Wheels from only one manufacturer. It is usually necessary to remove approximately $\phi 5$ mm to recover the flange thickness; deeper cuts indicate that RCF damage has propagated more deeply. Both graphs show a trend that RCF becomes serious more quickly on wheels of smaller diameter.

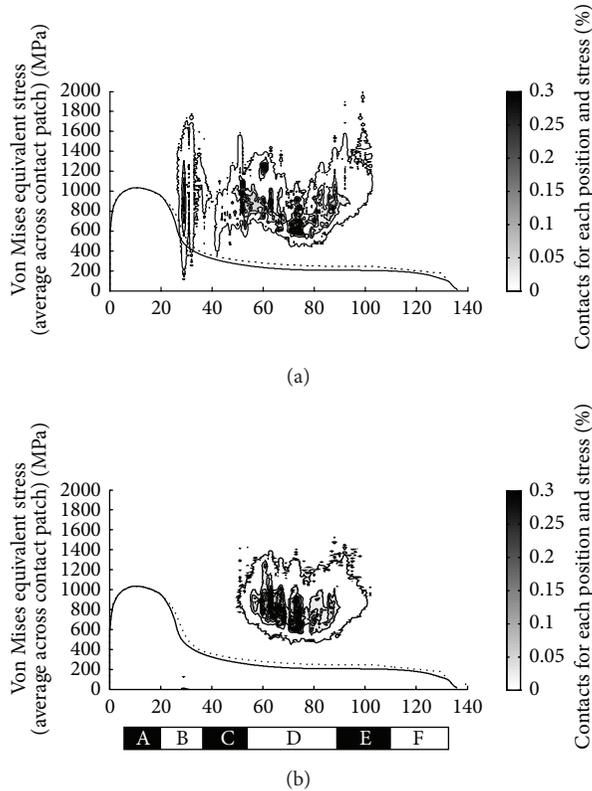
FIGURE 3: Distribution of contact conditions across a wheel profile for leading (a) and trailing (b) axle. The y axis shows the Von Mises equivalent stress (based on the average stress for each contact patch). Contours indicate the prevalence of contacts under each condition, with darker shades of grey representing a higher percentage of contacts, such as the frequent contacts in the centre of the tread at low stress. Higher stresses occur in other locations across the wheel profile when leading, but these are less frequent. On the trailing wheelset, the stress cycles are mostly in the running band (Region D) and with moderate stress levels. Approximately half the cycles on a given wheelset are experienced when it is leading the bogie, and half when it is the trailing wheelset.

Figure 3 shows the predicted distribution of contacts across the wheel tread of a powered wheel, based on Vampire

simulations with the associated Hertzian contact assumptions. Figure 3 also shows the new and fully worn wheel profiles and identifies six regions (A to F) across the wheel profile which are described below.

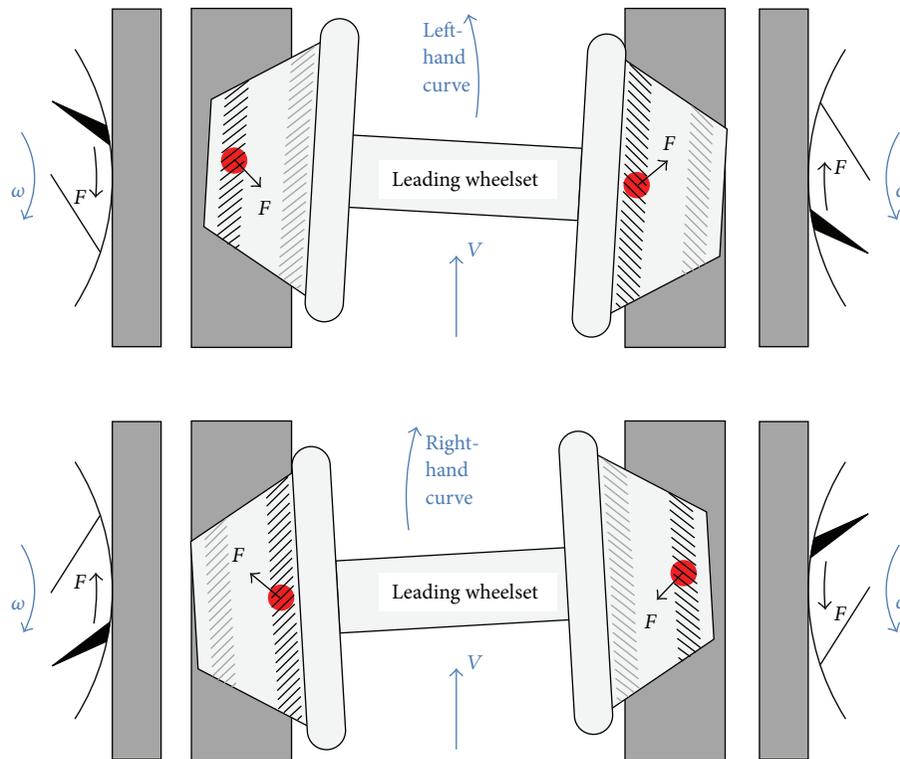
The simulated contact conditions can be associated with observed damage on the various regions across the wheel profile and with the changes in hardness and microstructure. The conditions in these regions are summarised in the following paragraphs and are described in more detail in [10]. The two observed crack bands are shown in Figure 4, while Figure 5 shows the curving conditions where this damage is formed on the leading wheelset of a bogie.

FIGURE 5: Orientation of leading wheelset on left and right hand curves, showing position of wheel/rail contact, direction of tangential force, and formation of two bands of cracks. The cracks near the flange of the wheel tend to be forced closed before contacting the rail and do not tend to propagate deep into the wheel. In contrast, the cracks near the field side of the wheel are forced open before they contact the rail; fluid entrapment and pressurisation in the contact can propagate these cracks into the underlying material.

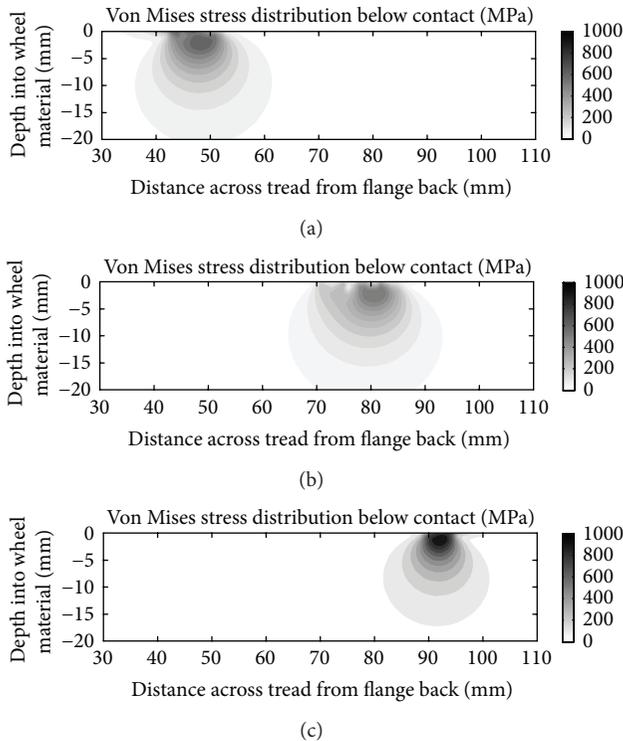
2.3. *Region C: Flange Root.* This portion of the leading wheel contacts the outer rail on moderate curves; there can be 2-point contact in regions B and C on sharp curves. This can cause significant normal and tangential stresses as the flange root is usually unlubricated. A typical sub-surface stress field is shown in Figure 6(a). Observed surface damage includes fine surface cracks; these do not tend to propagate deeper, most likely because the direction of the tangential forces does not promote propagation by fluid entrapment [10]; crack growth may also be counteracted by higher wear rates in this region.

2.5. *Region E: RCF Band.* This part of the leading wheel contacts the inner rail on curves; the opposite wheel is in flange face or flange root contact. There are fewer contacts in these conditions, but they typically occur with higher stresses and correspond with an increase in material hardening and observed RCF cracking. Contacts in this band can also occur on the trailing wheelset when curving at high cant deficiency, but these are less frequent and generally at lower stress. On many vehicles, cracks in this region are angled (as shown in Figure 5), but on the powered axles of the monitored fleet they are close to circumferential owing to the influence of traction forces. The surface direction of the observed cracks is approximately normal to the predicted tangential forces [10]. A typical sub-surface stress field is shown in Figure 6(c).

FIGURE 6: (a) Typical subsurface stress field in the flange root, Region C. (b) Typical subsurface stress field in the running band, Region D. (c) Typical subsurface stress field in the RCF band, Region E.

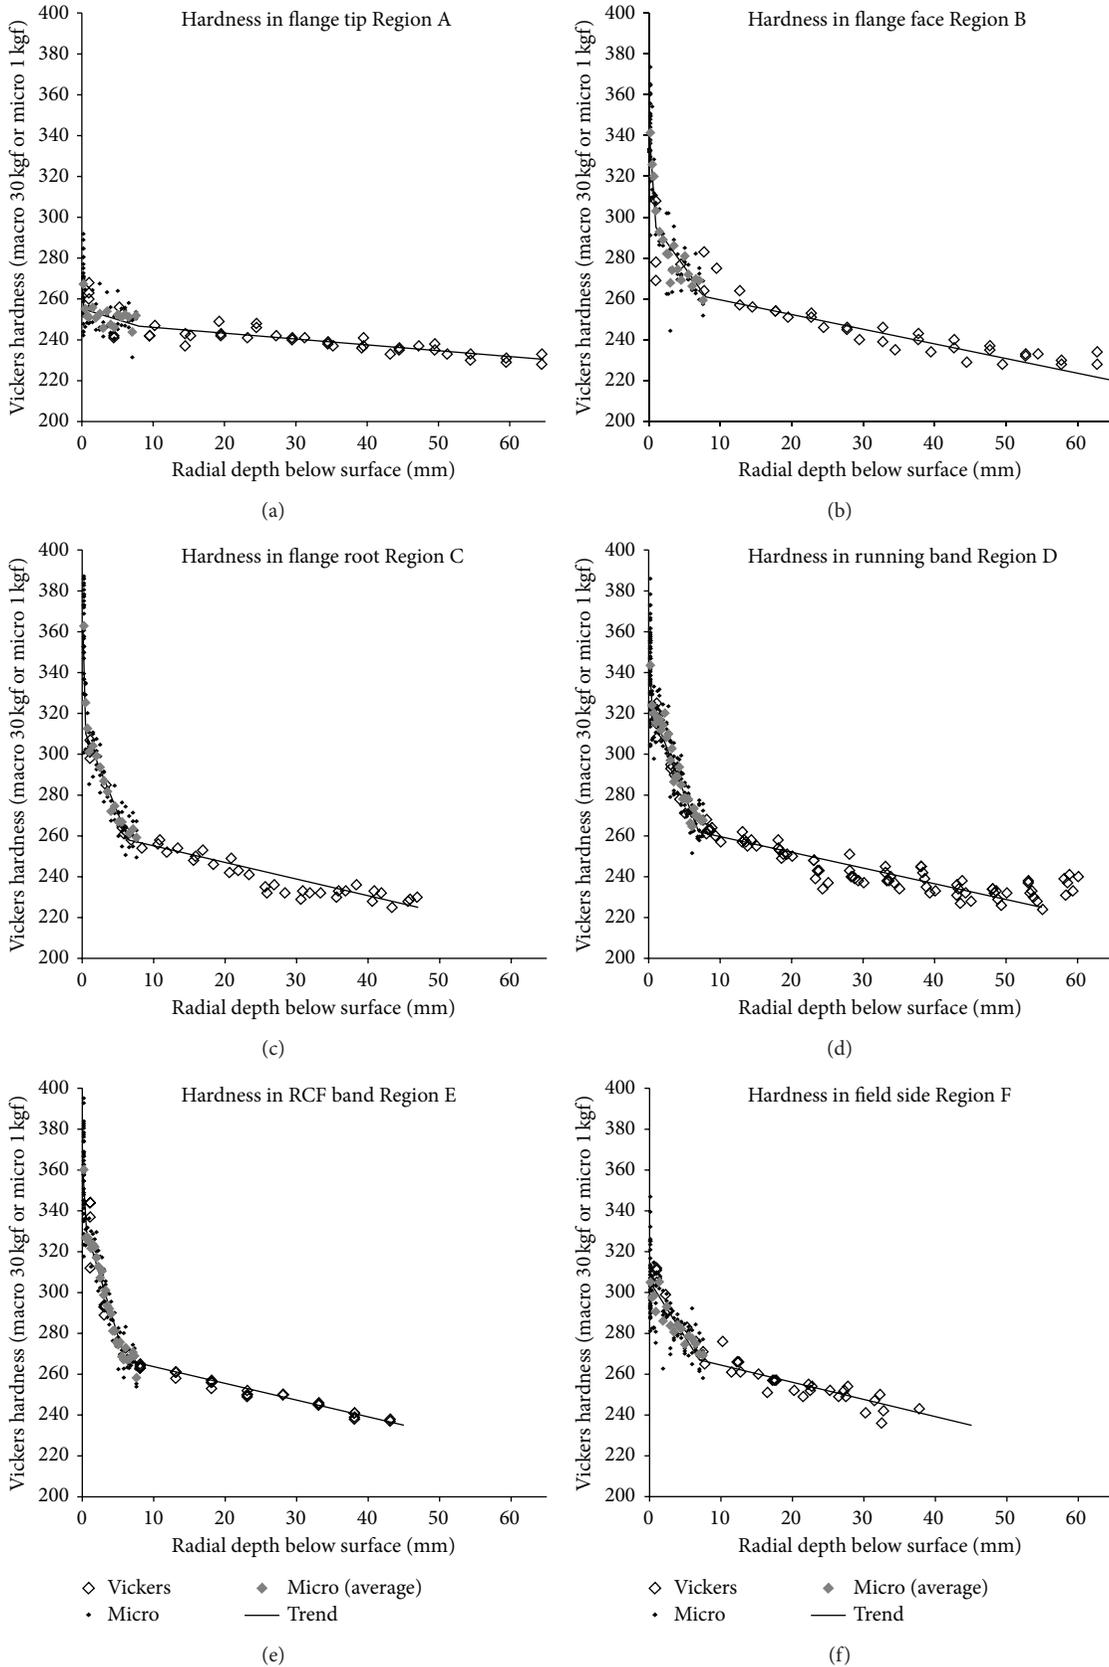
The lower part of Figure 8 shows hardness values typically in the range from 230 HV to 250 HV, with a slight trend of increasing hardness toward the surface and toward the right-hand (field) side of the wheel. Nearer the running surface, the hardness increases significantly. Figure 9 shows the hardness measurements as a function of depth for the six regions A to F across the wheel. In each region the hardness varies with depth according to a three-stage trend. However, the characteristics of these trends are different for each region of the wheel.

5.1. Underlying Hardness Trend: Ferrite Fraction and Pearlite Lamellae. Figure 9 demonstrates that in all six regions of the wheel rim section there is a gradual decrease in hardness with depth, below 8 mm under the running surface. This is similar to that shown in Figure 2 for a new wheel section, a consequence of the wheel manufacturing process.

FIGURE 9: (a) Hardness trend, regional DMU, in flange tip (A). (b) Hardness trend, regional DMU, in flange face (B). (c) Hardness trend, regional DMU, in flange root (C). (d) Hardness trend, regional DMU, in running band (D). (e) Hardness trend, regional DMU, in RCF band (E). (f) Hardness trend, regional DMU, in field side (F).

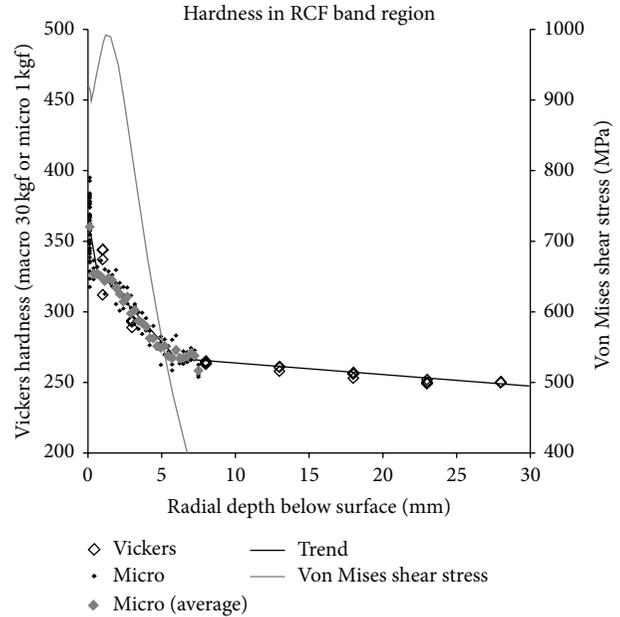
FIGURE 23: RCF band: relationship between predicted maximum von Mises shear stress and hardness in worn wheel.
