Bevan, Adam and Klecha, Stephanie (2016) Use of Magnetic Flux Techniques to Detect Wheel Tread Damage. *Proceedings of the ICE - Transport*, 169 (5). pp. 330-338. ISSN 0965-092X

Use of Magnetic Flux Techniques to Detect Wheel Tread Damage

Dr Adam Bevan*, Institute of Railway Research, University of Huddersfield, UK

Stephanie Klecha, MRX Technologies, Derby, UK

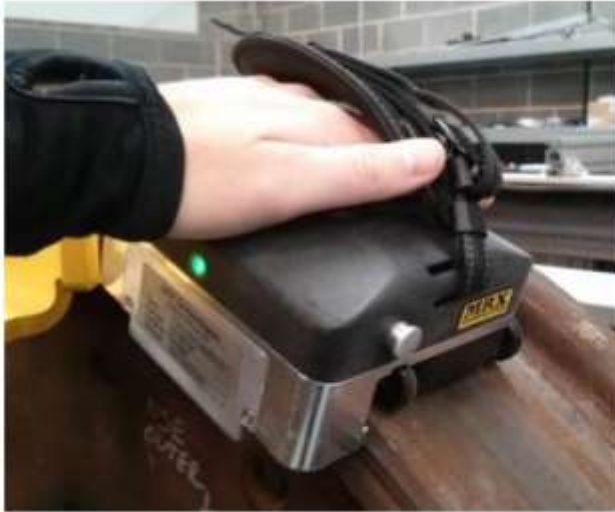
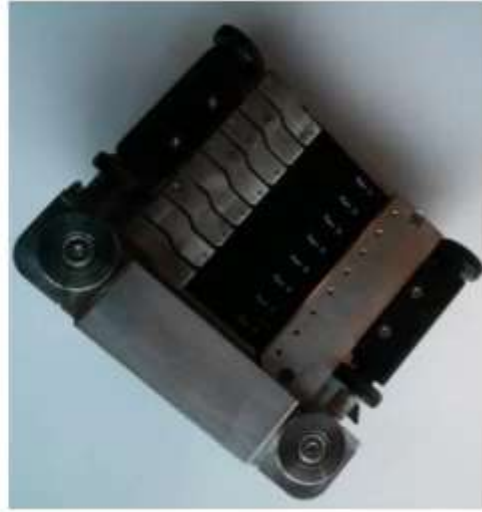
Figure 3. Wheel surface crack measurement hand-held unit and sensor array
