Bevan, Adam and Klecha, Stephanie (2016) Use of Magnetic Flux Techniques to Detect Wheel Tread Damage. *Proceedings of the ICE - Transport*, 169 (5). pp. 330-338. ISSN 0965-092X

Use of Magnetic Flux Techniques to Detect Wheel Tread Damage

Dr Adam Bevan*, Institute of Railway Research, University of Huddersfield, UK

Stephanie Klecha, MRX Technologies, Derby, UK

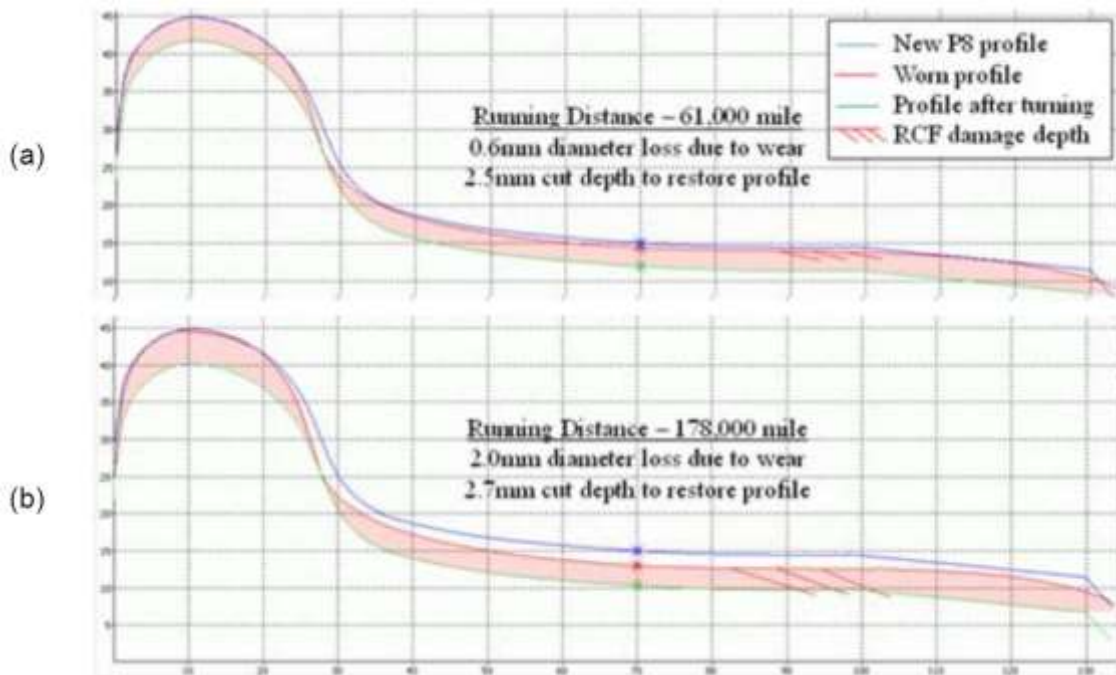
Figure 1. Example radial material loss from the wheel during reprofiling

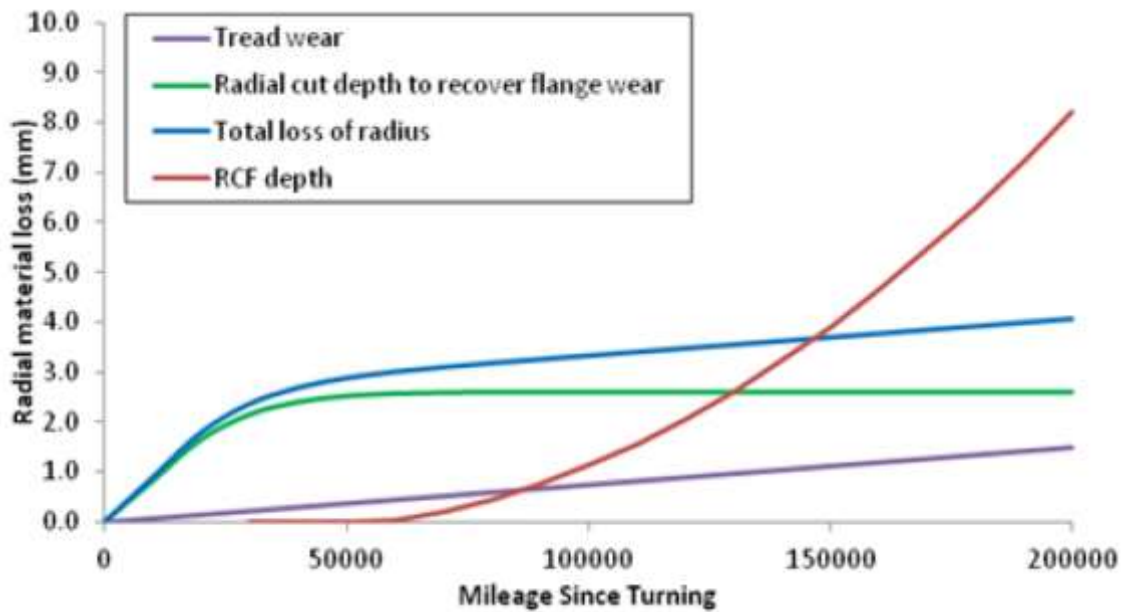
Figure 2. Influence of RCF damage depth on radial material loss (Bevan et al, 2013b)

During previous research (Bevan et al, 2013b; Bevan et al, 2013c), the interaction between the amount of material loss at the lathe to recover the profile (due to tread and flange wear) and to remove the RCF damage has been investigated. Figure 2 shows an example of the radial material loss due to wheel wear, tread damage and the cut depth required to recover the profile shape due to flange wear, expressed as a function of vehicle running distance. Due to the trend in flange wear, the depth of cut on the lathe required to restore the wheel profile remains fairly constant with mileage after the higher initial flange wear rate when the profile is new. As the mileage increases, RCF cracks propagate more rapidly, so the depth of RCF damage increases. At this stage it is necessary to take a deeper cut on the lathe to remove the damaged material. Therefore, there is an optimum turning interval where the material removal needed to restore the profile shape due to flange wear is the same as that required to remove the RCF damage.

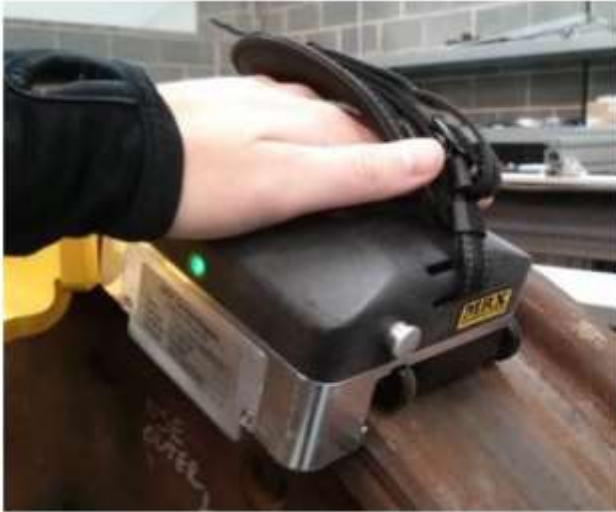
Figure 3. Wheel surface crack measurement hand-held unit and sensor array

MRX's Surface Crack Measurement (SCM) technology has been successfully used to quantify the severity of defects in rails for over 8 years. This SCM technology has recently been adapted to measure surface damage on wheels using a specially developed hand-held unit (HHU). The prototype HHU is illustrated in Figure 3 and is described in more detail below. As part of the Rail Safety and Standards Board (RSSB)/Future Railway Rail Operator Challenge Competition, funding was awarded to validate and further develop the SCM HHU.

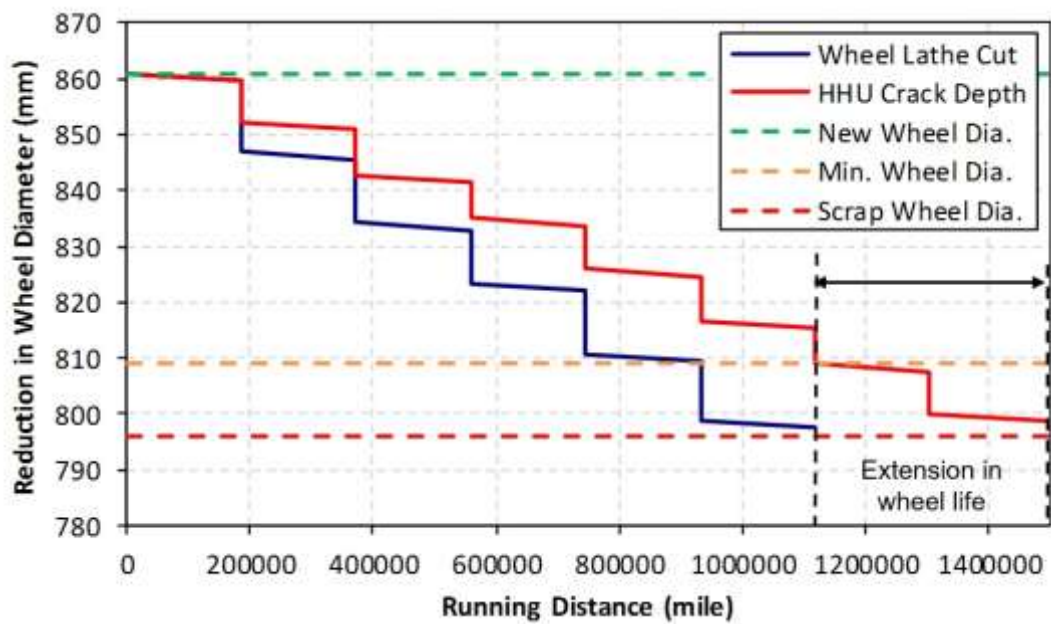
Figure 14 Wheelset life – with and without the use of HHU

This has been demonstrated by tracking the life of a wheelset based on the observed wear rates and cut depths (with and without the use of the HHU). This can be visualised in Figure 14, which shows in the reduction in wheel diameter, due to wear and reprofiling, with running distance. Optimising the cut depth by using HHU results in two additional wheel reprofiling activities (which in this case equates to approximately 370,000 miles of additional running) prior to reaching the assumed wheel scrapping distance.
