What is required to measure the wear of explanted metal-on-metal hips?

Bills, Paul J., Underwood, R.J., Cann, P., Hart, A, Jiang, Xiangqian and Blunt, Liam (2010) What is required to measure the wear of explanted metal-on-metal hips? In: British Orthopaedic Research Society Annual Meeting, 12th-13th July 2010, Cardiff University.

# WHAT IS REQUIRED TO MEASURE THE WEAR OF EXPLANTED METAL-ON-METAL HIPS?

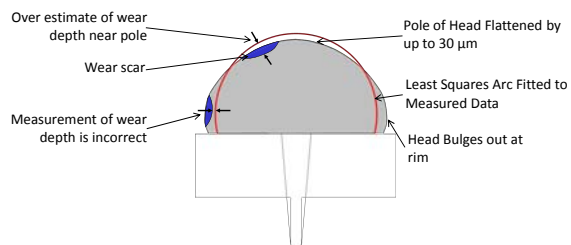
## Wear and Form

- Hip joints are not perfectly spherical as manufactured – the deviations are referred to as “Form”
- The manufactured shape of the components is unknown
- Form errors can be up to 30  $\mu\text{m}$
- Wear may be smaller than form errors
- Need to be able to separate wear and worn when analysing data

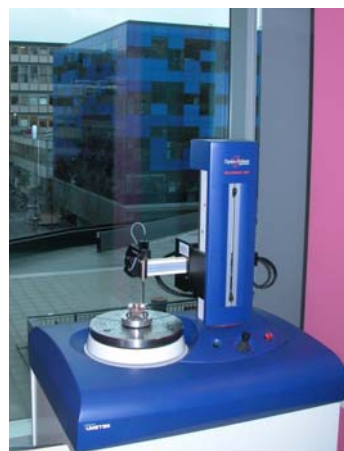
## Talyrond

The Talyrond 365 is a stylus based roundness machine.

Hip located on a rotating table and the stylus measures the deviation from a perfect circle.

Single profile measured to an accuracy of 30 nm and up to 72,000 data points per rev.

Accuracy: Gauge > 12 nm  
Spindle < 0.02  $\mu\text{m}$

Individual roundness profiles can be stitched together to build up 3D maps

### CIRCUMFERENTIAL CUP MEASUREMENT

### POLAR HEAD MEASUREMENT

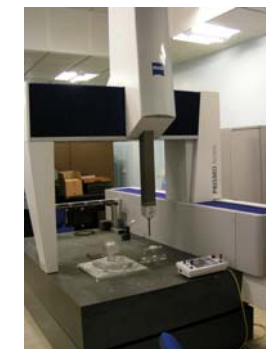
## Co-ordinate measuring machine (CMM)

The Zeiss PRISMO is a co-ordinate measuring machine.

- Hip located in a chuck, probe measures grid of points, scanning whole surface to determine extent of 'unworn area'.
- Unworn area scanned to create a reverse engineered 3D CAD surface which represents the component 'pre-wear' surface.
- Whole surface scanned and deviation is mapped.
- The maximum linear wear and wear volume are then calculated directly.

DIN EN ISO 10360-2

Probing error: 0.7  $\mu\text{m}$

DIN EN ISO 10360-4

Scanning Error: 1.3  $\mu\text{m}$
