The Identification of Shaft Current Induced Defects on Rolling Bearings in Wind Turbine Generators

Long Li, Guangbin Wang, Wenhui Deng

Hunan University of Science & Technology

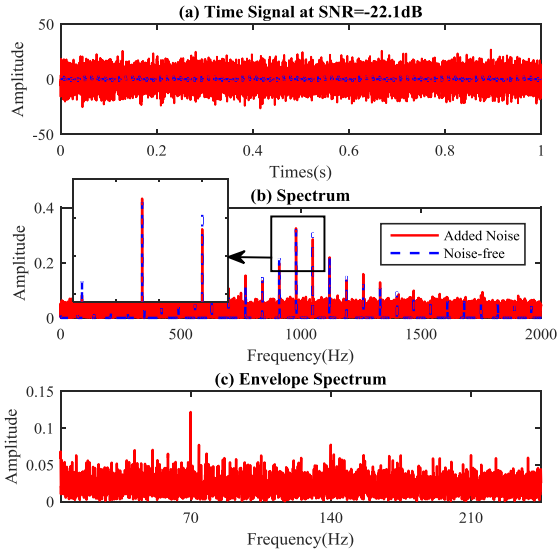
Figure 1. Time domain waveform and spectrum

where, $h(t)$ is the impulse response containing the information of system resonance, $u(t)$ is the periodic impacts at fault frequency and $n(t)$ is the white noise. The fault frequency is $f_x = f_f = 70$ Hz and the carrier frequency is $f_c = 1000$ Hz. Additionally, high level white noise is added to the signal, which results in a -25 dB Signal to Noise Ratio (SNR) to examine the performance of MSB in detecting the fault when it is incipient. The time domain waveform and corresponding spectrum are shown in Figure 1. The noise added signal show no chance to find the modulation feature. The spectrum exhibit certain features of modulation but it is difficult to identify the modulating frequency as the spectral lines are very redundant and many of them are buried by the background noise. Moreover, as shown in the magnified plots, the spectrum amplitudes show clear differences from the noise-free one, which can cause incorrect diagnosis of the fault severity.

Because of the high level noise or the tiny effect of the fault, the conventional envelope spectrum in Figure 1 (c) also fails in separating the fault signal.

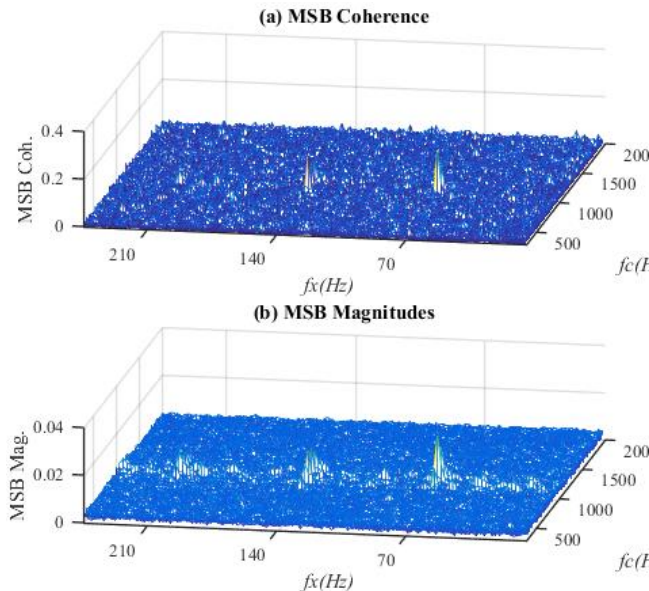
Figure 2. MSB versus conventional envelope

However, MSB results in Figure 2 show several distinctive peaks in the bifrequency plane, making it easy to correlate the peaks with the frequencies of interests. Particularly, either MSB coherence peaks in Figure 2 (a) or MSB magnitude peaks in Figure 2 (b) can indicate clearly the modulation effect between the fault frequency at 70Hz including its harmonics and the resonance at 1000Hz, and hence achieve the fault detection. MSB magnitudes can be used for fault severity diagnosis as its peaks are much less influenced by the noise whereas MSB coherence peaks are more influenced by noise and often an indication of the degree of noise contamination.

Based on these results, it can be concluded that MSB analysis outperforms conventional spectrum and envelope analysis in that it shows a clean or sparse results by integrating the modulating components and carrier components along with the high performance of noise suppression.

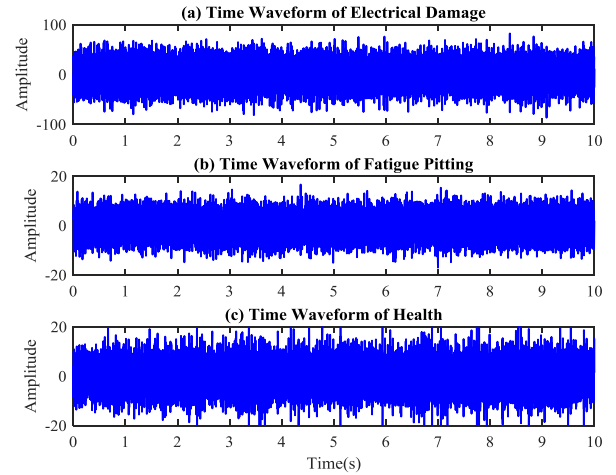
Figure 6. Time domain waveform

The time domain waveform of the normal bearing, pitting fault bearing and electric damage bearing are shown in Figure respectively. It is obvious that the amplitude of electric damage bearing is significantly higher than those of the normal bearing and pitting bearing. While the amplitudes of the pitting bearing and the normal bearing are very similar. So this cannot determine whether there have been damages or not on the bearings. Especially, it is not possible to accurately diagnose if the changes of the signal is from the bearing or other components because these signals exhibit highly random fluctuations and provide little information of bearing characteristic frequencies.

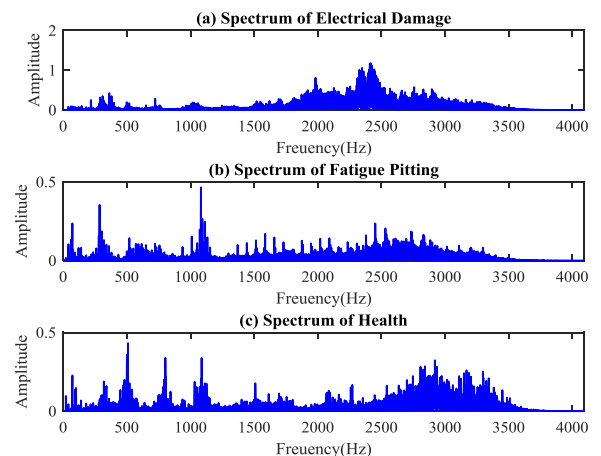
Figure 7. Amplitude spectrum

The frequency domain analysis is shown in Figure and the spectra of three cases shows the shift of the carrier frequencies in the high frequency band but the spectrum analysis is unable to detect the faults as it is hard to identify the components relating to the characteristic frequencies.

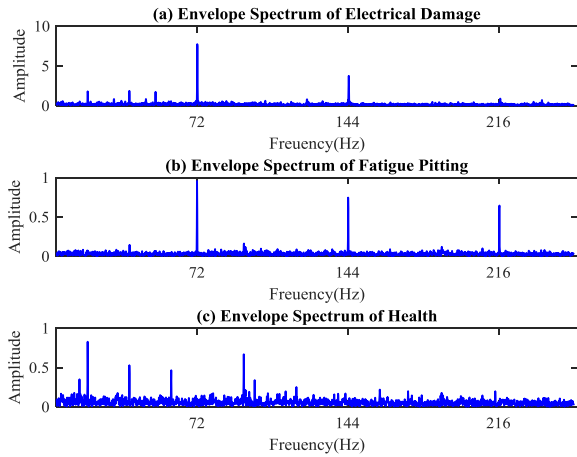
Figure 8. Envelope spectrum

Hence, envelope analysis is carried out to tackle signals from the normal, fatigue pitting, and electric damage bearings. Figure (a) and (b) demonstrate that the fault characteristics of the two fault cases are obvious and additionally, the fault frequency amplitude of the vibration signal from the case of electric current damage bearing is

higher than that of fatigue pitting one, which indicates the fault severity induced by electric damage is more serious. For the health bearing, only the rotating frequency and the corresponding harmonics are acquired by the envelope analysis. Although the envelope spectrum can identify the faults, the envelope analysis is not very sufficient to differentiate the difference between the two faulty cases.

As illustrated in Figure 8 and Figure 9, MSB results allows the fundamental fault frequency and its second and third harmonic to be extracted, which confirms the occurrence of the local faults without any doubt.

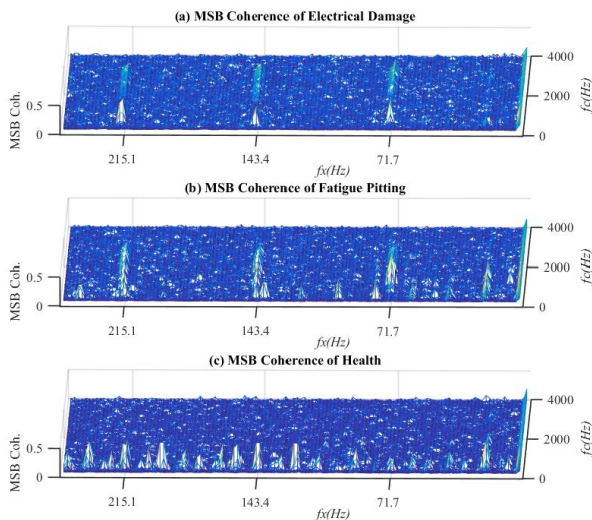
Figure 9. MSB coherence of vibration signals for three cases

MSB analysis is applied to the time domain signals, and then the results of MSB coherence and magnitudes are shown in Figure 9 and Figure 10 respectively. It can be seen that both MSB coherence and magnitudes have only several peaks are significant. Particularly, they highlight not only the occurrence of the outer race fault but also the resonant frequencies associating with the bearing structures, providing more information to make difference between different cases..

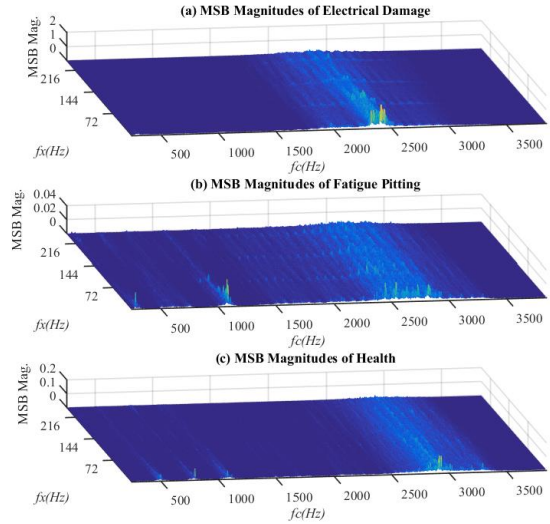
Figure 10. MSB magnitudes of vibration signals for three cases

Moreover, Figure 10 shows that the fault features of three cases are extracted and the carrier frequencies of three cases are different even though the test bearings are the same model. The natural frequencies of the normal bearing is around 2,800Hz while the pitting bearing is at 1,100Hz and 2,600Hz, and electric damage bearing focuses on 2,400Hz. MSB magnitudes, integrating the modulating components and carrier components, shows a clean and sparse spectrum to highlight the fault signature and the bearing system resonant frequencies. The faults induced by electric damage and fatigue affect the dynamics of the bearing system, which leads to the variation of the frequency response function. Combining the fault signatures and the shift of the natural frequencies, MSB is able to identify the fault origin.
